Prestressed Ring Beam in the Church of St. Peter's and Paul's in Bodzanow, Design and Realization

Rafal Szydłowski¹, Barbara Labuzek², Monika Turcza²

Abstract. The present trend in architecture is designing thin, slender and spacious architectural forms. It has become the reason for searching for new solutions and finding new ways of use of the existing construction ones. Recently, the first time in Poland, the post-tensioning has been used in realization of church building. In the Church of St. Peter's and Paul's in Bodzanow (near Cracow) was designed circumferential ring beam post-tensioned with 4 unbounded tendons to transfer peripheral tensile forces from the roof. Thanks to the use of a prestressed ring beam hidden in the wall, large cross-section of roof girders was possible to be avoided, as well as a massive reinforced concrete ring or additional steel tie-rods. The paper presents the applied solutions in details with the theoretical calculated results as well as the results of prestressing measured in site during tensioning of tendons. Based on presented results some conclusions have been drawn.

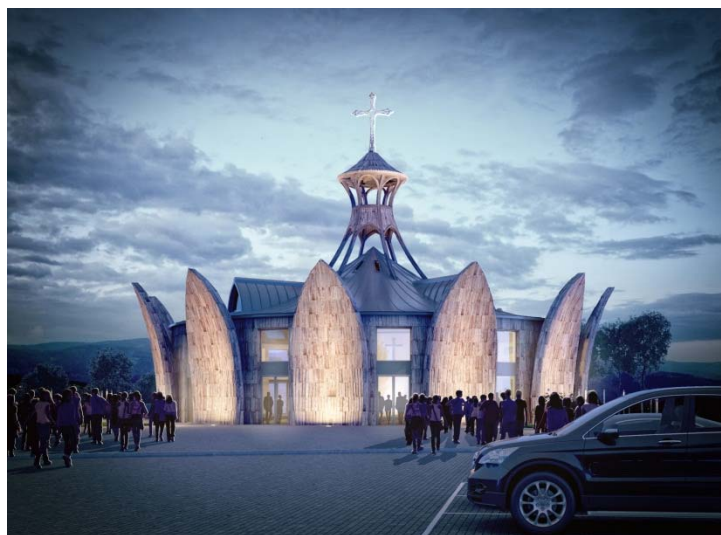
Figure 1. Visualization of Church of St. Peter's and Paul's

The architectural form of the presented church (figure 1) was designed by the Cracow Architectural Design Studio f-11 which implements many modern building projects [2]. In this paper, the structural details and results of theoretical calculation are presented as well as the report from realization and the results of radius displacements and concrete strains due to prestressing. Based on the obtained results some conclusion about the propriety of the design assumptions and calculation were presented.

The view of the Church of St. Peter's and Paul's in Bodzanow (nearby Wieliczka) is shown in figure 1. The shape of the church was designed on a plan of a 25.5m diameter circle (figure 2a), The structure of the building is made of 12, steadily positioned on the perimeter, RC columns of the cross-section of 0.4×0.6 m, On the columns, radiating roof girders made of laminated wood are sustained (figure 2b).

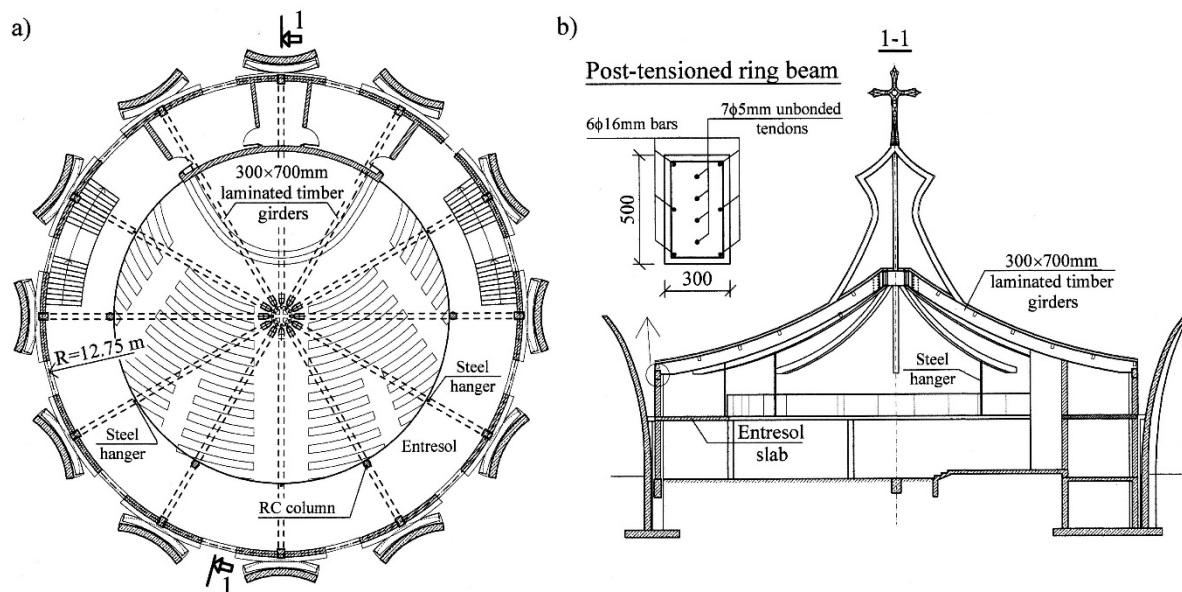
In the building, a ring-shaped entresol, made of reinforced concrete, was built on the level of the first floor, sustained on the external edge on 12 columns, and on the internal edge on 6 columns, made of concrete (figure 2a). Additionally, on the internal edge, between the columns, 6 suspensions to the roof girders were used.

Figure 2. The church plan (a), vertical cross-section and post-tensioned ring beam (b)

A reported prestressed ring beam was designed with the cross-section of 300×500mm (figure 2b and 3) and concrete class of C30/37. Prestressing with 4 unbonded tendons, positioned in the vertical axis of the cross-section, was applied. Tendons of 7φ5mm made of Y1860 steel were used. The ring beam is reinforced in the longitudinal direction, by 6 bars of φ16mm and by transverse stirrups of φ6mm every 200mm. It was assumed that the prestressing will be implemented once the reinforced structure will be done and before the installation of the roof girders.

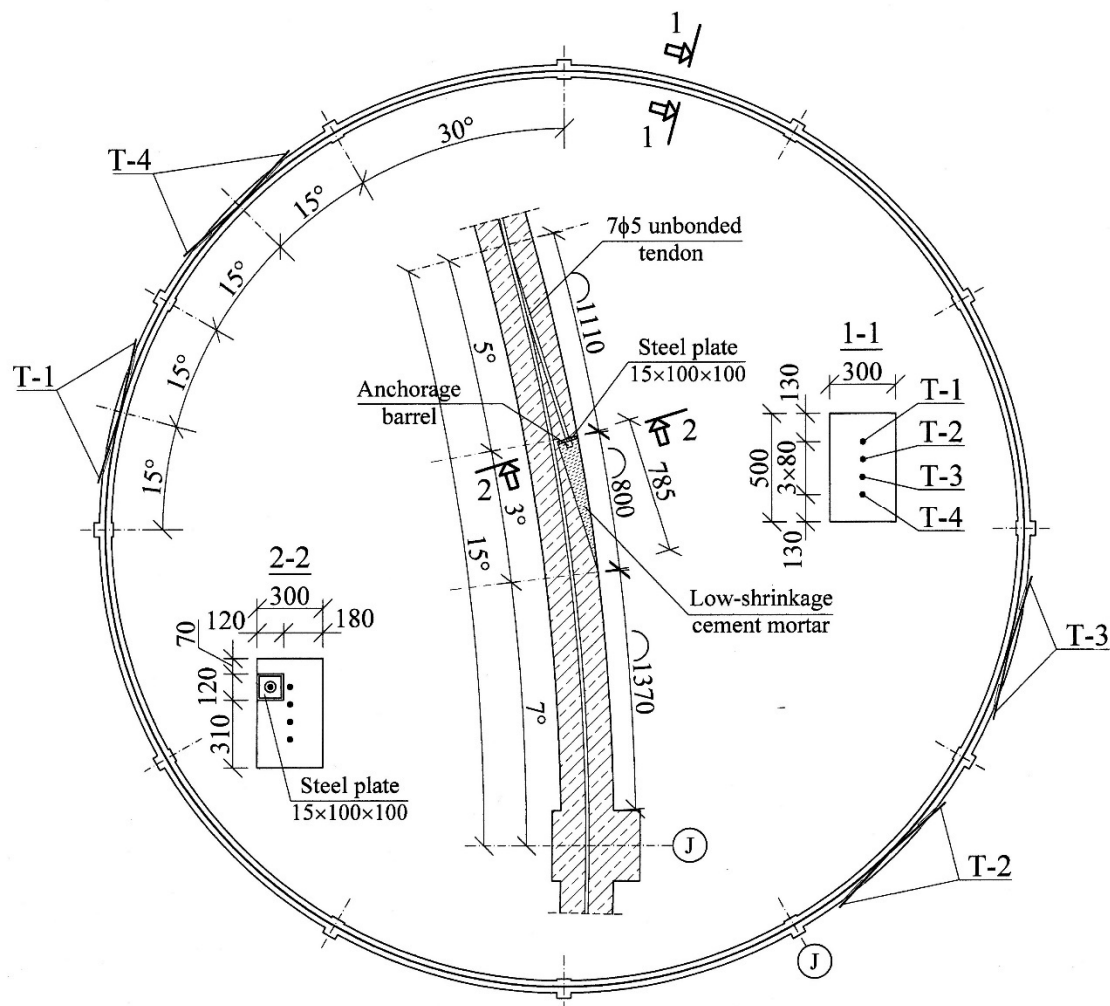
All of 4 tendons are tensioned with a force equal to 200kN. Each of the tendons surrounds the entire circumferential ring beam. The tendons are anchored in anchor grooves, two tendons on two opposite sides of the ring beam alternately (figure 3).

Figure 3. Circumferential post-tensioned ring – scheme of tendons anchoring

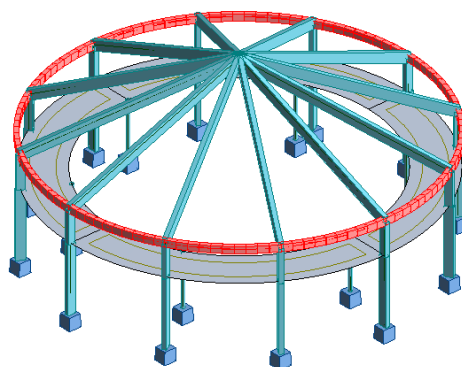
The analysis was carried out on the model created in the FEM system, which is shown in the figure 4. The model consisted of concrete columns, entresol slab, peripheral ring beam and roof girders. The bar and the shell elements of the geometrical and material characteristics, which matched the ones applied in the project, were used. The following two models were analyzed: prestressed model with and without the roof structure. The prestressing force was considered as the circumferential radial load applied to the ring beam and directed to the centre. The force after the total loss was assumed, which has value of 75% of the initial force (15% - immediate loss, 10% - time-dependent loss).

Figure 4. Church structure FEM model

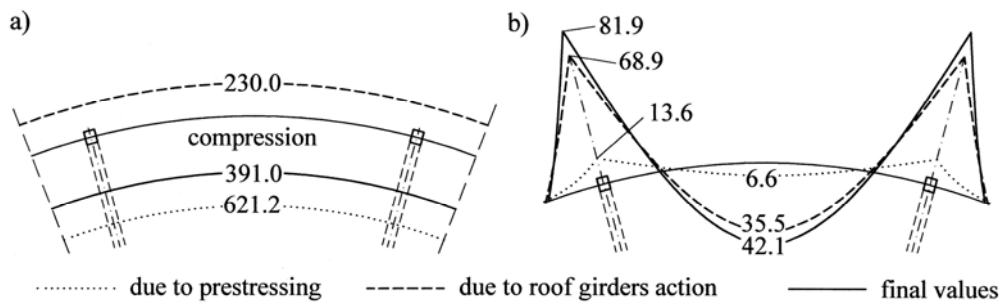
Figure 5 shows the distribution of the longitudinal forces inside the ring beam and bending moments after the prestressing (dotted line), due to roof girders action (dashed line) and final values (continuous line). The axial force of 621.1kN and bending moment with changeable sign caused by the stiffness of the columns, with the value of -13.6kNm above the columns and +6.6kNm between the columns, were entered due to prestressing. As a result of the forces coming from the roof girders, the compressive axial force was reduced to the value of 391.0kN, the bending moments escalated to the value of -81.9 and +42.1kNm.

Figure 5. Diagrams of longitudinal force in kN/m (a) and bending moment in kNm/m (b) in the beam ring

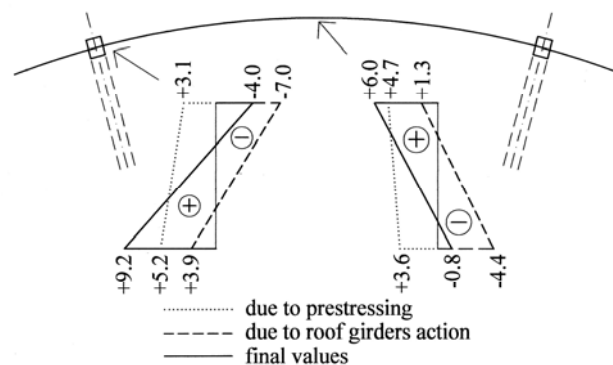
The analysis of the stress inside the ring beam (figure 6) showed the occurrence of tensioning in the cross-section above the columns, with a value of 4.0MPa (continuous line). This value does not guarantee that there are no cracks. The ratio of bending moment to the cracking moment is $81.9/45.0 = 1.82$. Such value is small and safe for the increase of deformations resulting from the cracking. The calculated width of the cracks according to [6] is 0.15mm.

Figure 6. Concrete cross-section stress diagrams (in MPa)

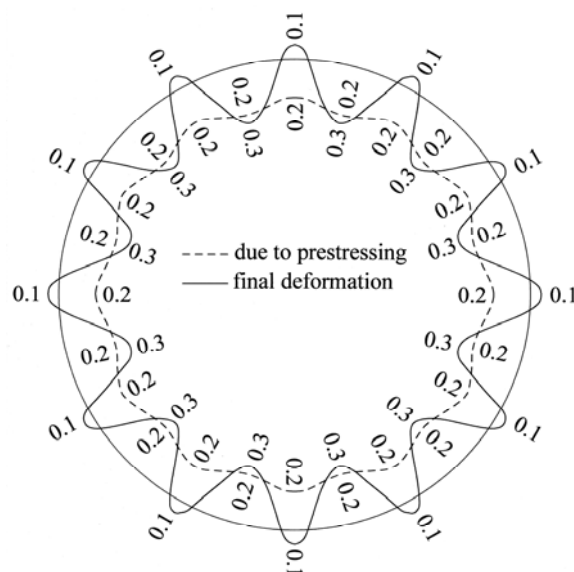
Figure 7 shows the deformation of the ring beam after prestressing (dashed line) and the final deformation (continuous line) resulting from the action of the load coming from the roof girders. Prestressing leads to the regular movement of the ring beam to the centre, with a value of 2.0mm. The load coming from the roof girders leads to the deflection of the ring beam. When the axial distance of the columns (measured along the chord) is 6.8m, the value of the deflection is 3.0mm.

Figure 7. The ring beam deformation (in mm)

The measurement of radial displacements was made with the use of a laser tachymeter set on a reinforced concrete slab at the center point of the church (figure 10a). Benchmarks were used in the form of aluminium sheets, with the dimensions of 30×30mm cut at an angle of 19°, so that the laser beam falls perpendicularly on sheet. Measurement of the displacement was made at all available points in the middle of the span between columns and on the columns. The accuracy of the used measuring device was ±0.05mm/m. which allows to deduct that the obtained results are measured with an accuracy of ±0.75mm. Figure 10b shows the distribution of measured radial displacements of the ring. The obtained results should be related to the calculated results (figure 7) amounting to 2mm on the whole circumference.

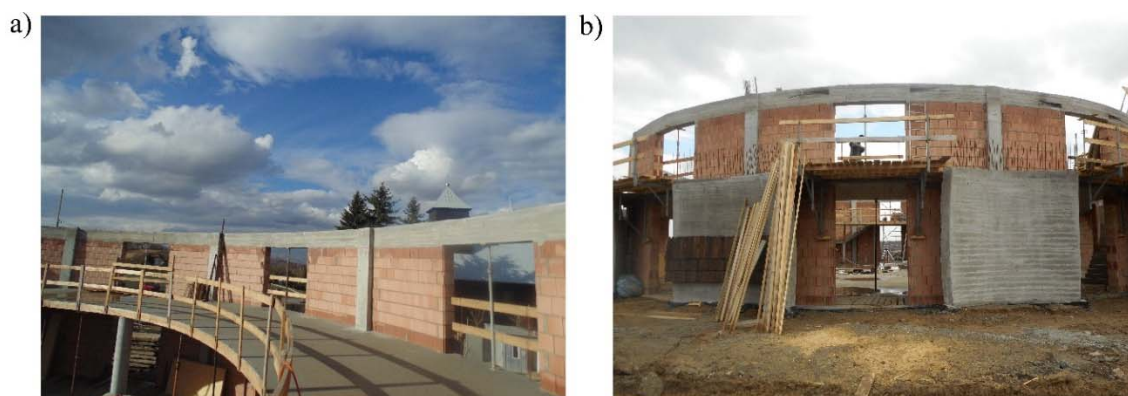
Figure 8 presents a view of the completed reinforced concrete and masonry structure of the church with the entresol slab and the circumferential ring beam with internal unbounded tendons installed. Photograph 8a shows the circle columns supporting the entresol on the inner edge in every second radial construction axis. On the rest of the axes, the slab will be suspended to the roof after its erection. Picture 8b shows the location of the anchor grooves on one side of the perimeter.

Figure 8. View of completed reinforced concrete and masonry structure

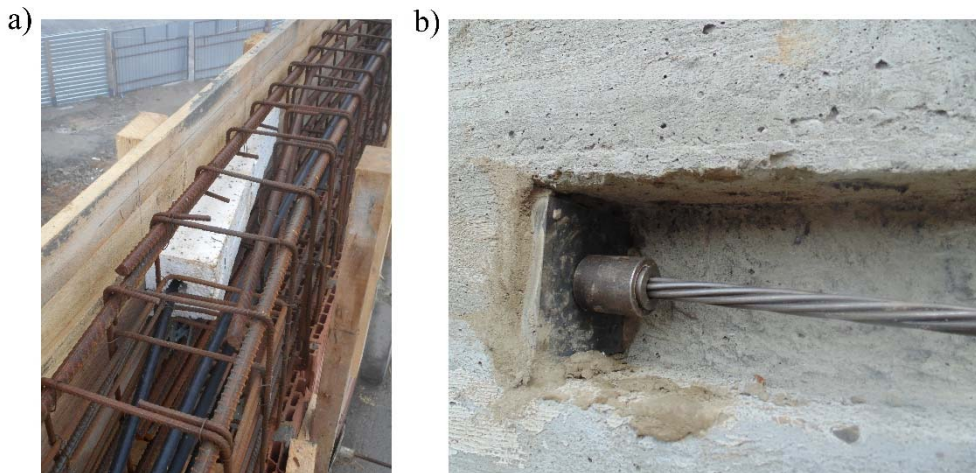
Figure 9a shows a method of forming a groove for anchorage. At the location of the groove, a profiled polystyrene insert was input with a hole inside, through which the tendon was passed. It was important to profile the duct and trace the tendon so that it would exit the forefront of the groove perpendicularly. In the case of non-perpendicular cable tracing in the anchorage zone, there is a risk of cutting the tendon during tensioning. Figure 9b shows the steel anchorage with a resistance steel plate installed. After the prestressing, the anchor grooves were filled with a low-shrinkage cement mortar to provide corrosion protection for anchorages and steel plates.

Figure 9. Ring beam reinforcement and styrofoam insert forming anchoring groove (a), steel resistant plate and tendon anchorage (b)

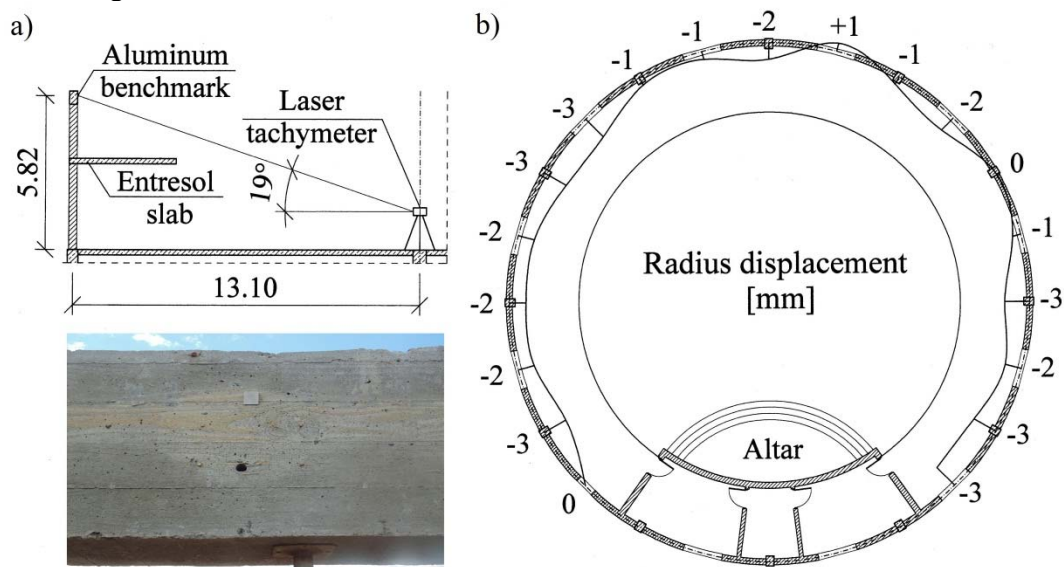
Figure 10. Method of measuring the radial displacement of the ring beam during prestressing (a), obtained results (b).

Although strong disturbance of regularity were observed on the perimeter (even opposite displacement with a value of 1mm in one of the spans), the average value of the measured points was 1.8mm, thus it was close to the estimated 2mm (this value is given with an accuracy to full millimetres and therefore to the nearest 0.5mm). The obtained compression effect corresponds to the expected one and the irregular deformation may be a result of impreciseness in the geometry of the ring beam arose during preparation and erection the structure, as well as the profiling of the tendons. Strong refracture of the ring line can be noticed, which could have contributed to its irregular deformation from the prestressing.

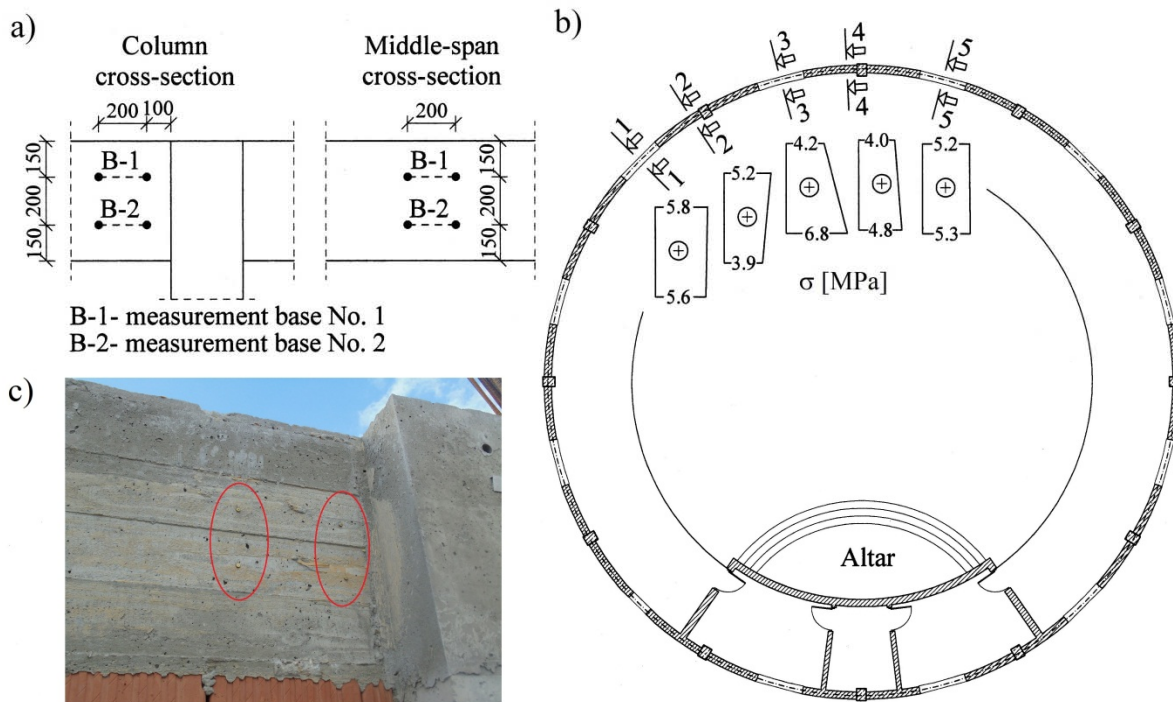
The measurements of concrete deformation were made through a DEMEC-type extensometer with a base of 200mm. The cross-sections, in which the deformation was monitored are shown in figure 11b. The measurement points were placed on the inner and outer sides of the ring. Localization of the measurement points in the column and middle-span cross-sections is shown in figure 11a and their and their view in figure 11c.

Figure 11. Localization of strain benchmarks in the column and middle-span cross-sections (a), localization of monitored cross-sections as well as the calculated stress diagrams (b), view of strain benchmarks (c)

Table 1 summarized the values of the concrete strains measured in the characteristic cross-sections of the ring beam (figure 11c) and the calculated stresses. The strains in each cross-section was calculated as the average value of the two measurement bases. Due to the fact that the prestressing was to be carried out not earlier than 3 weeks from concreting, mechanical properties of the concrete were not examined. The values of stresses in the cross-section were obtained by multiplying the measured deformations by the standard value of the elasticity modulus of concrete amounting to 32GPa. Because of the prestressing was completed 26 days after concreting the element, it is highly probable that the standard value was reached.

The results of the measured strains and the estimated stresses are shown in table 1 and figure 11b. While both in span cross-section and the column cross-section, no regularity of stresses was observed, it is interesting to compare the mean cross-section stresses in the middle-span and near the column. The calculated mean stresses in cross-section, right after tensioning of tendons, amount to 5.0MPa around the perimeter of the ring (do not compare with figure 6. there the stresses from prestressing are given after time-dependent prestressed losses. not after prestressing). The values of 5.7, 5.5 and 5.2MPa were obtained for the middle-span cross-sections and 4.6 and 4.4MPa for column cross-sections. The values obtained in cross-sections near the columns are therefore clearly lower than in the cross-sections in the middle of the span. This fact is certainly caused by masonry walls near the columns on which the ring beam was poured. Part of the prestressing force was transferred to that walls.
