# Non-Destructive Testing of Steel Fibre Reinforced Concrete

**D Corbett<sup>1</sup> and G Tronca<sup>1</sup>**

**Abstract.** For standard reinforced concrete, there are several non-destructive test (NDT) methods available for measuring the concrete cover and for locating subsurface objects and defects. Whether or not these methods may also be applied to fibre reinforced concrete has been the subject of a recent study. The results and a recommendation for the most suitable technology for use with fibre reinforced concrete is the topic of this paper.

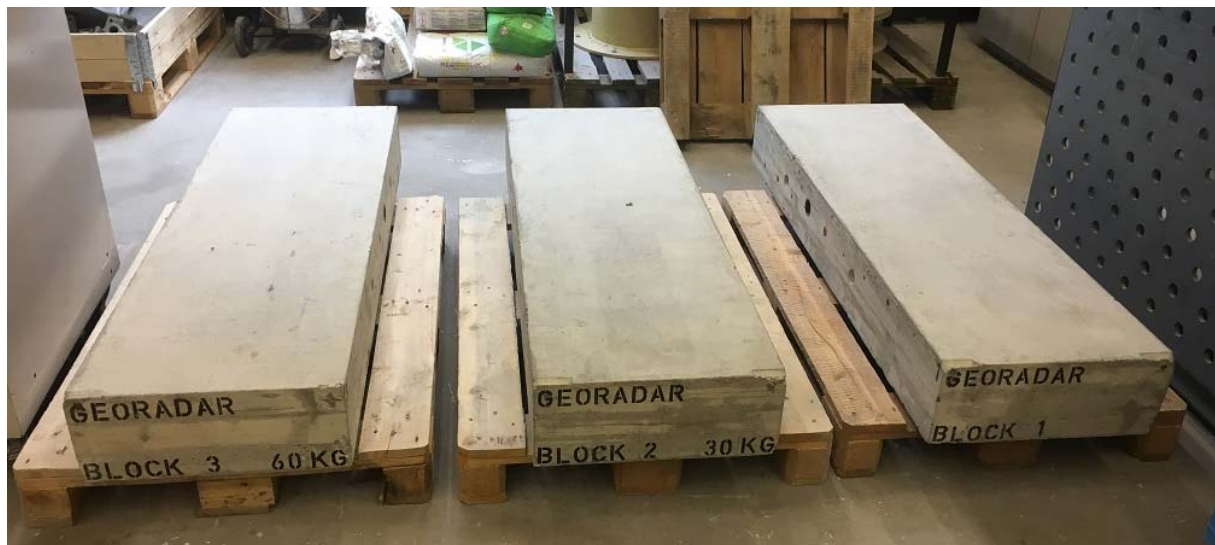
**Figure 1.** Test blocks

Three test objects were made available by HSR. Each test object was a 150x50x20cm concrete prism with eight different rebars and a plastic tube embedded at different depths (Figures 1 and 2).

Although identical in size and layout the difference between the test objects was in the fibre content of the concrete used. Test block 1 was constructed with standard concrete with no fibre content. Test block 2 had a fibre content of  $30 \text{ kg/m}^3$  and test block 3 had a content of  $60 \text{ kg/m}^3$ . Dramix steel fibres  $1 \times 50\text{mm}$  were used. The concrete used had a concrete compressive strength class of C25/30 with a maximum aggregate size of 32mm.

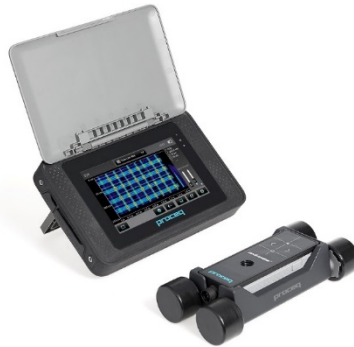
**Figure 3.** Profometer 650 AI Cover Meter

The instrument used for this test was the Proceq Profometer 650 AI (pulsed eddy current), Figure 3. This is a typical cover meter working on magnetic eddy current principles. This technology is generally recognized as providing the most accurate assessment of cover on site.

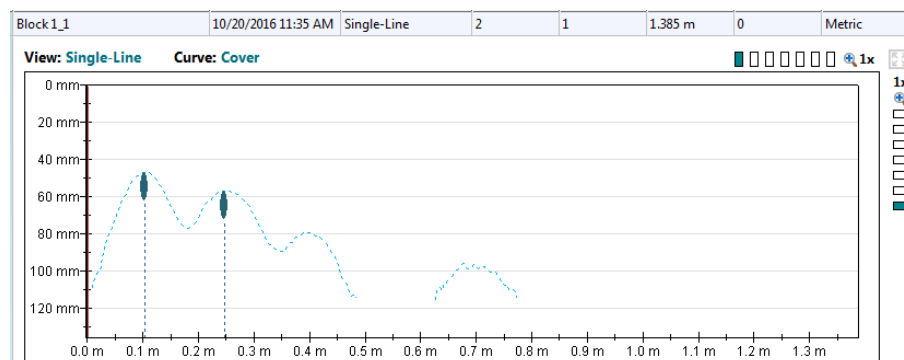
**Figure 4.** Block 1 Eddy Current Single-Line Scan

Longitudinal single line scans were made on all three blocks. Such scans record the signal strength as the scan cart is moved along the block and also detects the location of rebars automatically. The signal strength is converted into concrete cover based on the rebar size. Figure 4 shows the result from test block one which acts as the reference block.

The first two rebars can be easily detected as they lie within the standard measuring range. After that the signal strength becomes too small for automatic detection, although from the cover single line it is easy to see the location of the 3<sup>rd</sup> rebar and the 5<sup>th</sup> rebar. The 4<sup>th</sup> object is a hollow plastic pipe which cannot be detected by magnetic eddy current instruments.

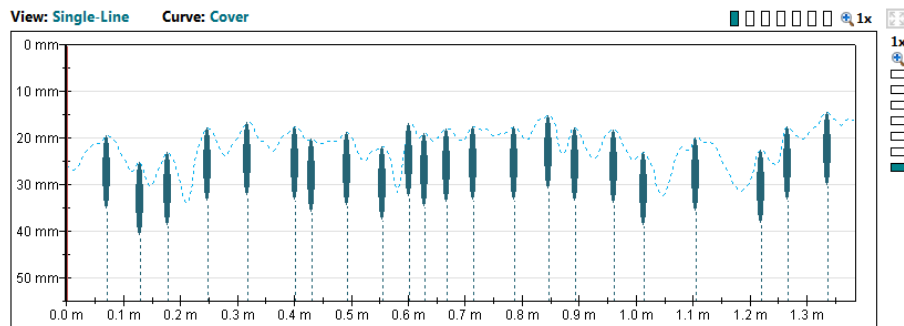
**Figure 5.** Block 2 Eddy Current Single Line Scan

Now compare this with the scan of block 2 containing 30 kg/m<sup>3</sup> of steel fibres.

No rebar can be clearly detected. The signal curve was always affected by large numbers of local peaks, completely masking the actual position of the rebars. The same occurred when testing on block 3 with the higher steel fibre content.

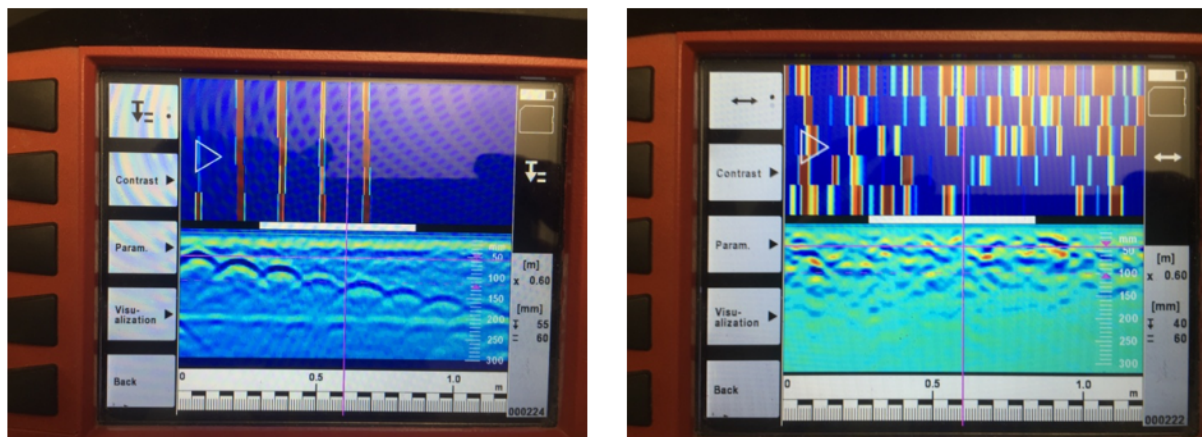
**Figure 6.** Hilti GPR scan of block 1 (left) and block 2 (right)

Two instruments were used for this test, the Hilti PS-100 and the GSSI Mini Structure Scan XT. Once again scans were carried out on the reference block and then on the blocks containing fibres. The results from each instrument can be seen in Figures 6 and 7.

In both examples, it can be seen that the rebars and also the hollow pipe can be clearly detected on block 1. The back wall is also clearly identifiable. However, on block 2 the results are meaningless. It is impossible to detect the objects.

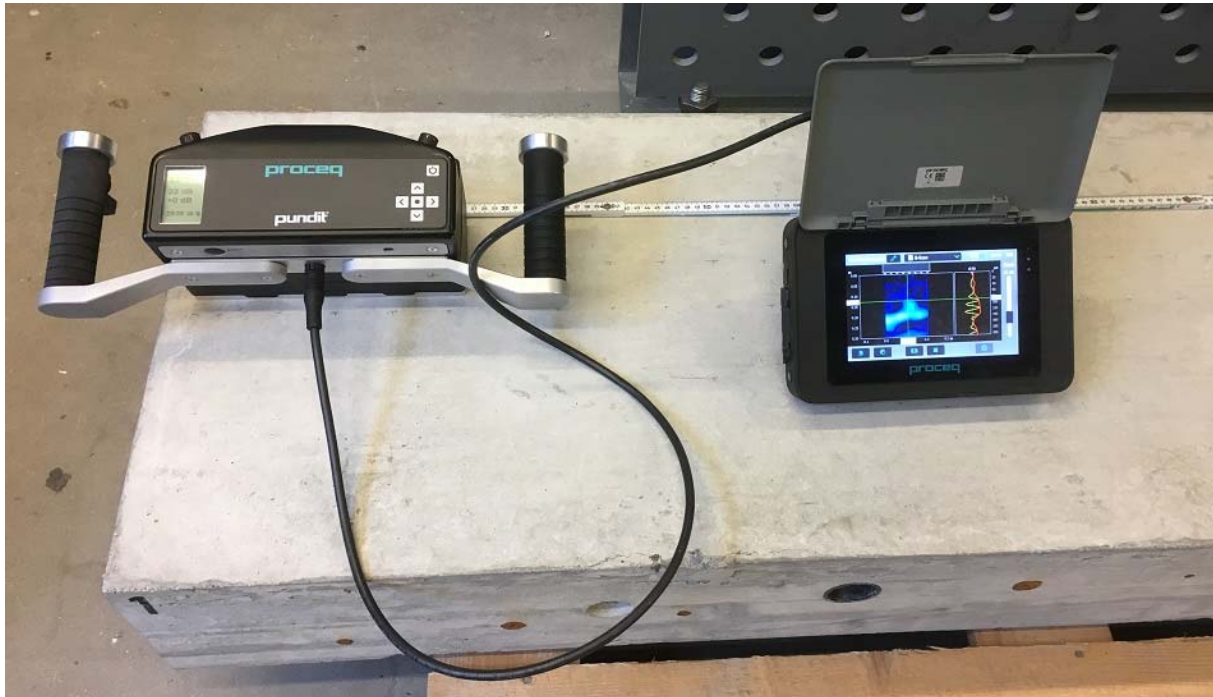
**Figure 8.** Pundit 250 Array Ultrasonic Pulse Echo Instrument

The instrument used for this test was the Proceq Pundit 250 Array.

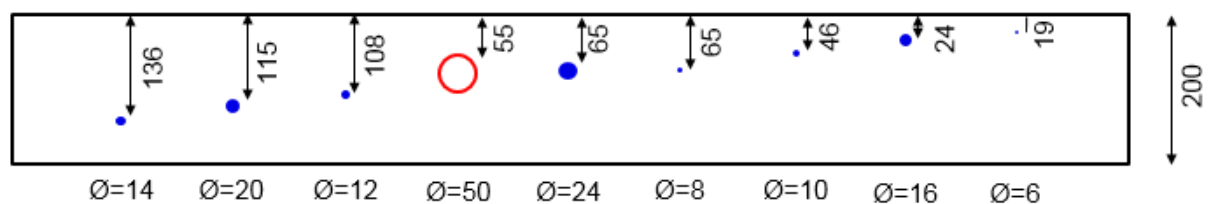
**Figure 10.** Test Block Orientation for Pulse Echo Tests

When the ultrasonic pulse echo testing was carried out the test blocks had been flipped over when compared with figure 2. The actual orientation can be seen in Figure 10

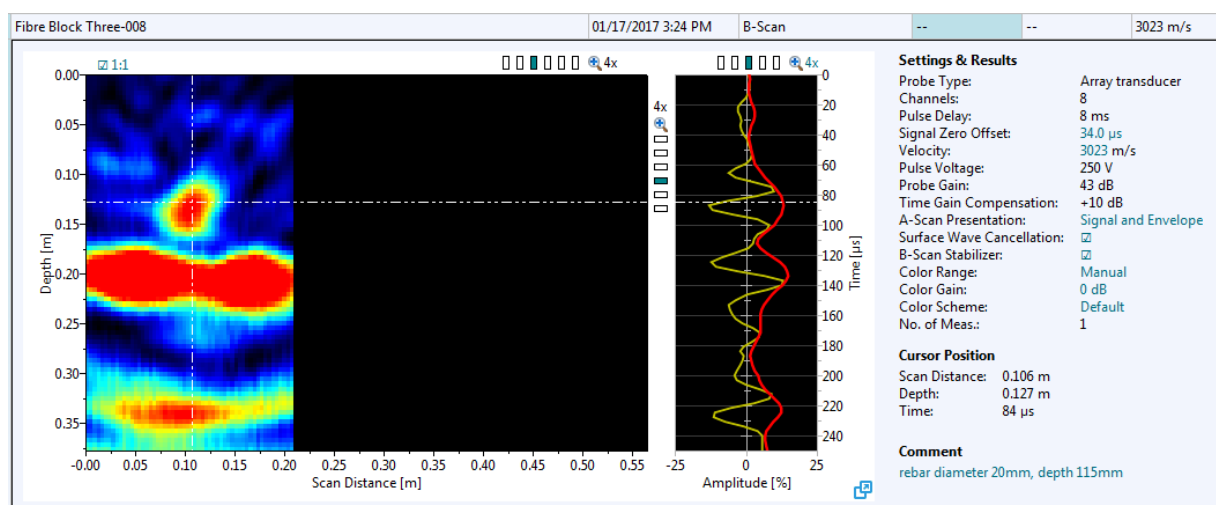
**Figure 12.** Rebar Depth Measurement

Once the pulse velocity has been determined the depth of the objects within the structure can be measured. An example is shown in figure 12.

Here we can see that the rebar depth is estimated at 12.7 cm. The actual depth is 11.5 cm. This has to do with the measurement technique using the peak of the echo. While easier to detect than the onset

of the received pulse, the effect of ringing of the signal is not always constant and this can lead to some errors. This is clearly something that needs to be refined if accurate depth information is required.
