Earth-Fill Dam Monitored by EIS Method during Application of Nutrient Aqueous Solution used in BioSealing Method

Abstract. The paper gives short information about the results of monitoring the electrical properties of an earth-fill dam during the application of a nutrient aqueous solution used in the method BioSealing. Monitoring is carried out using a Z-meter device when applying the method of electrical impedance spectrometry and, in some cases, is part of a system of monitoring seepage through the earth-fill dam of the water reservoir by its administrator. Information about the changes that take place in the body of the dam during the movement of the water level in the reservoir or after the influence of weather changes or human activity are given through the monitored changes in the electrical parameters of the soil of the dam with time.

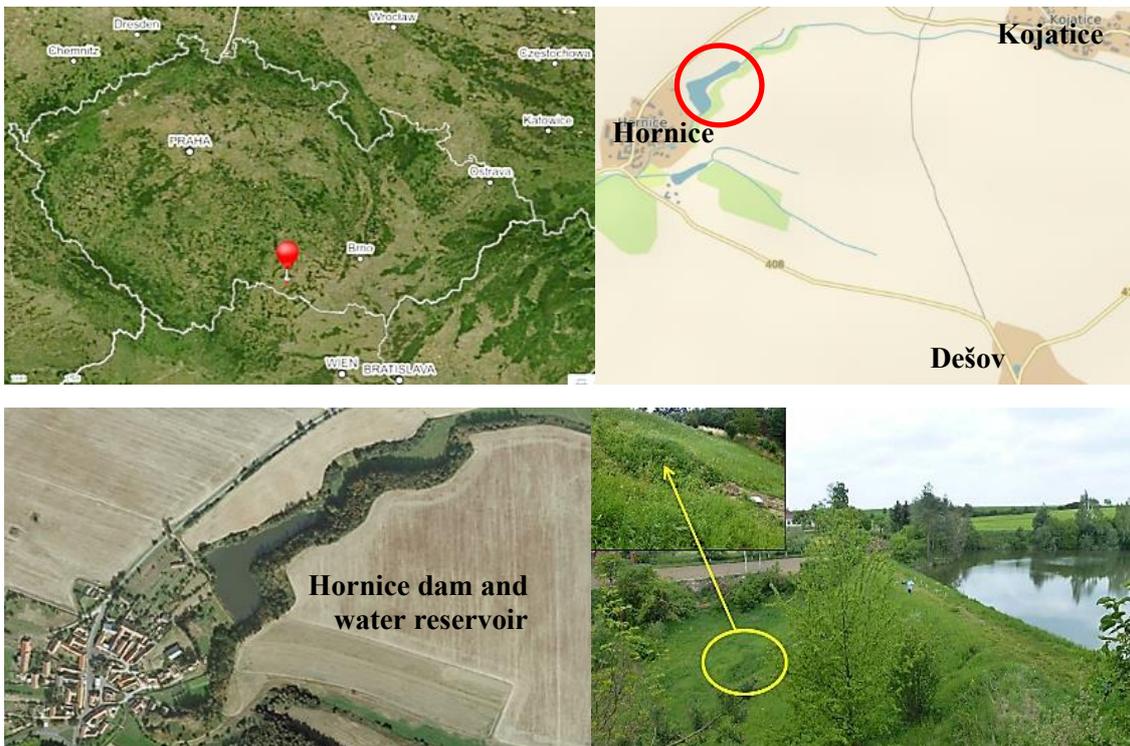
Figure 1. Situation of the location, earth-fill dam and seepage area.

The Hornice dam and water reservoir lies in the CR, southwest of the City of Brno, north of the municipality of Hornice (Figure 1). The dam and water reservoir was approved on 31 May 1985 and originally served as an irrigation reservoir. Water from the reservoir was collected through an accumulation tank to an irrigation station located below the dam and from there it was taken for irrigating adjacent plots of land. But it does not serve this purpose anymore. At the present time it is used only for the retention and accumulation of surface water and for fish farming and duck breeding by local unions and associations. Since 2012, when property settlement was agreed on, the owner of the dam and water reservoir is Zemědělské družstvo Dešov (Farming Cooperative Dešov).

The height of the dam above the original ground is 8.22 m, and the height of the dam above the base of the dam is 11.20 m [9]. A gravel road runs on the dam crest; its average width is 4.25 m (at the beginning it is 4.30 m wide, above the place of the observed seepage 3.80 m wide and at the railing securing the roughened chute 4.65 m wide). According to the project [9] the dam at its base is 46.80 m wide. The upstream face has a slope 1:2.5 and is fortified with stone packing. The downstream face of the dam has a designed slope 1:2.5 as well, but when installing the EIS monitoring system, a change in the slope was detected, which is probably a result of deformation of the downstream face due to the forming inrush area (Figure 1). The downstream face is provided with maintained grass cover.

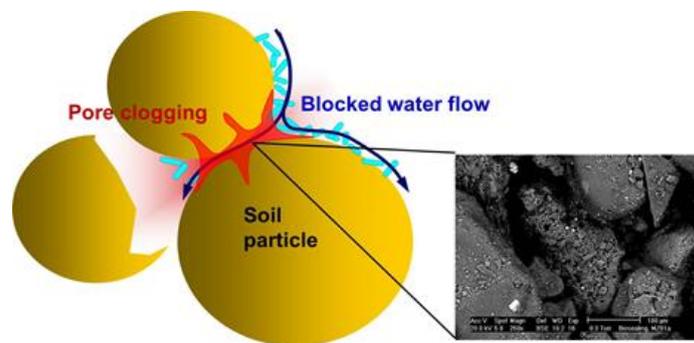
Figure 2. Principle of BioSealing - a combination of microbiological and biochemical processes.

The BioSealing method is based on the stimulation of the biological activity of bacteria, which occur naturally in soils (Figure 2) [12]. The number and type of these bacteria is governed by the properties of soils, such as pH value, temperature of water in soil or salt content. Their activity is stimulated using the injection of nutrients close to the place of seepage. Water flowing through soil transports nutrients towards the place of the highest seepage where the number of bacteria present and their products will rise due to nutrition. During the process the chemistry of the soil can change, as well as the transport of bacteria and the capture of fine particles transported by the flowing water.

Bacteria produce slime that surrounds particles and the soil is thus sealed. Approximately 8 weeks after the injection of nutrients, the bacterial activity begins to decrease and returns to the original state. The fine particles captured in the bacterial slime, however, form a solid seal which remain even after the death of the bacteria. The conditions under which it is possible to apply the technology are described by Liao [13].

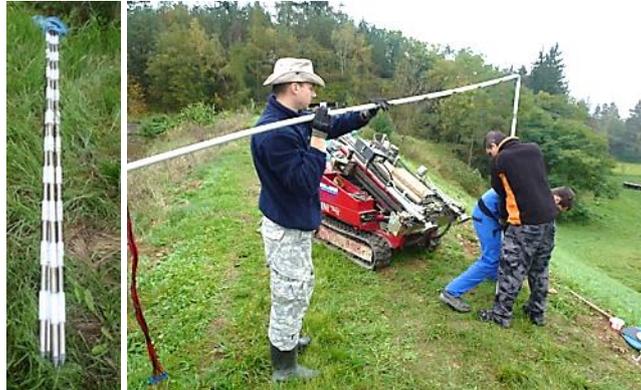
Figure 3. Detailed view of the EIS3 probe, installation of the EIS10 probe using a Pagani rig.

Measurement was conducted using two active EIS probes. One (EIS10) was installed from the dam crest, being 10 m long and containing 22 sensors, with the first sensor being placed at a level of 1 m beneath the dam crest, and the second (EIS3) probe was 3 m long, containing 16 sensors, with the first sensor being placed beneath the dam crest on the downstream face in the area of the forming inrush area at a depth of 3.03 m beneath the dam crest, with the first electrode being 0.03 m beneath the

surface. The probe 10 m long was installed in the dam crest 0.15 m from the upper edge of the downstream face of the dam; the installation was made using a Pagani rig (Figure 3) and the first electrode is at a depth of 1.0 m.

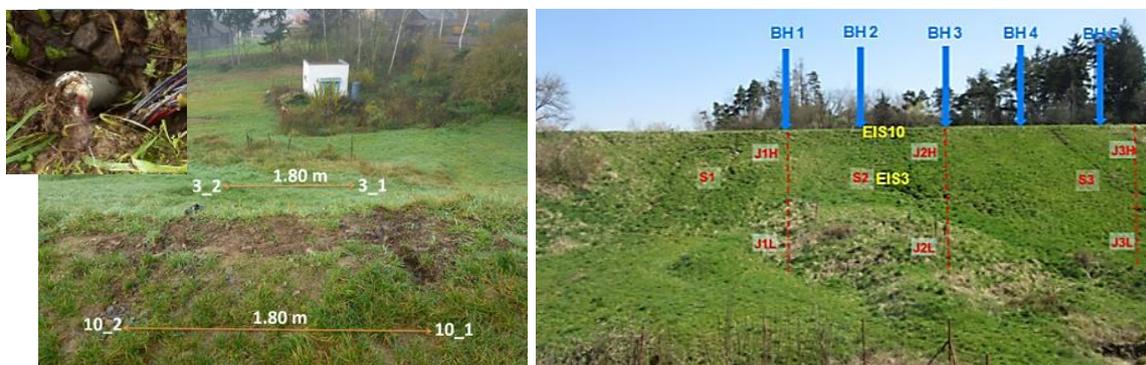
Figure 4. Detailed view of the position of the installed rods and the measuring system.

The probes are divided, with the conductive part (electrode) being made of a stainless steel tube of 0.025 m in outer diameter, 0.002 m in wall thickness and 0.05 m in length; the non-conductive part is made of a polyamide tube of 0.025 m in outer diameter. The probes of the EIS method are installed as pair probes in a two-terminal connection (the driving electrical circuit is not separated from the measuring electric circuit), with the spacing between the rods (Figure 4) respecting the field possibilities and the condition of not exceeding the spacing 2 m for the reasons of transmission of the generated driving signal (limiting the effect of the geoelectromagnetic field of the Earth). The transmission of the signal is ensured by the conductors passing through the tubes and then through corrugated cable protection hose pipes in the dam soil.

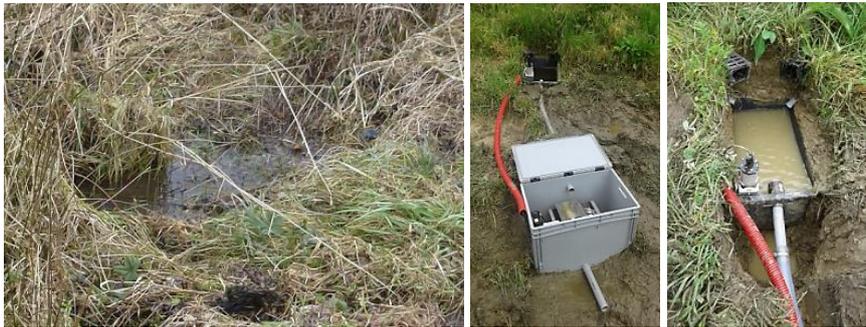
Figure 5. Detailed view of the place of seepage with the clear water inrush and the system measuring seepage, temperature, electrical conductance and pH of seepage water.

Two sensors were used for the measurement of the water level in the reservoir, the first one was based on the measurement of electrical impedance and the other one (ESMWLPS Water Level Sensor) was based on measurement of relative hydrostatic pressure. The patterns were supplemented by the values of visual observation and manual measurement. The main parameter documenting the application of the nutrient aqueous solution used in the BioSealing method was seepage measured by a PF500 shuttle tilt flowmeter (Figure 5). The system was also fitted with an ESP11 sensor of electrical conductance, pH and temperature.

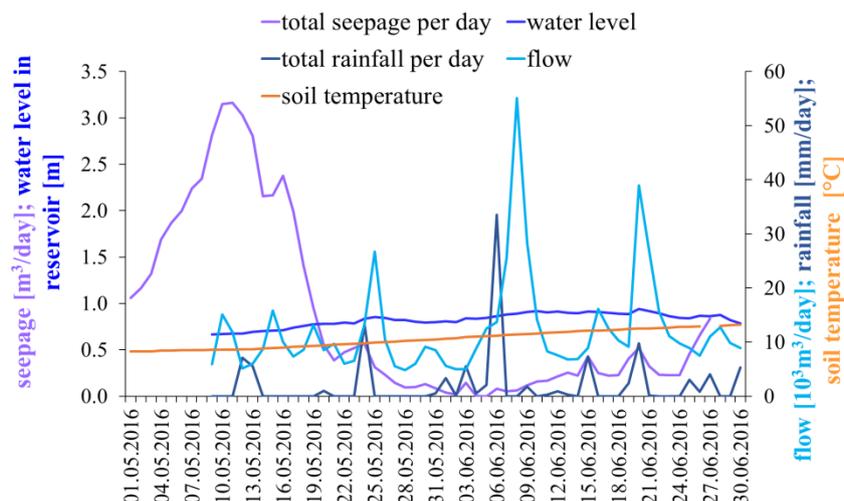
Figure 6. Monitoring of the BioSealing process.

The achieved values of seepage, water level, precipitation and temperature with time are given in Figure 6. The application of the nutrient aqueous solution took place in a period between 9 May 2016 and 3 June 2016. In this period, seepage through the dam body significantly dropped. On 24 May 2016, a more striking precipitation episode was recorded on the site, reflected in the patterns of practically all the parameters. On 2 June 2016, the emergency spillway was gated and the water level in the reservoir was gradually rising. Conversely, on 29 June 2016, the spillway was opened. In the period following 5 June 2016, several more significant precipitation episodes occurred, manifested in increased seepage (15 June 2016 and 20 June 2016).

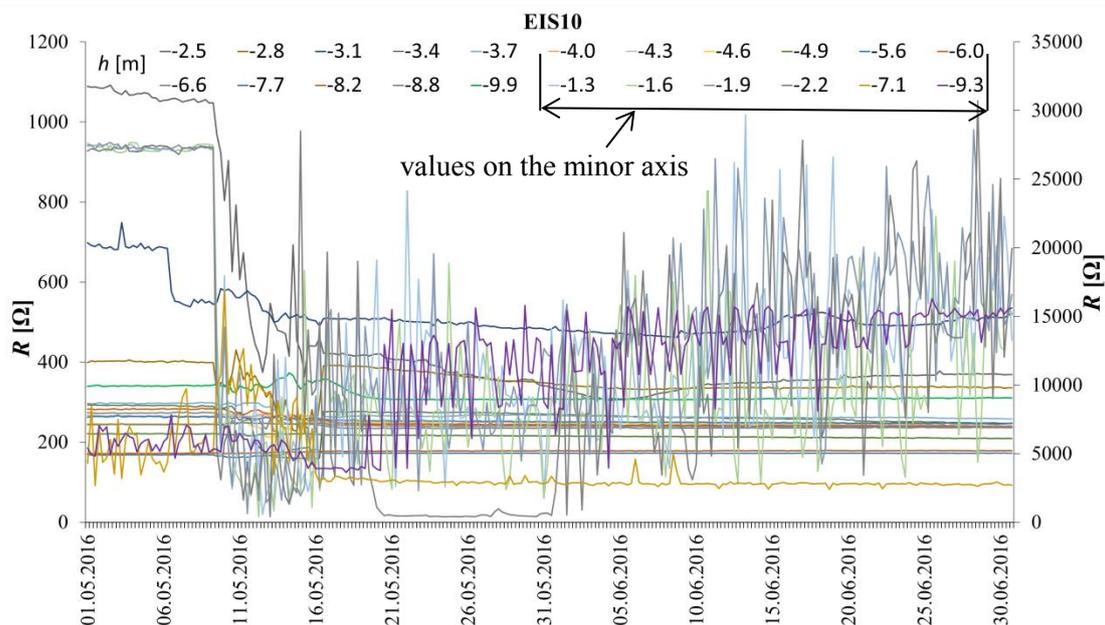
Figure 7a. BioSealing process monitored by the EIS method.

The curves obtained from the measurement of resistance made by the EIS10 probe is given in Figure 7a, and by EIS3 probe in Figure 7b. When discussing the patterns of the measured electrical variables, an assumption was accepted that during the measurement neither significant mechanical nor chemical changes occurred in the measured profiles of the dam soil. The resistance of the Nutrolase-based nutrient aqueous solution was 150Ω . The patterns of the resistance R measured at the known levels of the dam soil in both probes shows the period of dosing – a sudden drop of the values at all levels accounts for an increase of water content in the measured profiles due to the dosing of the nutrient aqueous solution and the flushing of the dosing boreholes.

Significant changes measured by the EIS10 probe (Figure 7a) can be observed at the level -2.2 m beneath the dam crest, when about a 98% drop of the values R occurred in the measured profile in a period between 21 May 2016 and 31 May 2016, i.e. a rise of water content. In the following period, water from the profile flows away and the values R gradually reach the original level, which they, however, did not exceed. The large fluctuation of the signal measured at the levels -1.3 m to -2.2 m is probably caused by a very variable content of air, which water transports when flowing through the soil. The higher the air content in the measured profile, the higher the values of the measured resistance R and vice versa, the higher the water content in the measured profile, the lower the values of the resistance R . Based on an engineering-geological survey performed [16], it is possible to state a more significant abundance of coarse-grained soil in the given range of the measured levels. As a consequence, it is also possible to assume a more significant dependence of the measured values of the resistance R on the soil porosity and on the given transport features.

The positive effect of the application of the BioSealing technology, i.e. the local additional sealing of soil documented by the rise of the values R (almost twice higher), is evident at the level -9.3 m, i.e. the dam base, to which reaches the active dosing of the nutrient aqueous solution according to the measurement. At the following measured level (-9.9 m), the same effect, i.e. the rise of the values R , was not observed anymore.

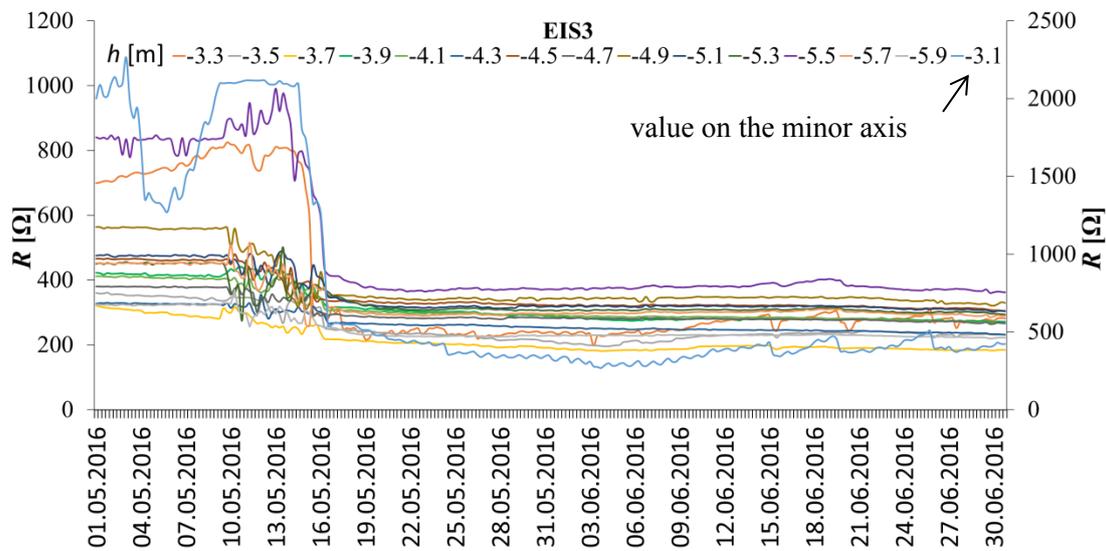
Figure 7b. BioSealing process monitored by the EIS method.

The EIS3 probe (Figure 7b), which is placed directly in the inrush area, also clearly recorded the application of the nutrient aqueous solution used in the BioSealing method. In the following period, a rise of the resistance values R can be observed at the levels -3.1 m (the surface layer of the downstream face of the dam), -3.3 m, -3.5 m and -5.9 m. In the other monitored levels, the values R remained low, which indicates a soil with higher water content.
