Renovation and design of double casement windows with regard to the occurrence of water vapour condensation or mould on the interior surface of the window jamb

L Kudrnacova¹ and L Balik¹

¹ Klokner Institute, Czech Technical University in Prague, Solinova 7, Prague 6, Czech Republic

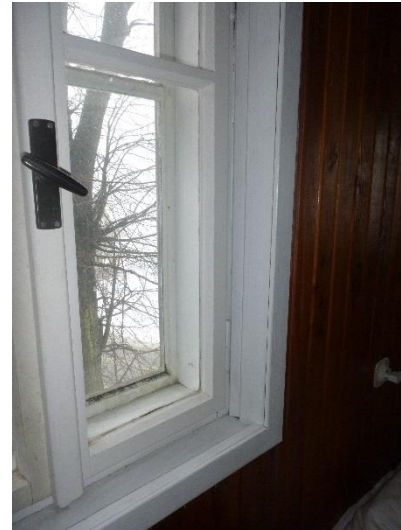
Figure 2. Photo of double casement window.

interior and exterior panelling is 298 mm thick. The external frame of the window is located 20 mm from the interior face of wall. The distance between the two panes is 119 mm. The sill (wooden panelling) is 99 mm deep. Figure 1 and 2 depict the double casement window in question. [3]

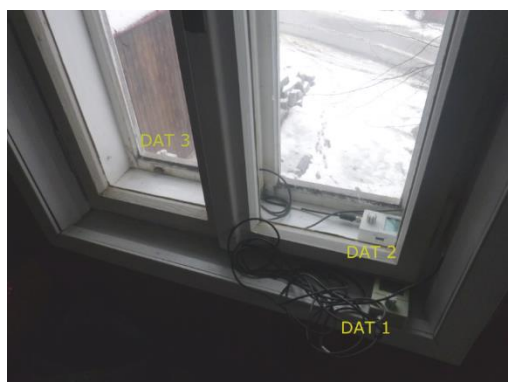
Figure 3. Placement of dataloggers and probes on the double casement window.

Measurement of existing window were taken in two periods (in November and in March). The reason were the first availability of measurement, the second measurement in winter season. The jamb framework was fitted with dataloggers and temperature probes. Dataloggers (Comet 3120) that measure and record temperature and relative humidity of air and temperature of connected probes at regular 15 min intervals were placed on the exterior, in between the two window panes and in the interior (on the window sill). The measuring accuracy of datalogger is $\pm 0,4^{\circ}\text{C}$ and $\pm 2,5\%$ relative humidity. The dataloggers were connected to probes (Comet Pt 1000) that measure surface temperature. The measurements were taken in two time periods: November 2016 and March 2017. The interior surface probe was located on the surface of the jamb, approximately 20 mm from the face of the interior window pane. The second probe was situated in the middle of the window pane. Figure 3 and figure 4 depicts how the dataloggers were fitted.[4]

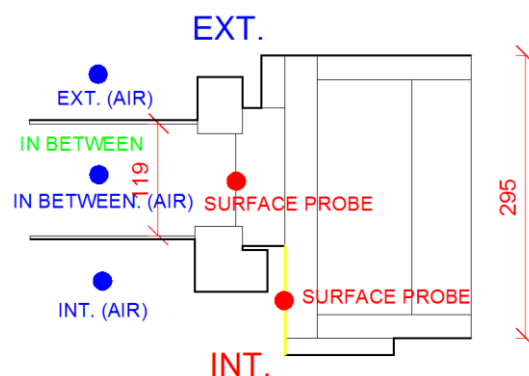
Figure 4. Cross-section with probes

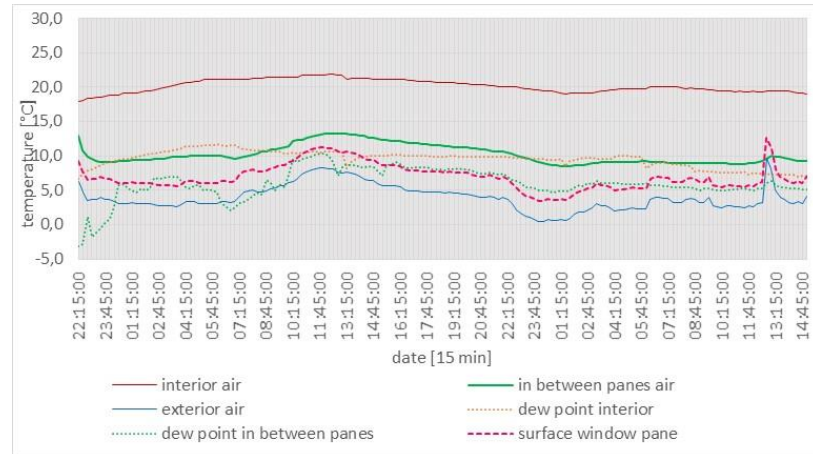
Figure 5. Evaluation of variables (temperature) during observation period, November 2016.

The following figures (Fig. 5 through Fig. 8) depict variables measured over the observation period. Each datalogger measures the values of air and of surface probe. Table 1 shows the minimum, maximum and averaged values.

- During measurement there was visible condensation on the exterior panes in between the window panes. See Fig.5 and Fig.6 where is temperature of window pane under dew point of air in this space and condensation occurs.

- The graphs show the visible influence of sun exposure (yellow vertical line) and opening of the interior pane (violet vertical line) to surface temperature in interior.

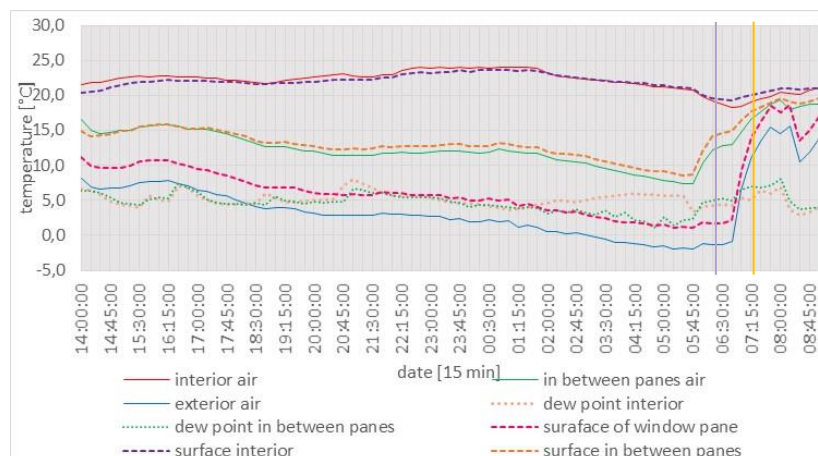
Figure 6. Evaluation of variables (temperature) during observation period, March 2017.

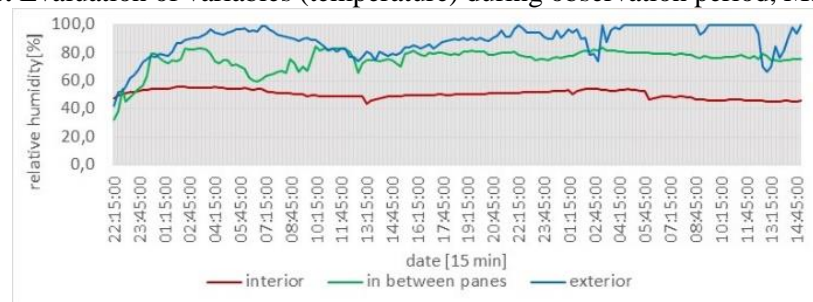
Figure 7. Evaluation of variables (relative humidity) during observation period, November 2016.

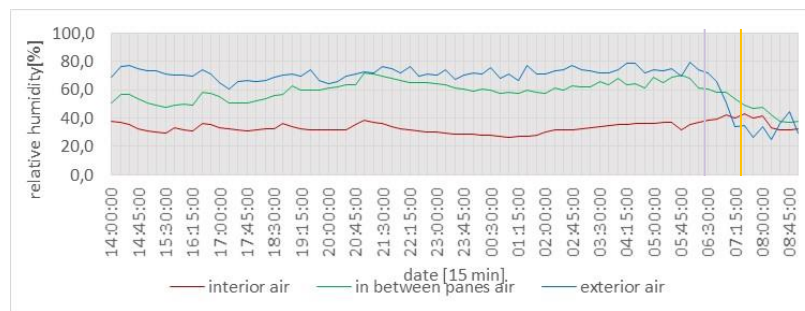
Figure 8. Evaluation of variables (relative humidity) during observation period, March 2017.
