Short term endurance results on a single cylinder diesel engine fueled with upgraded bio oil biodiesel emulsion

Abstract: This paper deliberates the endurance test outcomes obtained from a single cylinder, diesel engine fueled with an upgraded bio oil biodiesel emulsion. In this investigation a bio oil obtained by pyrolysis of woody biomass was upgraded with acid treatment. The resulted bio oil was emulsified with addition of biodiesel and suitable surfactant which is termed as ATJOE15. The main objective of the endurance test was to evaluate the wear characteristics of the engine components and lubrication oil properties, when the engine is fueled with the ATJOE15 emulsion. The photographic views taken before and after the end of 100 hrs endurance test, and visual inspection of the engine components, wear and carbon deposit results, are discussed in this paper.

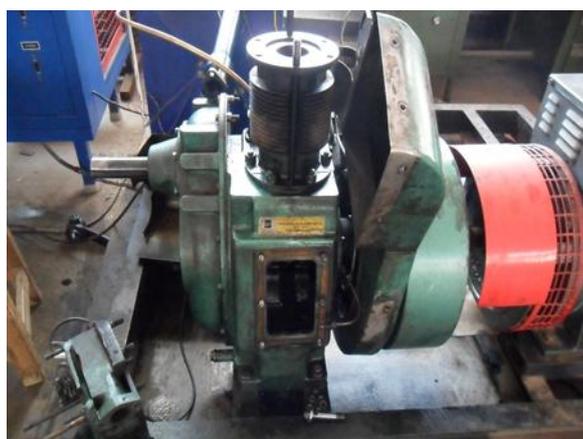
**Figure 2.** Photographic view of the dismantled engine before endurance test

The main objective of the endurance test was to evaluate the wear characteristics of engine components and changes in lubrication oil properties of test engine fueled with the ATJOE15 emulsion. Short term endurance test was conducted with the ATJOE15 emulsion as per IS 10000 Part V – 1980 method for 100 hrs. Before the start of the durability test, the existing fuel injection pump, fuel injector, fuel filter, oil filter were replaced with new one. Before the endurance test in the engine, the fuel injector and fuel injection pump were dismantled completely and photographs were taken in order to compare the wear and deposits on them after the durability test. The used lubricating oil was drained completely and fresh lubricating oil of SAE 20-40 grade was filled in the oil sump up to its full capacity. The engine cylinder head was dismantled and the carbon deposits on the cylinder head, piston crown were completely cleaned using methanol. The cylinder head gasket was also changed with new one and the cylinder head was fitted in the engine block. Once the engine was reassembled, it was allowed to run for 12 hours in the manner as per the recommendations of the manufacturer. This test was carried out to verify of any misalignments occurred during dismantling and re-assembling of the engine.

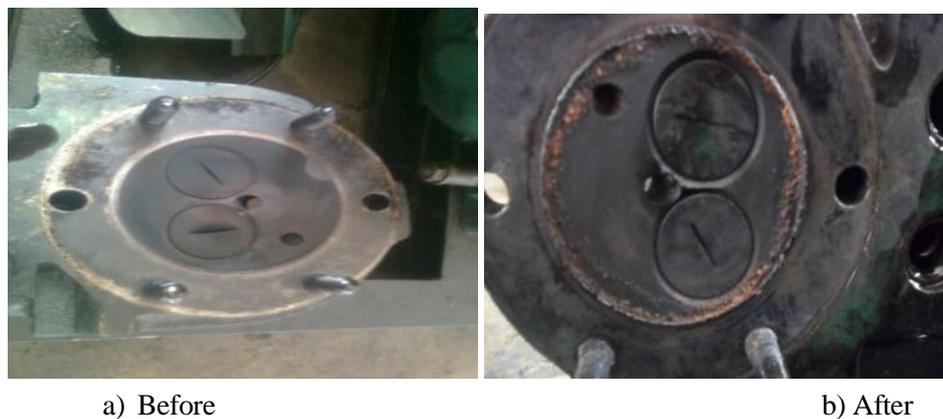
Figure 3. Comparison of cylinder head deposits earlier and after the endurance test

When the engine was running with the ATJOE15 emulsion, carbon deposits were detected in the cylinder head and on the piston crown. A comparison of the carbon deposits on the cylinder head and piston crown earlier and after the endurance test is shown in Fig.3 and Fig.4. About 26 g of carbon deposits were originated in the cylinder head and piston crown. The deposits formation is probably due to the properties of WPO in the ATJOE15 emulsion. The ATJOE15 emulsion comprises of unsaturated and saturated fatty acids, which experiences chemical reactions at high temperatures inside the combustion chamber. On the other side, the polymerisation of the fuel in the liquid core resulted in the contraction at the spray core. These polymers cannot evaporate completely, and this will get deposited on the existing surfaces[11].

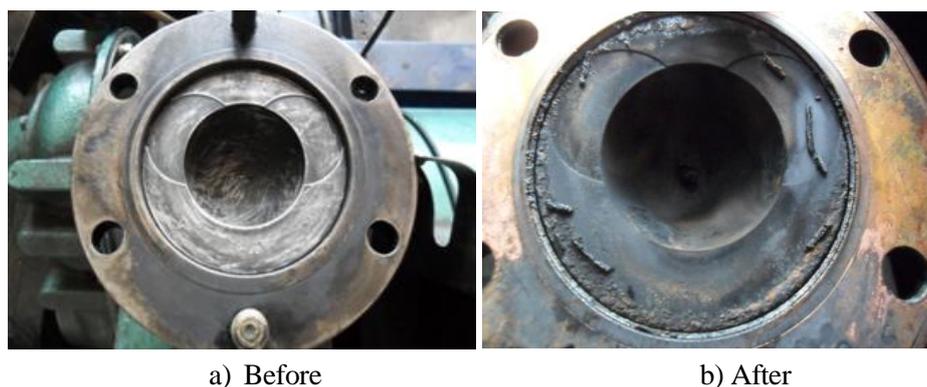
Figure 4. Comparison of piston crown deposits earlier and after the endurance test

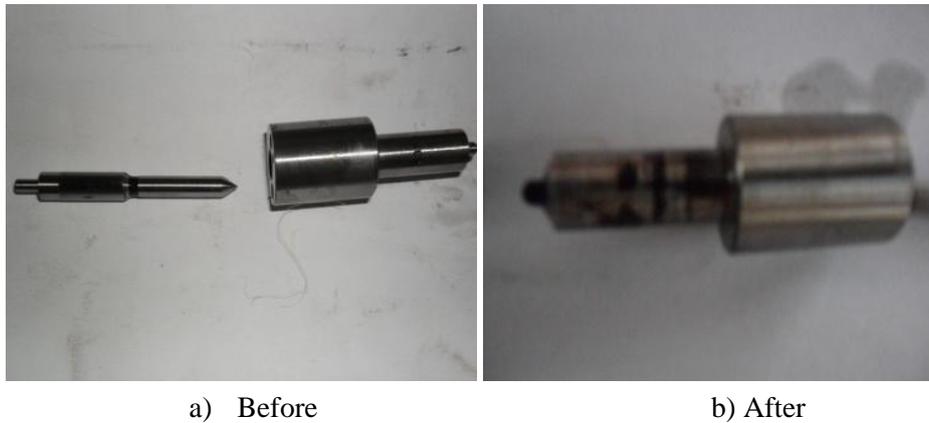
Figure 5. Comparison of nozzle and needle earlier and after the endurance test

A comparison of the deposits on the fuel injector components, like the needle and nozzle tip, earlier and after the endurance test, is shown in Figs. 5 -6. The deposits were noticed at the injector nozzle tip and in-between the holes. A spray test was conducted on the nozzle with the nozzle tester under room conditions. On visual observation of the spray, a worsened quality of the spray, less misty spray and uneven spray distribution were noticed from the injector.
