Influence of surface rectangular defect winding layer on burst pressure of CNG-II composite cylinder

Abstract. To study the influence of composite materials' surface defect on the burst pressure of CNG-II composite cylinder, the surface defect was simplified as a rectangular slot of certain size on the basis of actually investigating the shape of cylinder's surface defect. A CNG-II composite cylinder with a rectangular slot defect (2mm in depth) was used for burst test, and the numerical simulation software ANSYS was used to calculate its burst pressure. Through comparison between the burst pressure in the test and the numerical analysis result, the correctness of the numerical analysis method was verified. On this basis, the numerical analysis method was conducted for composite cylinders with surface defect in other depth. The result showed that surface defect in the form of rectangular slot had no significant effect on the liner stress of composite cylinder. Instead, it had a great influence on the stress of fiber-wrapped layer. The burst pressure of the composite cylinder decreased as the defect depth increasing. The hoop stress at the bottom of the defect in the shape of recta

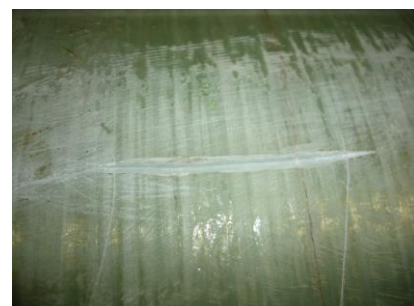
The defect on the surface of the composite cylinder were in the shape of a rectangular slot, and the defect was in the center of the composite cylinder. The scratch, which is along the axial direction of the cylinder, was 2mm in depth, 50mm in length, and 3.5mm in width, is shown in Figure 2.

Figure 2. The shape of the defect

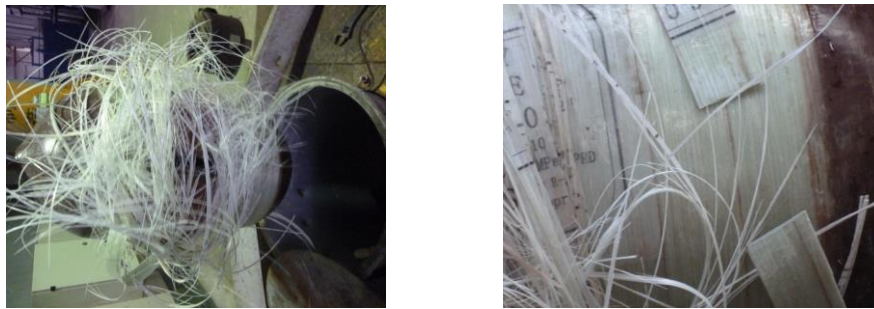
The specific test procedures were as follows: The cylinder with scratch defect was fully filled with water first. Then it was fitted with a connector. A blasting machine was used for boosting water pressure. The pressure was boosted after air was exhausted. As the pressure reached approximately 43MPa, it was observed that the fiber-wrapped layer of the composite cylinder was initially broken at the zone of rectangular slot defect with the pressure dropping. Then the pressure was fluctuated and the fiber-wrapped layer continued to rupture with crack. Finally, the liner ruptured at approximately 26MPa. The shape of the burst composite cylinder is shown in Figure 3. The data of the hydraulic burst test was recorded and the time-pressure curve is shown in Figure 4.

**Figure 3.** The shape of the burst composite cylinder
