Monitoring underground water leakage pattern by ground penetrating radar (GPR) using 800 MHz antenna frequency

T S T Amran¹, M P Ismail¹, M R Ahmad¹, M S M Amin¹, M A Ismail¹, S Sani¹, N A Masenwat¹ and N S M Basri²

¹Non-Destructive Testing - Material Structure Integrity group (NDT-MSI), Industrial Technology Division, Malaysian Nuclear Agency, 43000 Kajang, Selangor, Malaysia

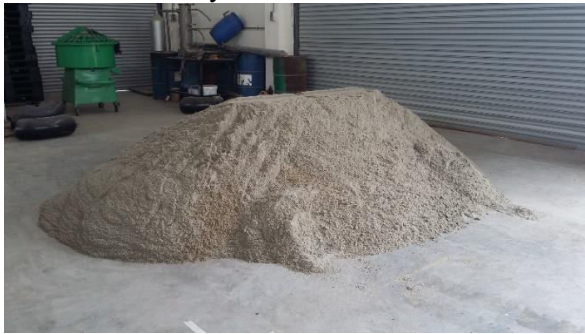
Figure 1. Six tons of dry sand used for the entire experiment.

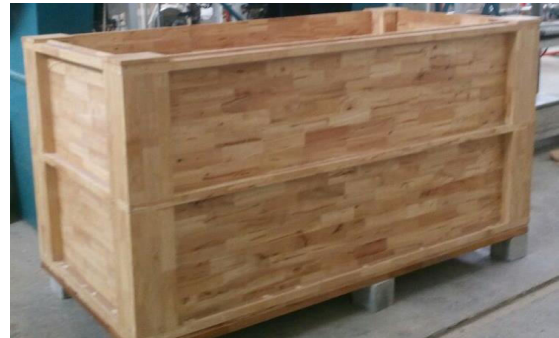
Figure 2. Real photograph of test bed for the laboratory experiment.

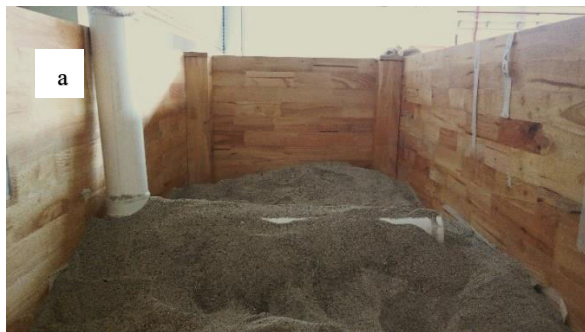
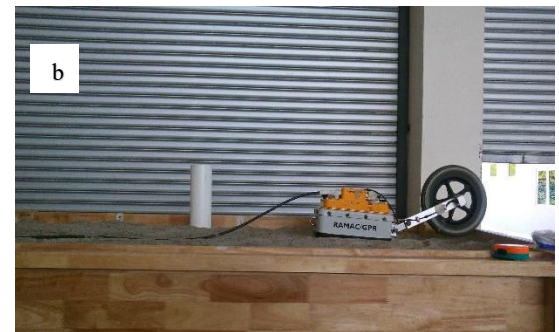
Figure 3. (a) Photograph of PVC pipe buried at the depth of 0.60 m, and the PVC pipe is in L-shape to inject water for water leaks simulation, (b) 800 MHz shielded antenna is perpendicular along the PVC pipe.

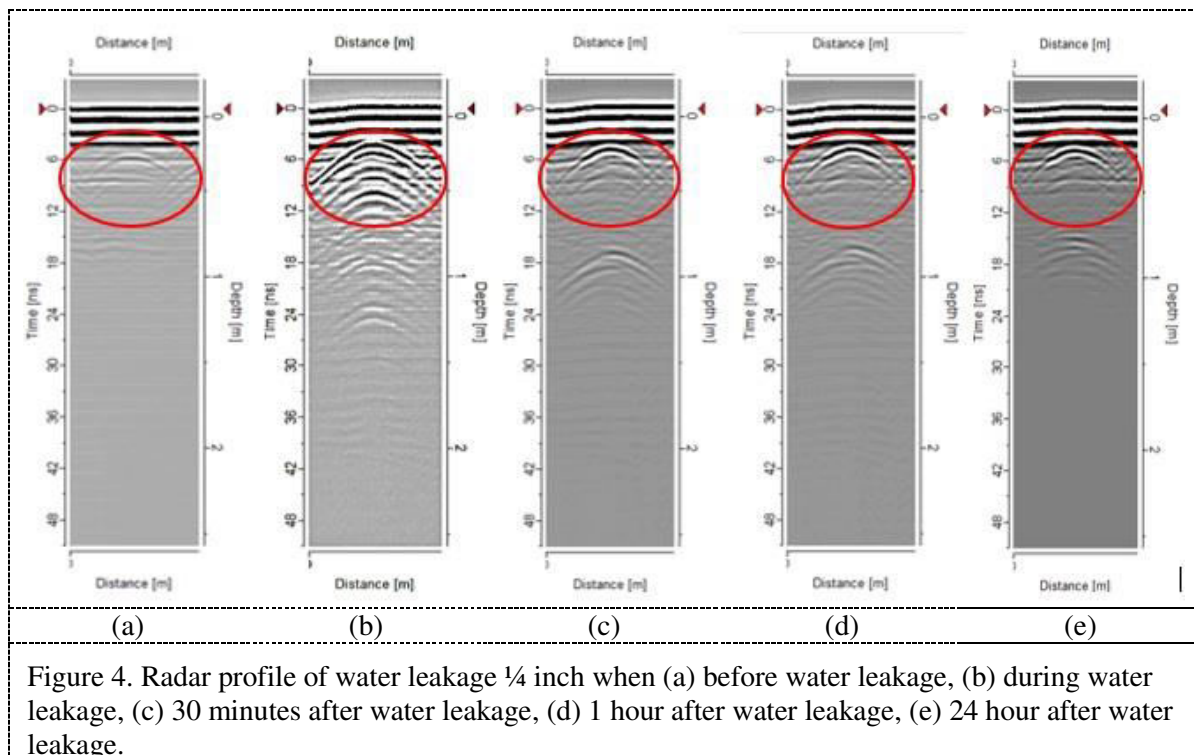
3.1.1. Comparison between time interval of water leakage at $\frac{1}{4}$ inch hole diameter. Three different diameter of holes, $\frac{1}{4}$ inch, $\frac{1}{2}$ inch and $\frac{3}{4}$ inch were chosen as variable for the water leakage simulation, to observe the variation of water pressure during water leaking. 800 MHz exhibits strong signal and provides sufficient penetration to detect the water leakage. Hyperbola pattern was exhibited as shown in figure 4 (a), (b), (c), (d), and (e), with the center is located approximately at 0.60 cm as proven in red circle. This illustrate that the position of the buried PVC pipe at approximately 0.60 m, almost 100% accurate as presented in Figure 4 (a). Generally, the hyperbolic pattern projected downward was generated to represent the buried pipe [6]. It can be seen from figure 4 (b), during water leaking at $\frac{1}{4}$ inch hole, the reflection pattern was totally clear and seems massive below the PVC reflection line, where the hyperbola intensity increased. The change in hyperbola pattern was influenced significantly

by changes in dielectric medium [7]. The changes in dielectric medium were caused by the presence of water leaks. Due to highest water pressure, the water flow rate is the fastest. The hypothesis on the smaller the pipe diameter, the higher the pressure was justified. That was perhaps, the water leakage already reached at the bottom of the sand in the short period of time due to fastest water flow rate. There is no significant difference in figure 4 (c) and (d), since the water runs to the bottom at similar rate. However, the reflection of water leakage getting blurry after 24 hours as depicted in figure 4 (e). The purpose of GPR scanning after 24 hour was to analyze the water dissipation in the dry sand. The result indicates that the saturation water was already dissipated into the dry sand. The GPR scanning profiles for time interval illustrate the depth of water leakage can reach up to more than 1 m, even after 24 hours of water leaks simulation.

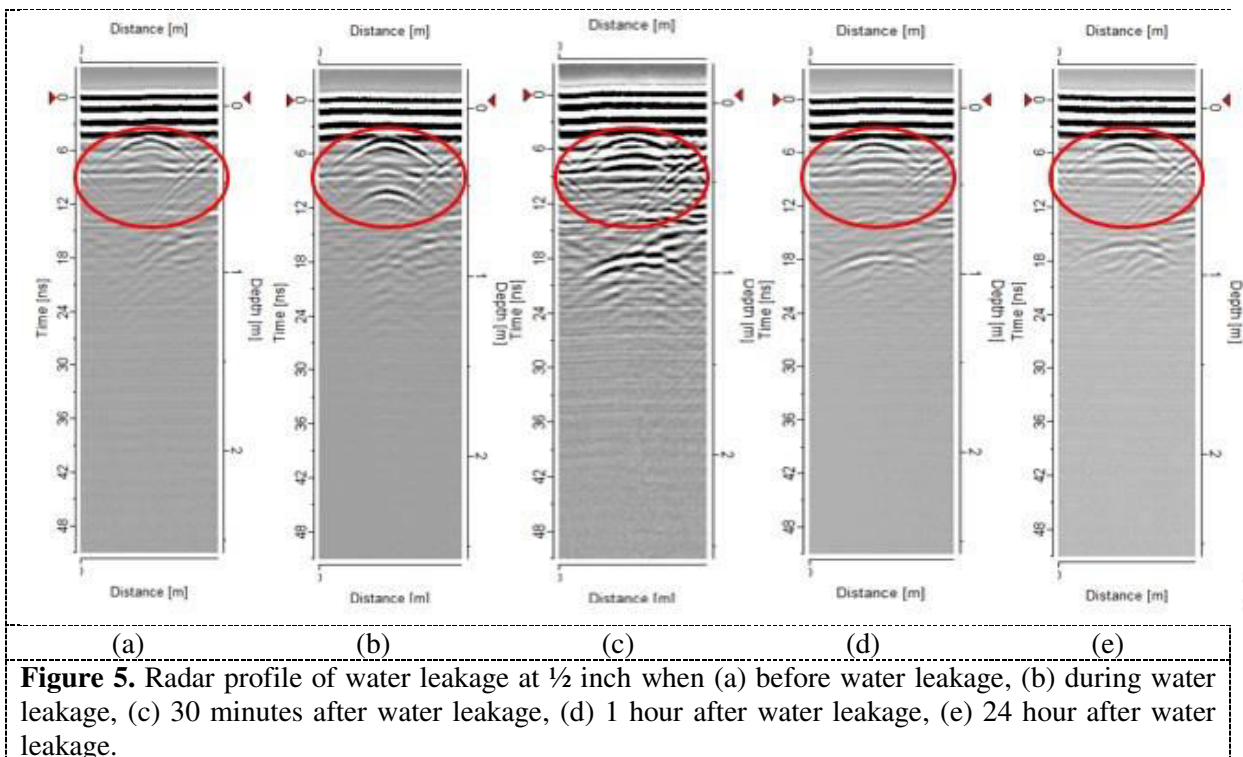
3.1.2. Comparison between time interval of water leakage at $\frac{1}{2}$ inch hole diameter. Figure 5 represents the radargram profile of water leakage simulation for hole diameter of $\frac{1}{2}$ inch. The differentiating factor between the radargram profile in figure 5 (a) and other figures 5 (b), (c), (d), and (e) is the presence of water as marked with red circle. The presence of water created new hyperbolic reflection pattern in figure 5 (b). The water has substantially changed the dielectric properties of the dry sand. The pattern showed increased in intensity and the range of hyperbolic pattern started to extent after 30 minutes of water leakage as depicted in figure 5 (c). The low water pressure was caused by bigger hole diameter as compared to $\frac{1}{4}$ inch diameter. That was the reason on why the great difference in water leakage can only be seen after 30 minutes. The anomalous change then started to disappear as the phenomena demonstrates that the water leaks low started to move downward and dissolve into the dry sand as presented in figure 5 (d) and 5 (e). Figure 5 (e) illustrated that resemble to radargram in figure 5 (a), as the anomalies pattern was not notably detectable, where indicating that most of the saturation water has moved downward to the bottom of the test bed.

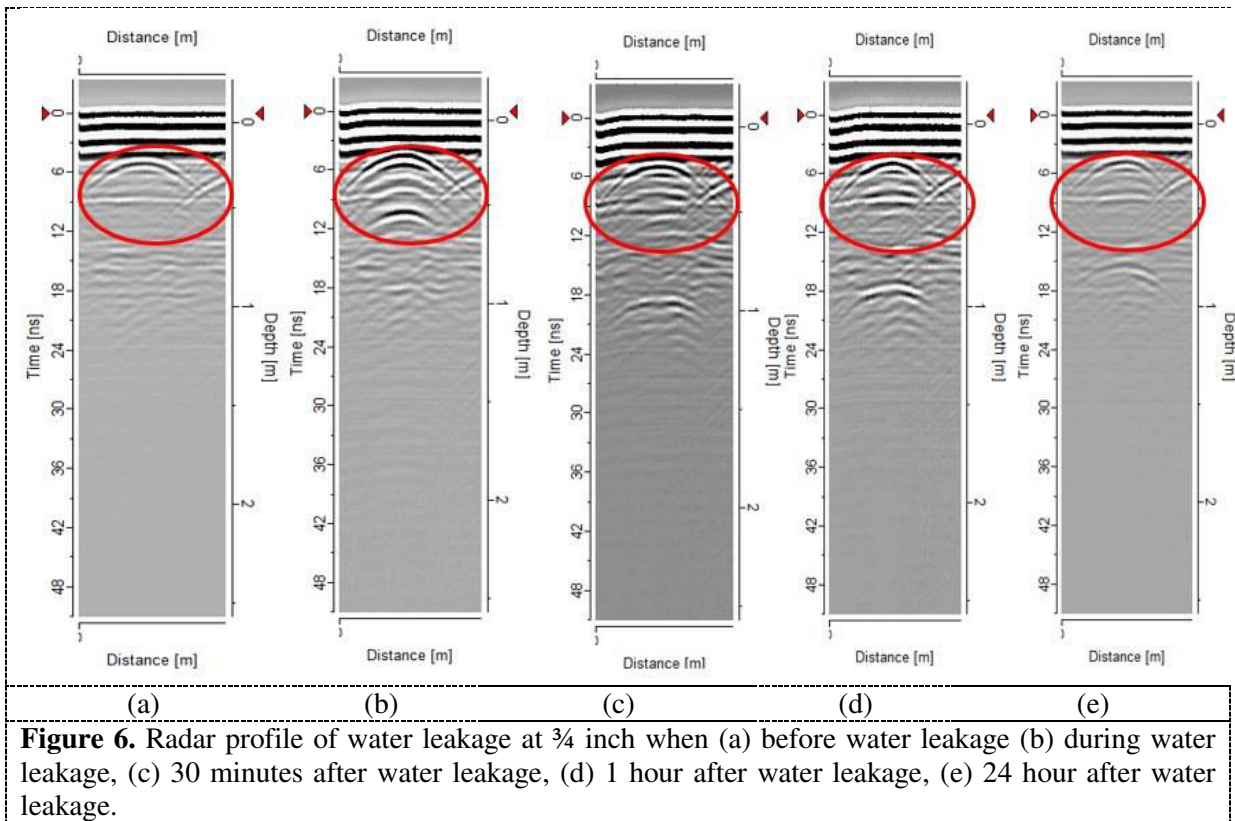
3.1.3. Comparison between time interval of water leakage at $\frac{3}{4}$ inch hole diameter. Figure 6 illustrates the radargram images for water leakage simulation for $\frac{3}{4}$ inch hole diameter, the biggest hole for the experiment. The GPR scanning was conducted right after the injection of 15 litres of water. The radar profile during the water injection showed that more than one hyperbola were observed due to the presence of water in figure 6 (b). The reflection pattern through the GPR scanning was marked in red circle as shown in figure 6. The large amount of dielectric constant of water with the value of 80, is clearly make a huge difference between before and during of water injection. Low water velocity was caused by smallest water pressure, where only little water leaks detected through GPR scanning in figure 6 (b). The intensity of hyperbola reflection pattern increased and the water anomalous feature was sharp as illustrated in figure 6 (c), and still remain the same after 1 hour of water leakage as presented in figure 6 (d). Due to lowest water velocity, the water reflection pattern is clearly visible in figure 6 (d). The sharpness of water leaks anomalous features slightly lost after 24 hour in figure 6 (e), because the water leaks already dissipated in the dry sand and already shifted downward toward the bottom of the test bed.

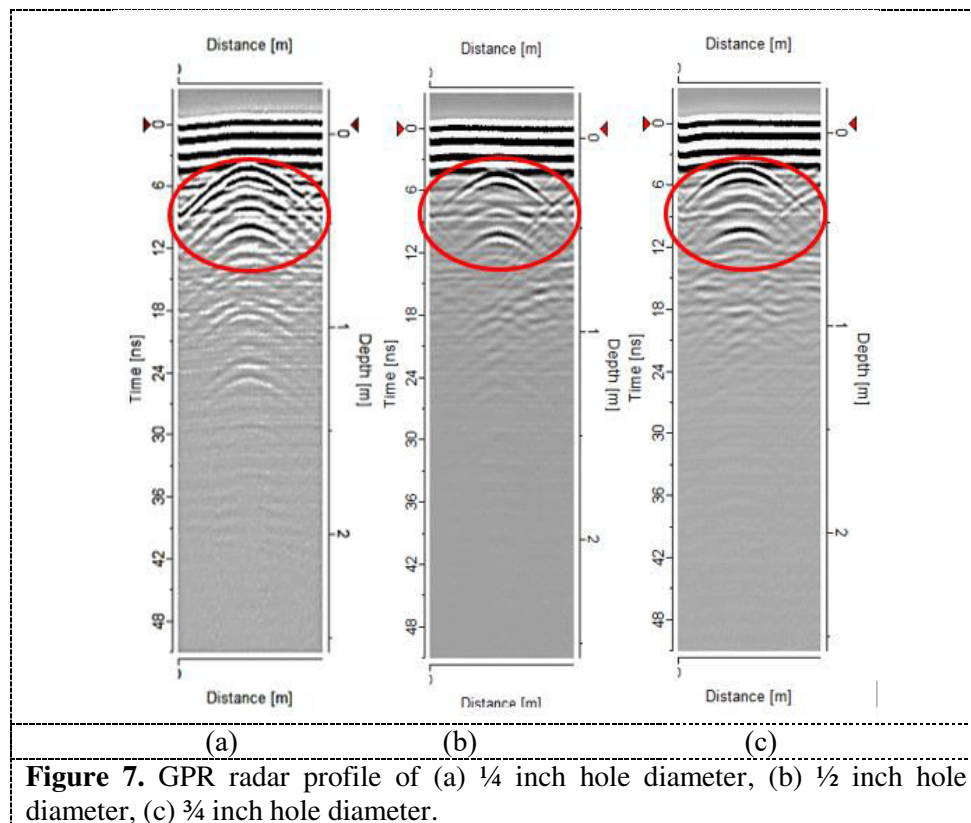
3.1.4. Comparison between $\frac{1}{4}$ inch, $\frac{1}{2}$ inch and $\frac{3}{4}$ inch during water leaking. The radargram profiles during water leakage for the three different hole-diameter were portrayed in figure 7. Significant differences of hyperbolic reflection pattern were observed during water leakage between $\frac{1}{4}$ inch hole diameter and other two holes, $\frac{1}{2}$ inch hole diameter, and $\frac{3}{4}$ inch hole diameter as illustrated in red mark position. The great differences show that, at highest water pressure, the water flow rate is fastest compared to others. More hyperbolic reflection patterns were observed in figure 7 (a) compared to figure 7 (b) and figure 7 (c). One of the factors that can be weighed into the discussion was the presence of high dielectric constant of water as can be observed through the anomalies features. The dielectric constant of PVC pipe, dry sand, wet sand, and water is 3, 3-5, 30-60 and 80 respectively [8]. The intensity of hyperbolic reflection pattern is highest in figure 7 (a), as comparing to figure 7 (b) and figure 7 (c). Greatest water pressure leads to highest water velocity, hence the water flow rate is the fastest through smallest hole diameter. The phenomena then leads more hyperbola pattern can be produced during water leaking. Penetration water reaches up to 1.5 m as depicted in figure 7 (a), (b) and (c) through the GPR scanning. Hence, the argument that suggested GPR is capable on detecting water leakage was validated.

Figure 7. GPR radar profile of (a) $\frac{1}{4}$ inch hole diameter, (b) $\frac{1}{2}$ inch hole diameter, (c) $\frac{3}{4}$ inch hole diameter.
