# Influence of processing factors over concrete strength.

**Abstract.** Construction of facilities of cast in-situ reinforced concrete poses additional requirements to quality of material, peculiarities of the construction process may sometimes lead to appearance of lamination planes and inhomogeneity of concrete, which reduce strength of the material and structure as a whole. Technology compliance while working with cast in-situ concrete has a significant impact onto the concrete strength. Such process factors as concrete curing, vibration and compaction of the concrete mixture, temperature treatment, etc., when they are countered or inadequately followed lead to a significant reduction in concrete strength. Here, the authors experimentally quantitatively determine the loss of strength in in-situ cast concrete structures due to inadequate following of process requirements, in comparison with full compliance.

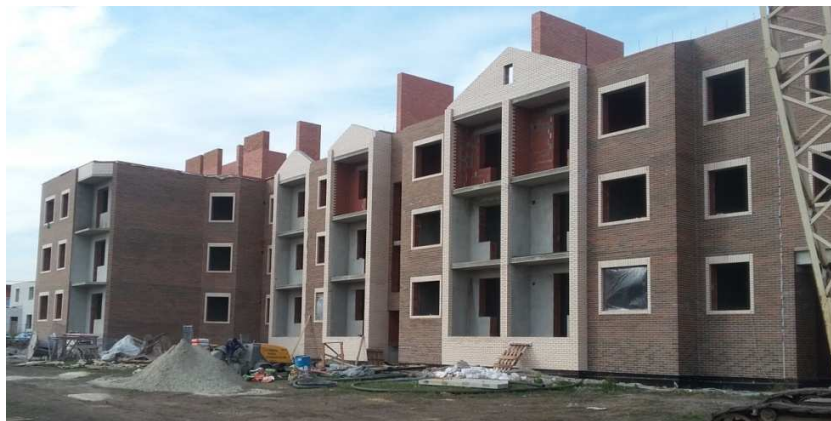
**Figure 2.** External appearance of the subject of research

To determine difference in strength characteristics in full and partial compliance to the work rules of in-situ casting, an experiment was conducted during which 5 cubic samples  $100 \times 100 \times 100$  mm were produced by concrete casting. Several months after completion of the casting works, 5 core samples were collected from the cast in-situ reinforced concrete structures of the studied building (Fig. 2), with height ranging from 145 mm to 153 mm, design grade of the concrete is B20 [4]. Dimensions of cubic and cylindrical samples were measured and then their concrete strength was determined with a destructive method as per [6] in Test lab no. 1 of BGTU-sertis testing center by destruction of concrete samples of cylindrical (Fig. 3) and cubic (Fig. 4) form with a hydraulic press PSU-125 [5]. The results of the tests are shown in Tables 1 and 2.

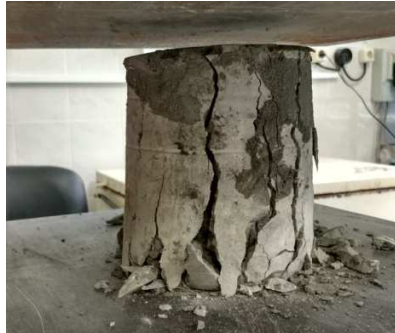
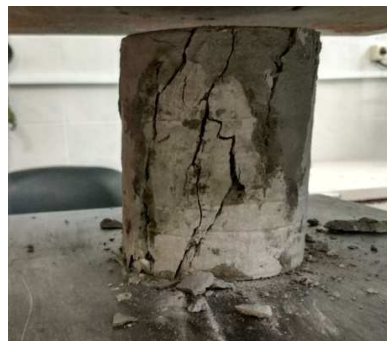
**Figure 3.** Unsatisfactory fracture pattern in cylindrical samples collected from cast in-situ structures

It is noted that fracture pattern in cylindrical samples taken from cast in-situ structures is unsatisfactory, as per diagrams no. 4, 5, 9, 10 of [6], that of cubic samples produced under production control conditions is satisfactory as per [6].

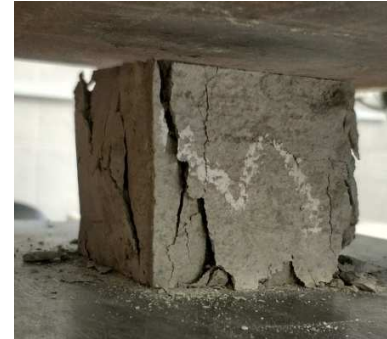
**Figure 4.** Satisfactory fracture pattern in cubic samples produced under production control conditions
