Geotechnical monitoring to ensure reliability of construction and operation of buildings and structures

Abstract. To improve the reliability and durability of construction structures it is necessary to thoroughly study their behaviour during the construction process & operation and based on their behavioural analysis we can develop measures which will aid in avoiding future emergency situations. Well-timed application of geotechnical monitoring warns and minimizes the risk of deformation & destruction of the examined object as well as adjoining buildings. The necessity of conducting geotechnical monitoring should be decided during the stages of concept design or the design of new construction or reconstruction of a building structure. Geotechnical monitoring of buildings & structures includes research & analysis of «foundation soil – foundation – above-ground structures of the building» system and it consists of complex work to ensure the safety of the entire construction process as well as safe operation of buildings & structures. Its usage allows us to detect and avoid irreversible procedures occurring in the system «foundation soil – foundation – above-ground structures of the

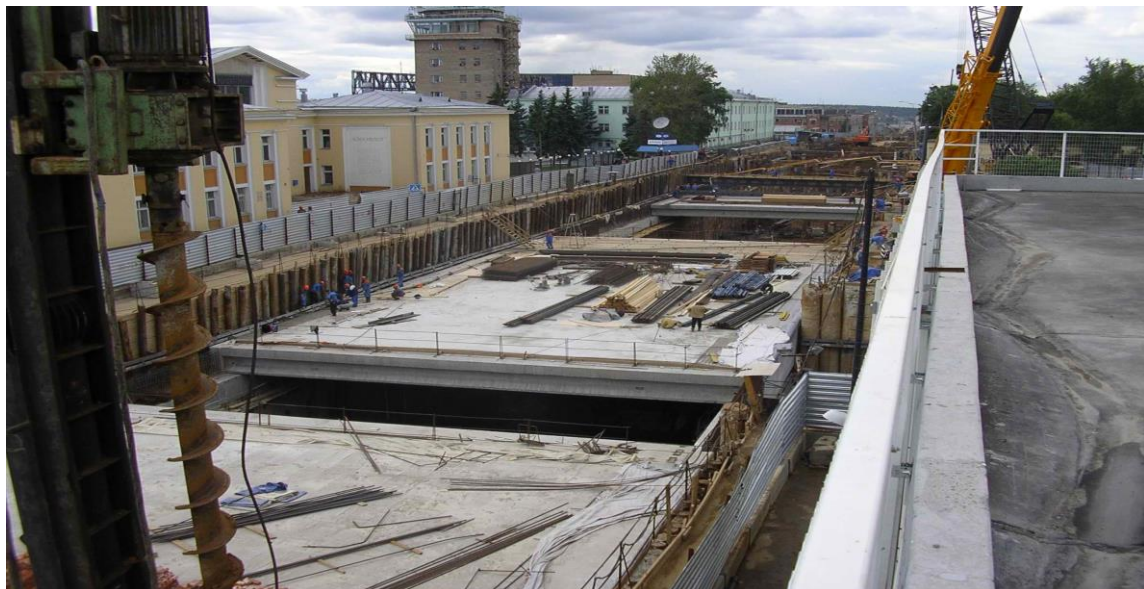
The railway line which connects the underground terminal with the railway station «Vnukovo airport» has an above-ground and a tunnel section. The total length is 1432m. The tunnel section varies from 14,5m to 19,5m in width. The depth of the tunnel according to the project is 22m up to the exit to the surface of the ramp part. The tunnel line was built in an open cut construction with load-bearing buried wall and closed off with precast floor slabs as shown in figure 1.

Figure 1. Construction of the railway line tunnel

The roadway was constructed above the tunnel. This design solution of the construction led to cutting of the upper water-bearing horizon, which had a sporadic distribution as mentioned above.

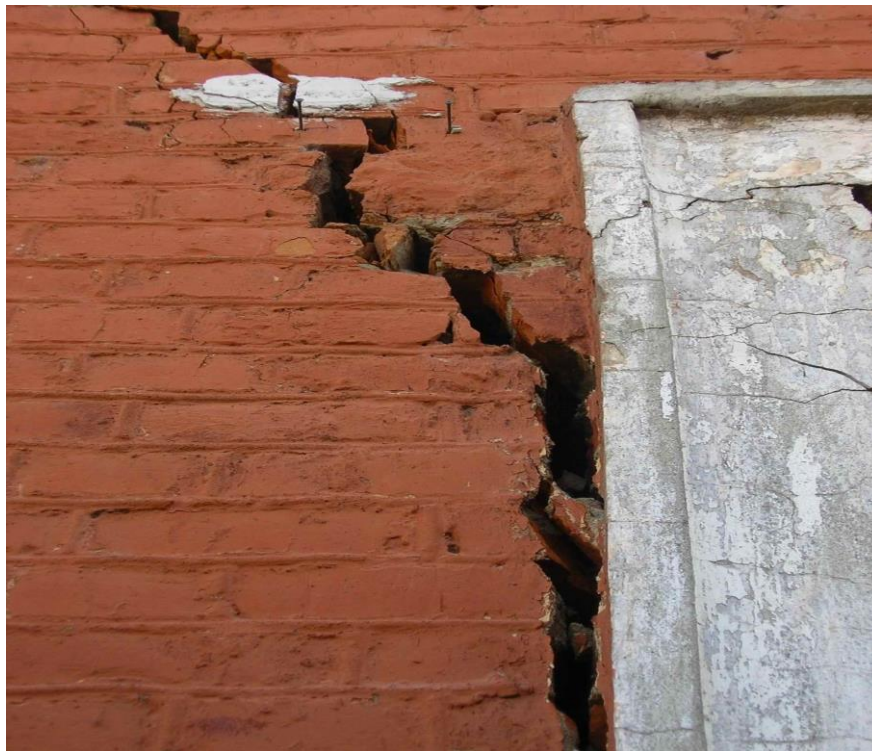
As a result of the above-mentioned monitoring for one quarter of the year, MGSU identified that due to the construction of the tunnel the actual subsidence of the flight control tower exceeded the maximum permissible value in 3 times, and subsidence of aircraft maintenance facility building exceeded this value in 9 times. The walls of the tunnel deviated from vertical by a few dozen millimeters.

However, despite the relative stabilization of deformations, the crack-formation process was actively developing. The beginning of this process indicated disorder of the spatial rigidity of the buildings. In addition, twisting of vertical structures was documented.

Figure 2. Crack-formation of the aircraft maintenance facility building

Because of such processes (figure 2) aircraft maintenance facility building was immediately resettled and demolished.

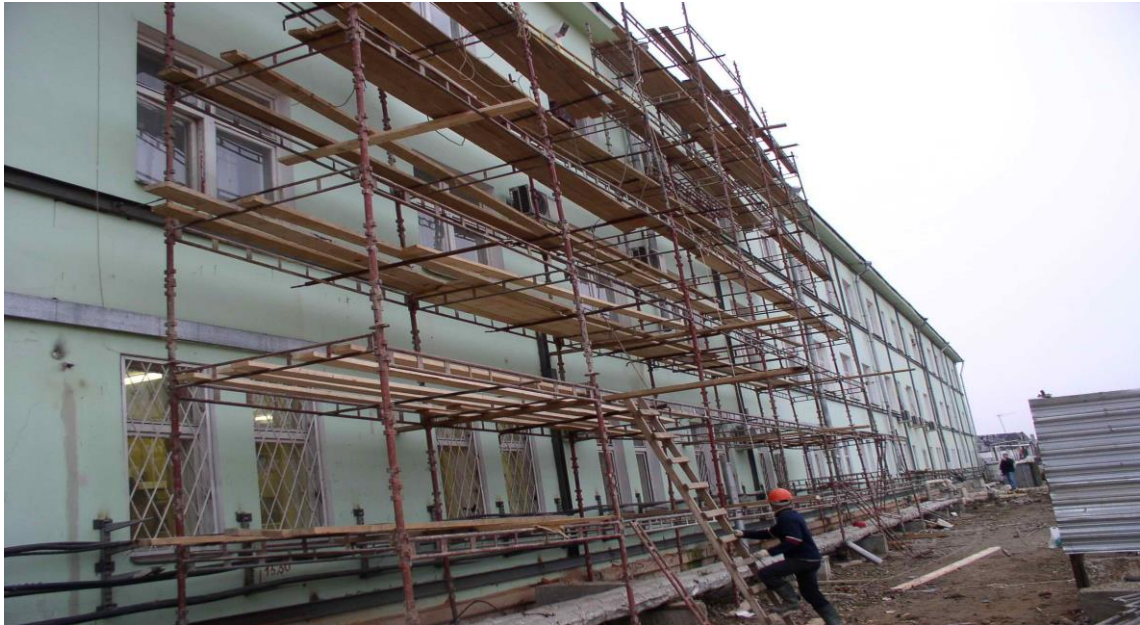
Figure 3. Realization of the project to strengthen the office buildings of the airport control tower in Vnukovo-1 airport

However, due to the limited space availability of airport infrastructure, resettling office buildings of the flight control tower was not possible. In this regard, decision was made to strengthen the flight control tower building by using metal belts, according to special project designed by MGSU employees (figure 3).

These measures were taken to restore spatial rigidity of the building and to increase reliability of its building structures. After carrying out emergency measures, the office building of the flight control tower continued to operate for two years, after which it was dismantled.

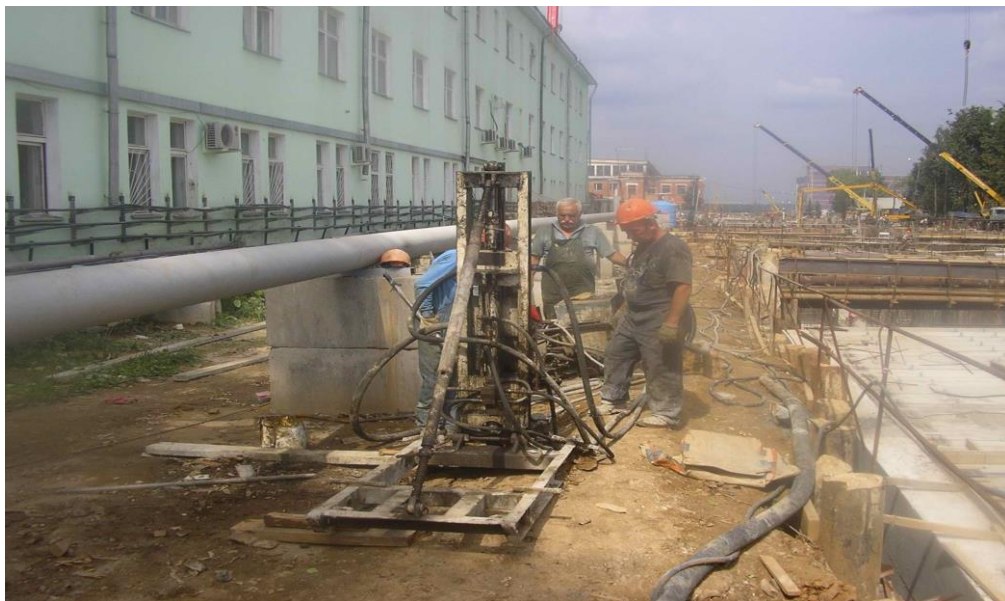
Figure 4. Execution of the cut-off wall between the office building foundation of the flight control tower and the excavation wall of the tunnel

In addition to strengthening of the above-ground structures, a cut-off wall was made between the foundations of buildings and the excavation wall of the tunnel to prevent possible additional vertical deformations of adjacent buildings (figure 4.)

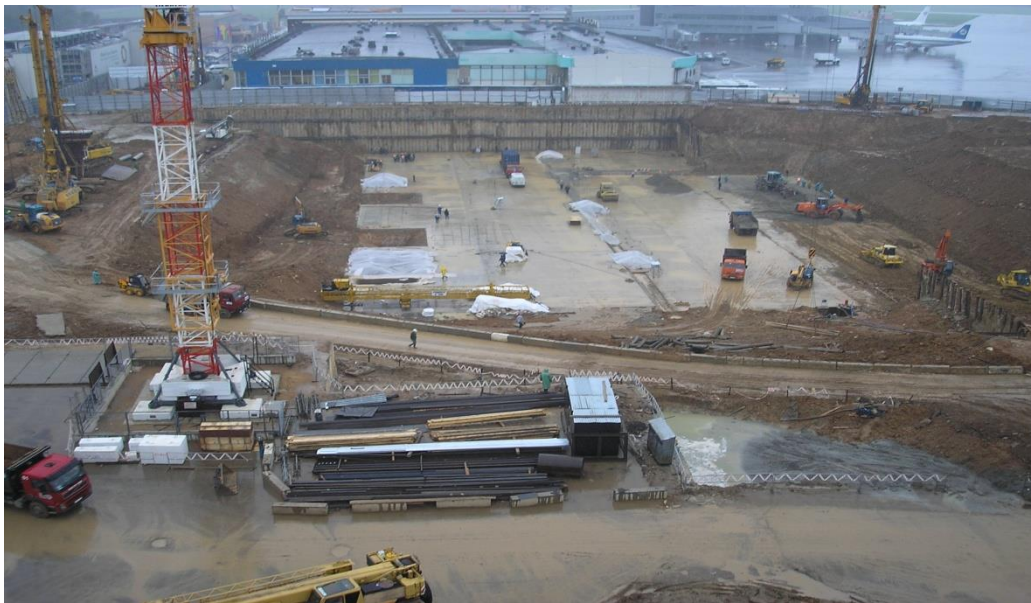
After completing the railway line, construction of the new air terminal building started. The neglected influence of tunnel excavation on adjacent buildings, as well as errors in protecting buildings from the effects of construction works related to its sinking were taken into account during construction of the cofferdam of the excavation pit and excavation works on foundation pit of the new air terminal (figure 5).

Figure 5. Excavation pit of new Vnukovo-1 airport

Load-bearing buried wall was used as cofferdam of the excavation pit with a thickness of 600 mm, held in a vertical position by ground anchors in two rows in height. The length of the anchor, including its root, was 21m, and the angle of inclination is equal to 30° at the depth of the excavation of 8m.
