# Experimental research on RC beams strengthened in shear with PBO-FRCM composites

**Abstract.** The article presents an experimental research conducted on beams with PBO-FRCM shear strengthening with end-anchorage system. PBO-FRCM (Fibre Reinforced Cementitious Matrix) composites consist of mineral mortar and PBO (p-Phenylene Benzobis oxazol) composite fibres. Using of mineral mortar makes them as a good alternative to the commonly used FRP composites, especially in structures exposed to high temperatures and historical buildings. For FRCM composites most commonly failure mechanism is debonding of the fibers from mineral mortar with no rupture of fibres. To prevent premature debonding of the composite and increase the effectiveness of reinforcements FRCM suitable anchorage should be used. In this case, experimental research was conducted on 4 T-shaped reinforced concrete beams strengthened in a shear using PBO-FRCM with anchorage. One beam was a control beam without strengthening, and 3 beams had the same shear strengthening with PBO strip anchorage. All elements failed in a shear with formation of main diagonal crack. Despite the presence of anchorage, the failure mode of all st

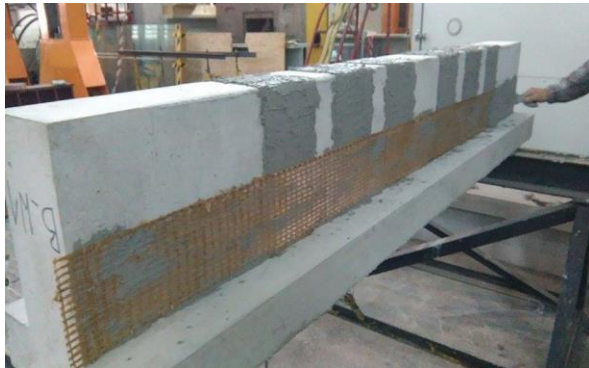
**Figure 3.** PBO strip application along the beam under the slab

The utilized PBO-FRCM system consisted of one layer of the fabric with the associated mortar. FRCM strengthening was applied on the both sides and bottom of the web. This type of strengthening configuration is called U-wrapped. Beams were strengthened in shear discontinuously with 150 mm wide FRCM strips with spacing of 100 mm (Fig. 2). To ensure a good bonding the bottom and side surfaces of each beam were cleaned of laitance, dusted and washed. The corners of each of the beam were rounded in the areas where the reinforcing was applied, in order to prevent the local stress concentration. The surfaces of the web were saturated with water for 15 min prior the placing the FRCM strips. Then first layer of the mortar was applied and fabric strips were placed. The second layer of mortar was applied in place of the strips and under the slab along the entire beam. The PBO strips with 150 mm wide and the length equal to the length of the entire beam, was placed under the slab as an anchorage (Fig. 3). The direction of the main fibers in this strip was perpendicular to the main fibers in shear strips. Finally, the second layer of mortar was applied to the anchorage. (Fig. 4)

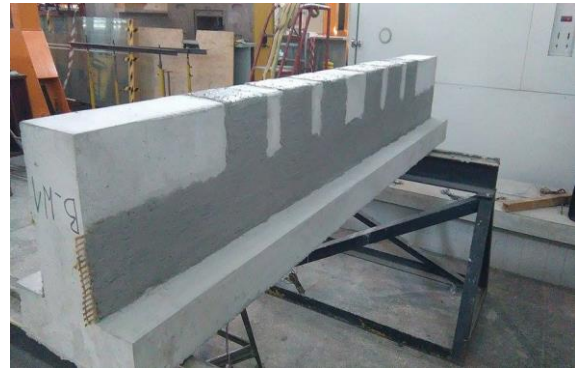
**Figure 4.** Anchorage after applying the outer layer of mortar

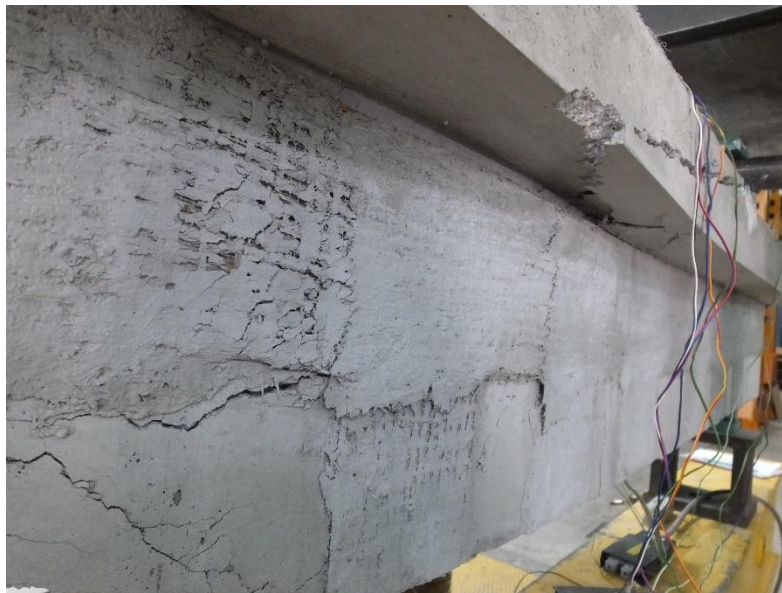
**Figure 7.** B\_W1 failure. Vertical cracks at the edge of the vertical strips and slippage of the fibers at the ends of the longitudinal PBO strip, beyond the supports

supports, did not become debonded, but the slippage of the fibers was visible on them (Fig. 7). This means that the length of anchoring the longitudinal strip beyond the support (350 mm) was sufficient.
