Cracks in monolithic concrete constructions, their correlation with capacity and durability forecast

Abstract. The article describes the analysis of authors' experience in the field of the inspection of buildings' technical condition.

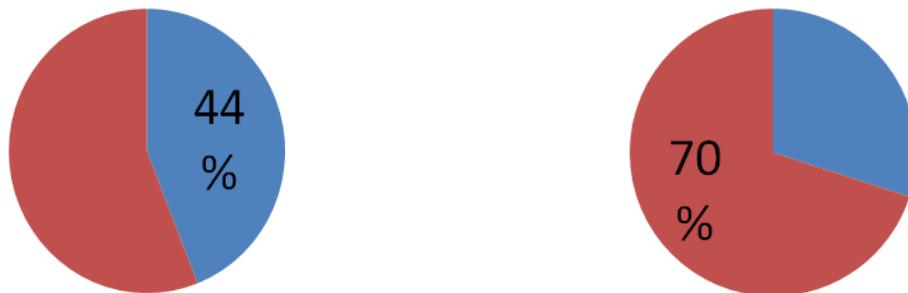
Figure 1. 44% - number of cracks among all possible defects
70%- number of dangerous cracks in constructions

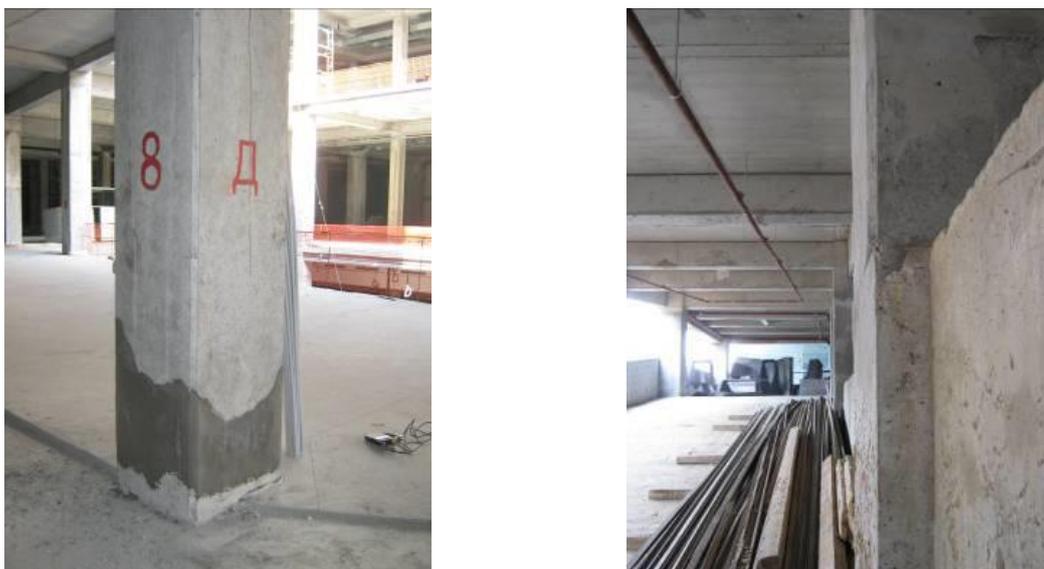
The building, complex according to its plan, had a considerable length (around 1.5 km) and consisted of 6 sections divided by deformation seams. The overall number of defects mentioned in the statement included in the Technical report [5] was more than 300, and the survey processes had more photos like the ones presented below. Therefore, it can be concluded that the amount of information for statistical processing was sufficiently large. Figure 2 presents fragments of building construction in their mutual arrangement.

Figure 2. Fragments of building construction in mutual arrangement

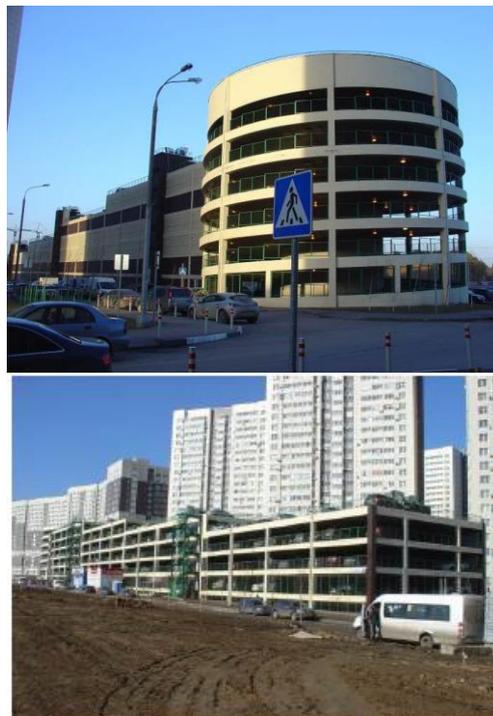
Figure 3. A general view from the entrance and from the four-floor part

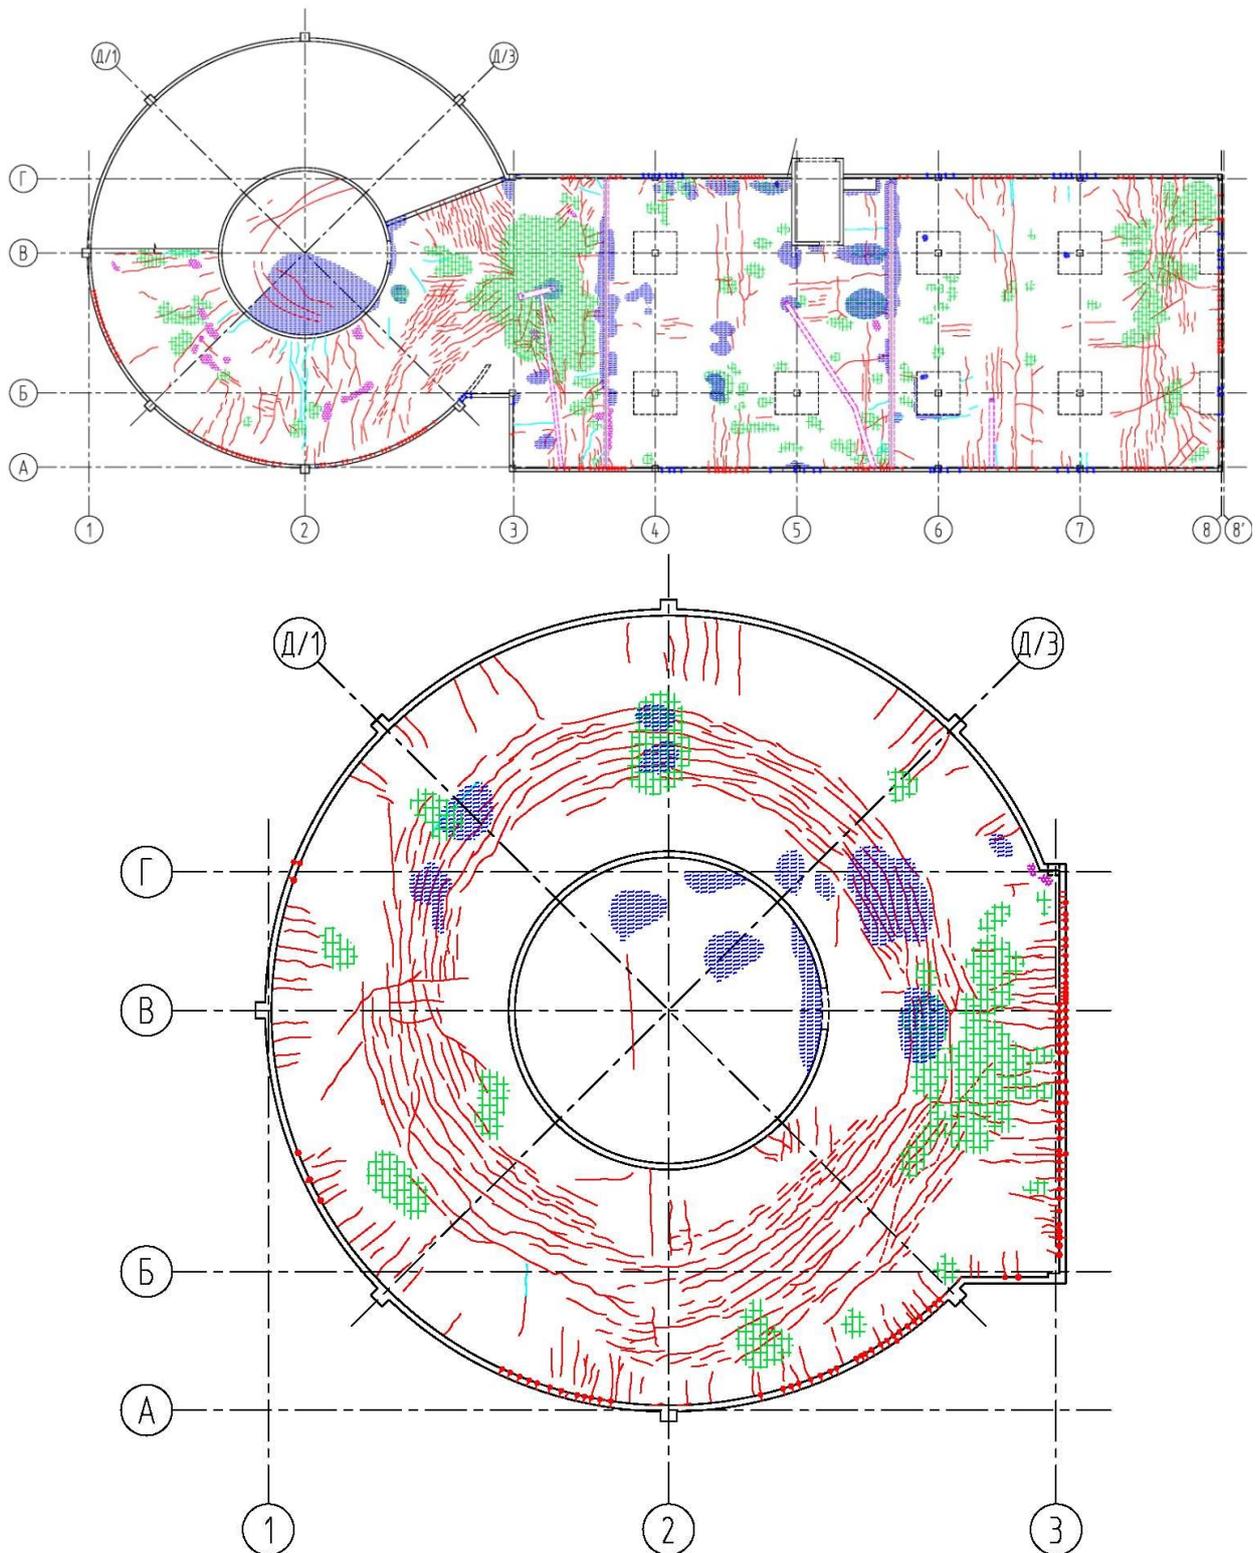
Figure 4. Fragments of ceiling plan at +16.67 metres and at +19.45 metres

The monolithic reinforced concrete building of the car park with a bearing frame and ceilings, built according to the beam-less scheme consisted of three blocks separated by temperature and deformation junctures. Floor slabs are 8.2 metres in span in one direction, 4.35 and 8.2 metres in

transverse direction and have the thickness of 220 mm with capitals near the columns of 250 mm and were reinforced by strapped beams with a cross-section of 200x470(h) mm around the block's contour.

A check of geometrical parameters of the construction was carried out for this object and defects and damage were added to the plan. The floors and the roof were opened in order to specify the exact load and characteristics of used materials.

As seen in the previous example, the defects observed in bearing ceiling constructions, floor slabs and spiral ramp included cracks in slabs and strapped beams. In general, the width of the said cracks was no more than 0.2mm and did not exceed the accepted norm [11] - 0.3mm (the calculated width of cracks under the influence of the operational constant and short-term load was 0.25 mm).

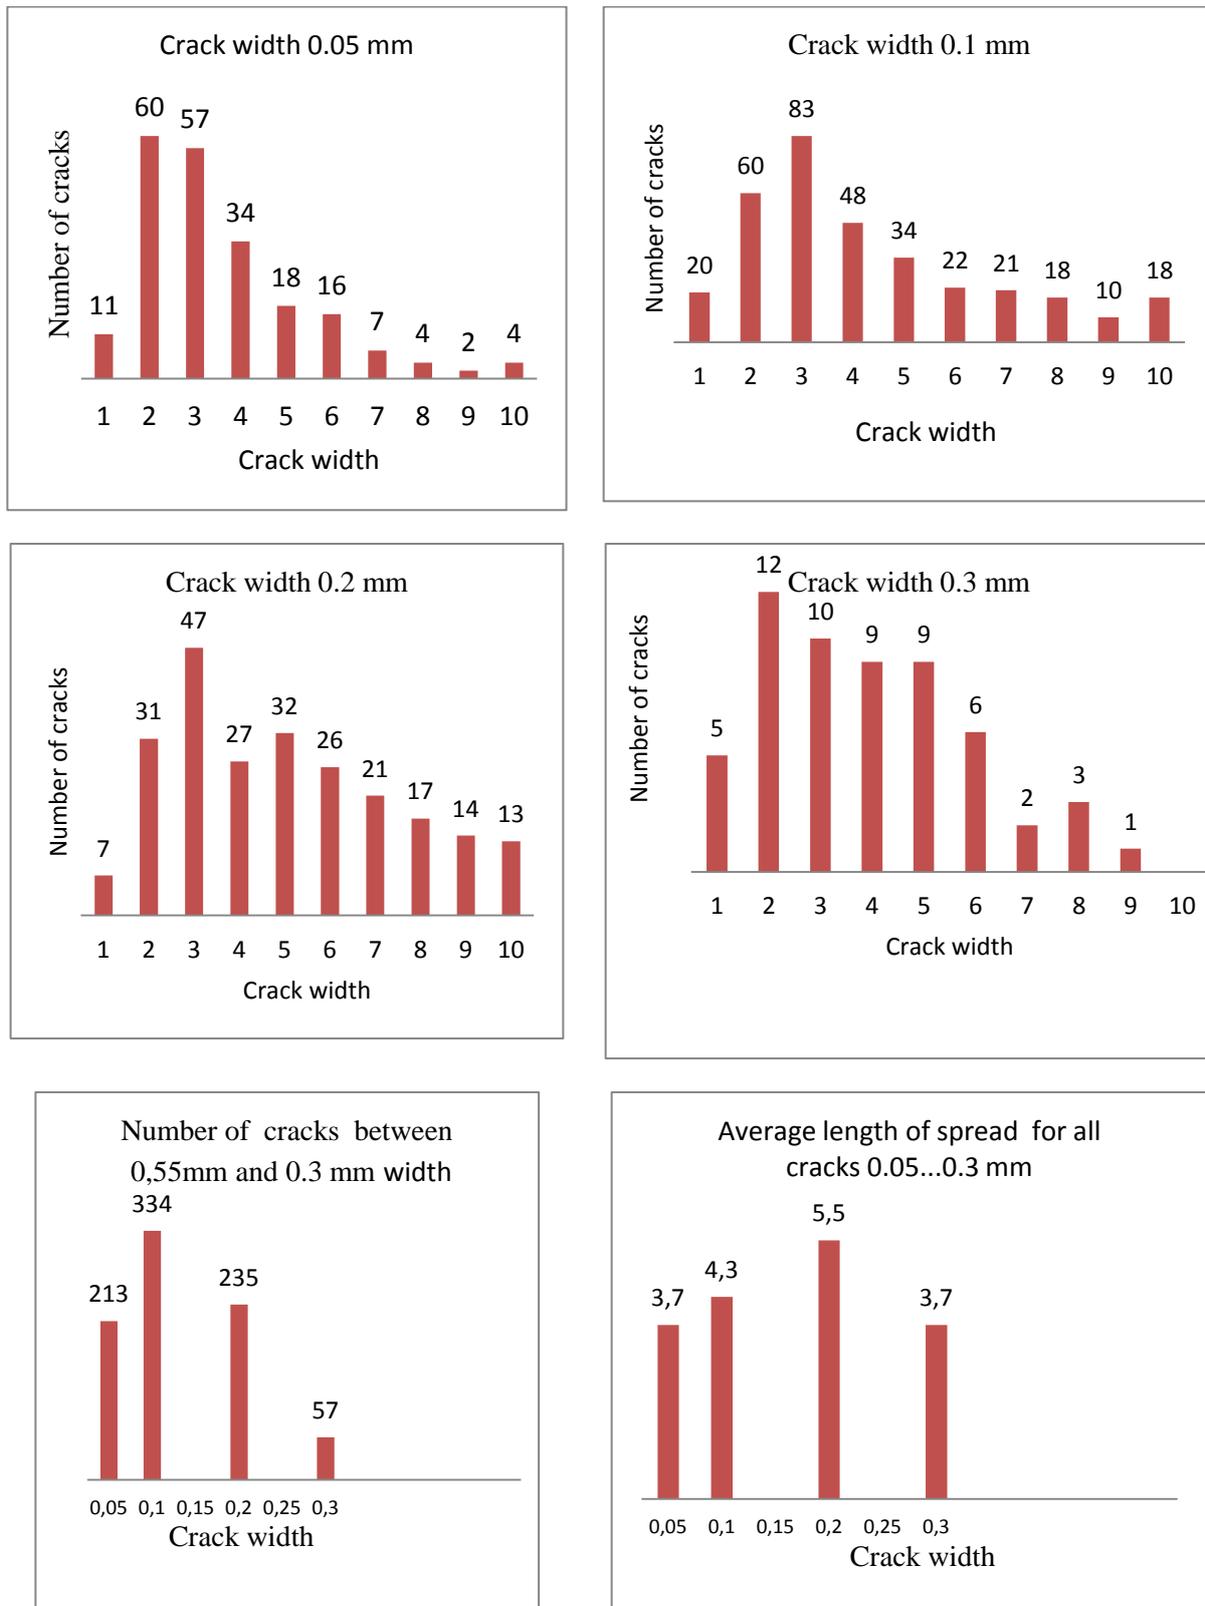
The basis for such a conclusion was the data presented in Table 1 for cracks discovered as a result of the study of constructions of the car park and the histogram of statistical distributions, presented on figure 5. The majority of the cracks primarily spread depth-wise without exceeding the protective layer of concrete. The width of all observed cracks was between 0.05mm and 0.3mm, which means that it did not exceed the norm [11].

- cracks with the largest allowed width of 0.3m constitute only 6.8%;
- the biggest number of cracks has the width of 0.1mm;
- the most frequent are the cracks with the length between 2 and 3 metres;
- the biggest number of long cracks has the width of 0.2mm which is less than the largest allowed width of 0.3mm and the estimated width of 0.25mm;
- the number of long cracks with the increasing width between 0.05mm and 0.2mm is growing which conforms with the logic of reinforced concrete;
- as the width nears 0.2mm and gets closer to the estimated width, the length of cracks significantly decreases which might mean that there is a local increase of deformations in the construction and that the crack in question is caused by load pressure.

Figure 5. Frequency of appearance of cracks of different length and width determined for cracks in ceiling and floorslabs
