# An Experimental and Numerical Investigation on Static Vibration Response of Multi-Cracked Rotor Shaft

**Abstract.** Many process industries make wide use of rotating machineries such as engines, pumps and turbines. It is seen that heavy-duty and high-speed shafts develop cracks due to fatigue at some time during their life cycle. Under certain conditions, the catastrophic failure of shaft unavoidable as stress required for propagation is smaller than that required for crack initiation. The above conditions mean that the detection, diagnosis and analysis of crack plays important role in reliable operations. Using measurement of vibration characteristics condition of the machine periodically monitored. Many researchers have analyzed the nonlinear dynamic analysis of cracked rotors. In this paper, the experimental investigation has been carried on single and multi-transverse cracked rotor shafts by measurement of static vibration characteristics. The present study aims to, experimental investigation of the vibration response of uncracked, single cracked and multi-cracked rotor shaft with different size and locations of cracks. The experimental setup has been developed for measureme

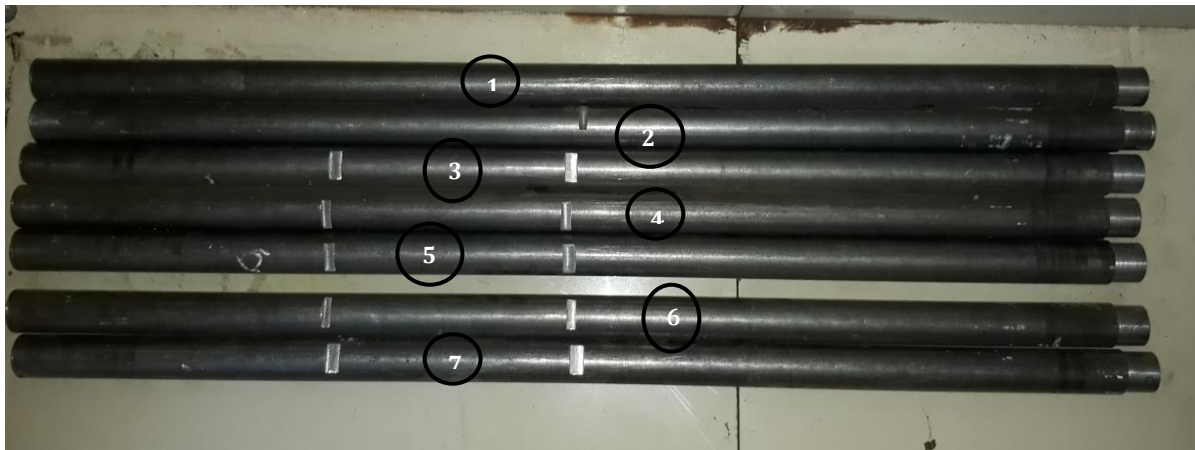
**Figure 2.** Different cases of shaft

The shaft specimens as shown in figure 2. Following are the cases selected for the static experimental analysis:

- 1 Case I: Uncracked Shaft
- 2 Case II: Single Cracked Shaft(5mm\*3mm)
- 3 Case III: Multi-Cracked Shaft (6mm\*3mm ; 5mm\*3mm)
- 4 Case IV: Multi-Cracked Shaft (7mm\*3mm; 6mm\*3mm)
- 5 Case V: Multi-Cracked Shaft (8mm\*3mm ; 7mm\*3mm)
- 6 Case VI: Multi-Cracked Shaft (9mm\*3mm; 8mm\*3mm)
- 7 Case VII: Multi-Cracked Shaft (10mm\*3mm; 9mm\*3mm)

The transverse cracks are created with the help of fine jewel saw. The dimensions for single cracked considered of 3 mm of diameter and in the range of 0-14 % of the diameter of shaft. The above mentioned cases of crack depth have been considered for analysis.

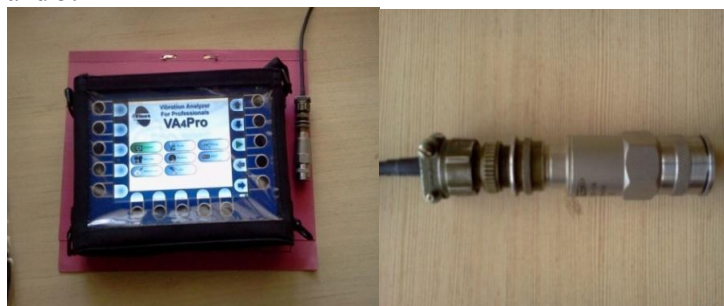
**Figure 3.** VA4 FFT Analyzer

The present study categories the measurement of natural frequency at crack condition on shaft as mentioned above. The experiments are performed with the help of ADASH VA4 FFT analyzer, which is shown in figure 4 and 5.
