Non-magnetic drill collar failure analysis and prevention measures

Abstract. Non-magnetic drill collar is a kind of drill collar made of high quality stainless steel in drilling tool. It is widely used in oil fields, but its failure rate is rising directly, and the oil well is safe. In order to better the failure reasons explored, this article through to the non-magnetic drill collar failure parts of the macroscopic characteristics, chemical composition, mechanical properties and metallographic analysis, study the cause of non-magnetic drill collar failure and failure causes and failure process for seeking the non-magnetic drill collar failure before the defects of some form of expression and master some regularity of no magnetic drill collar failure, for we can effectively prevent the non-magnetic drill collar failure accidents mat set a foundation, but also effectively control magnetic drill collar failure accidents occur frequently.

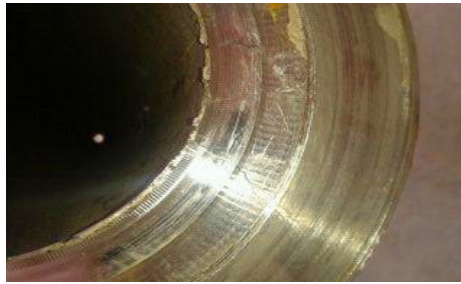
Thread failure forms to leak and fatigue fracture failure as shown in figure, the reason is due to the region at the same time by the tensile, compression, torsion, bending, vibration, friction, impact and other load fatigue damage are produced by combined action of fatigue and abrasion, position mainly in three thread position near the roots.

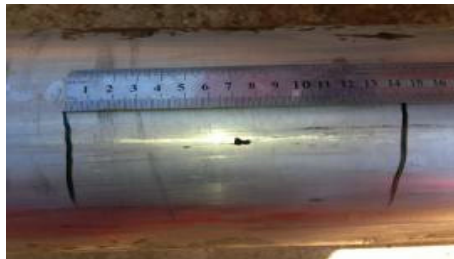
Wear out, often occurs in two: 1. When the non-magnetic drill collar by the whole drill string as the repeated action of bending moment is passed, non-magnetic drill collar thread teeth between the relative displacement happens, happen in pressure under the action of wear and tear, cause tooth type change, reduce the intensity of threaded connections, resulting in thread wear figure. 2. In the process of drilling, non-magnetic drill collar outer surface, direct contact with all kinds of rocks and composite force will increase the surface wear is shown in figure, so there may be in a rock surface wear sharply when working outside diameter is too small or severe eccentric.

Wear, reduce overall torsional performance of non-magnetic drill collar, serious eccentric wear and easy to create convenient conditions for stress corrosion thorn leakage, lead to uncertainty of wear failure. Corrosion failure. During drilling, sulfide can cause stress corrosion crack, puncture or fracture when drilling into sulfur-bearing stratum. Similarly, the drilling fluid containing chloride and chloride ions can easily cause stress corrosion in the non-magnetic drill collar.

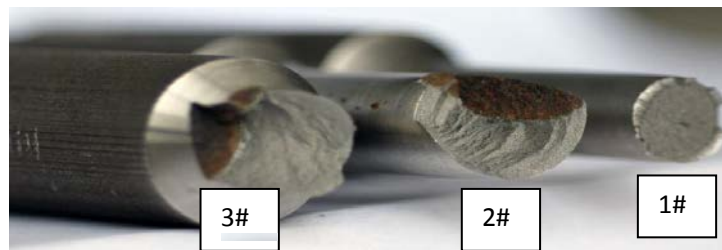
**Figure 1.** Tensile fracture of no magnetic drill collar**Table 2.** hardness test results /HB

Accordance with API Spec 7-2008 standard, the tensile, impact and hardness test is conducted in the vicinity of the non-magnetic drill collar fracture. Longitudinal bar tensile samples within the range from 12.5mm diameter, gage length is 65mm, the test results are shown in table 1, 1 # for the initial tensile test specimens, the tensile fracture position normal (within the range), but the tensile strength and yield strength do not meet the requirements of API Spec 7-2008 standard ^[4]. To conduct re-inspection then take 2 # and 3 # sample, test results show that the tensile strength of samples # 2 and # 3 and lower yield strength, test specimen fracture, found 2 # and 3 # sample fracture are within the range defects (due to the sending within a large number of crack defects, non-magnetic drill collars from tensile samples are hard to avoid these defects), the fracture morphology is shown in figure 2.

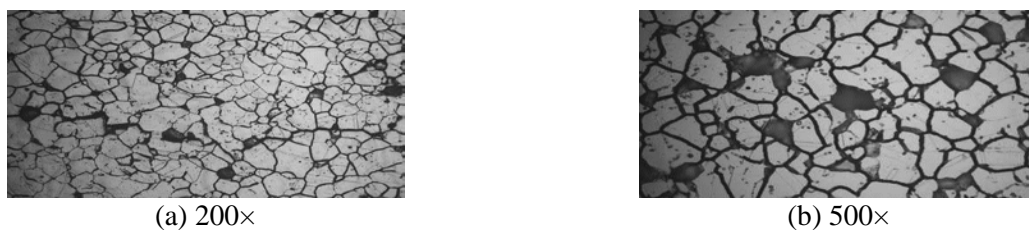
**Figure 2.** Non-magnetic drill collar metallographic structure**Table 3** Non-metallic inclusion rating and grain size in steel

Microstructure observation was performed on the drill collar along the transverse cutting of the gold phase specimen, as shown in Fig. 2. It can be seen from the figure that the structure of the drill collar is austenite, and the grain boundary corrosion is more serious. The non-metallic inclusions were graded along the longitudinal cut and the grain size was 8. See table 3.

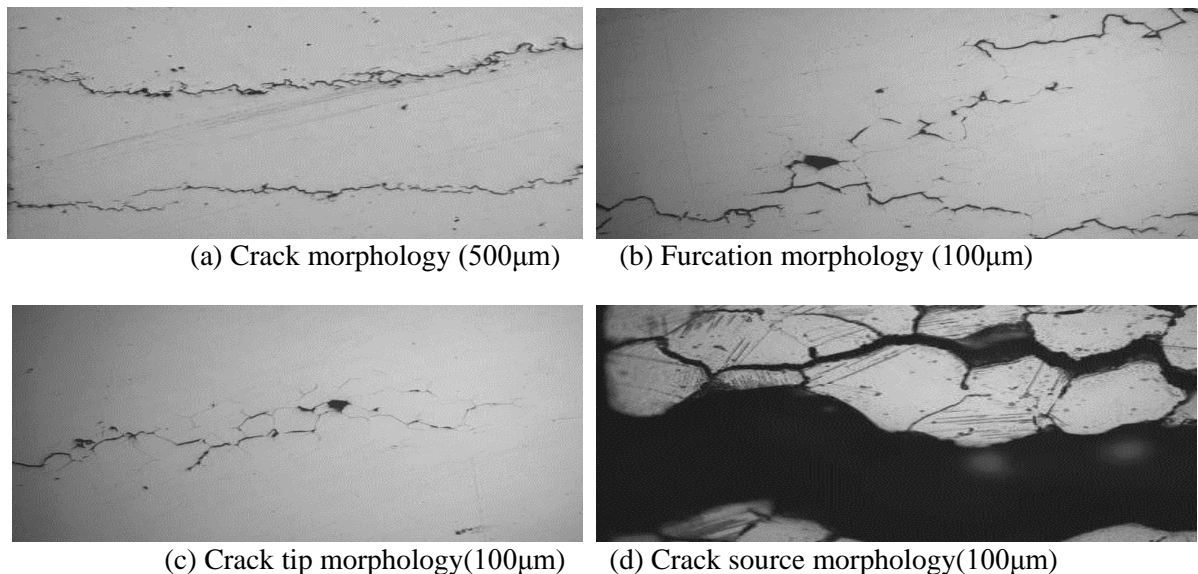
In the absence of magnetic drill collar fracture sampling, the path of crack propagation under metallographic microscope is shown in Fig. 3. As can be seen from the figure, the crack originates from the inner wall of the drill collar and is spread along the crystal expansion [1]. The results show that the steel performance of this fracture position has not reached the specified standard.

Figure 3. Crack propagation path of no magnetic drill collar

According to the above analysis results, there is the possibility of puncture and fatigue fracture failure in the threaded joints of the non-magnetic drill collar. At the same time, the main body has the possibility of wear failure and corrosion failure. Therefore, we made the following measures for these measures:

- (1) Select high-quality non-magnetic steel raw materials.
- (2) Optimize the design of non-magnetic drill collar thread structure.
- (3) Optimized drill string coordination design.
- (4) Optimized drilling well body design.
- (5) Strengthen the field detection of non-magnetic drill collar.
- (6) The non-magnetic drill collar is classified and managed, and the accident rate is reduced by strengthening the level management level.

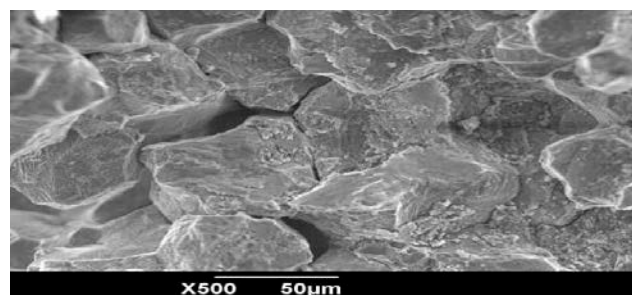
The longitudinal crack of the non-magnetic drill collar was opened mechanically, and the morphology of the fracture was observed by scanning electron microscope, as shown in Fig. 4 and Fig. 5. As can be seen from the figure, the fracture characteristics of the fracture along the crystal are consistent with those observed under the metallographic microscope. As shown in figure 6 and table 4, there is a large gap between the grain grains of the crack source area and corrosion products on the fracture surface (32.79% oxygen element and 0.26% chlorine element). It is concluded that the radial crack of the unmagnetic drill collar is caused by the corrosion failure of chloride.

Figure 4. The origin of the crack (near the inner wall)

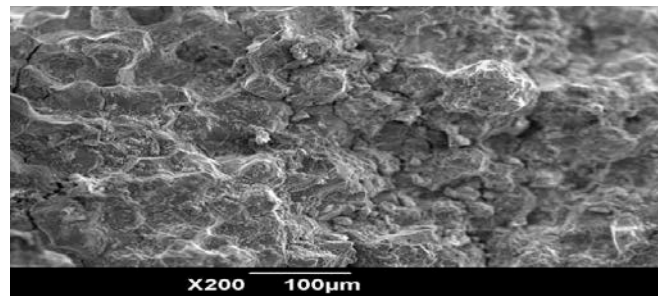
Figure 5. Morphology of crack expansion zone

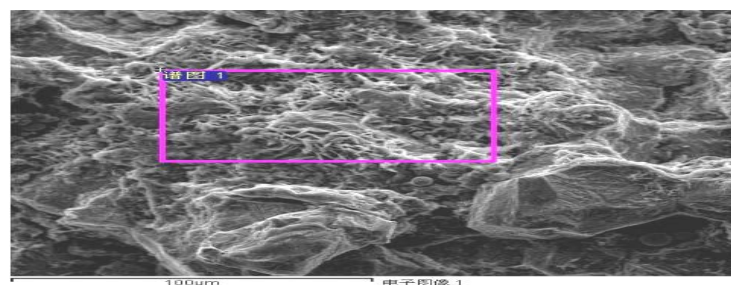
spectra	C	O	Na	Al	Si	Cl	Ca	Cr	Mn	Fe	The total
spectra 1	5.82	32.7	3.62	1.02	2.20	0.26	0.44	3.27	15.8	35.5	100.00

Figure 6. Energy spectrum analysis position (100μm)
