Impact test of composite sandwich beam with built-in FBG sensor

Haiping Pei, Yingying Wei, Yongzhen Chen, Li Wan¹ and Weiqing Liu

Department of civil engineering, Nanjing Tech university, No 30, Puzhu Road(s), Nanjing, China.

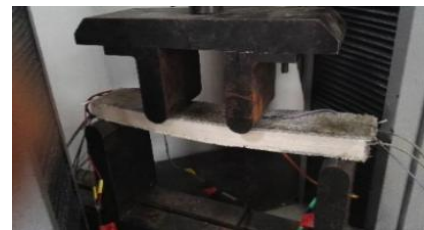
The test is based on ASTM C393 "Standard Test Method for Flexural Properties of Sandwich Constructions"[16] and GB/T 1446 "Test Method for Bendability of Sandwich Structures"[17]. The dimensions of the test pieces are shown in Table 1 and the equipment uses a 50kN electro-hydraulic servo universal test. The machine is shown in Figure 3, equipped with a four-point fixture. The top of the ballast head and both ends of the support structure are hemispherical with a diameter of 20 mm. The distance between the two ballast heads is 100mm, and the distance between the support structures at both ends is 300mm.

**Figure 3.** Test apparatus.

Similar to the repeated four-point bending test described above, the static four-point bend test was performed on the impacted specimens in accordance with ASTM C393 [16] and GB/T 1446 [17]. Trisection loading was performed using displacement loading to 2 mm/min loading speed to load. The sample parameters are the same as Table 3, and the test loading device is shown in Figure 3.

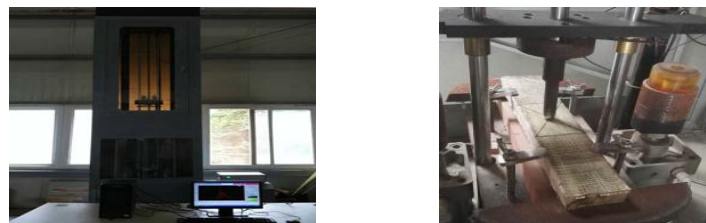
According to the standard ASTM D7136 "Standard test method for measuring the damage resistance of a fiber-reinforced polymer matrix composite to a drop-weight impact event"^[18], low speed impact test is performed. The test instrument is DTM1203 series drop hammer impact tester; punch is a hemispherical hammer with a diameter of 16mm and a mass of 5.5kg. The drop hammer falls freely from a certain height, the relevant data is collected by the hammer internal sensor to analyze the impact resistance. The hammer was dropped from heights of 400mm, 600mm, 800mm, 1000mm, and 1200mm to represent different impact energies by the control system setting parameters. The data was collected by computer, and the damage of the surface of the mixed sandwich beam was observed. Loading device shown in Figure 5, test parameters see Table 3.

Figure 5. Experimental setup of low-velocity impact test.
