# Mechanical Behaviour of Narrow Gap MAG Welding of API 5L X65M Steel Pipeline

**Abstract.** The paper analyzes the main mechanical characteristics of pulsed MAG welded joints obtained from API 5L X65M thermo mechanical treated steel. The results of the tensile strength measurements corroborated with those of toughness tests and metallographic investigations, highlighted the effect of structural changes in the heat affected zone (HAZ) and weld (W) area, on the mechanical behavior of the welded joints.

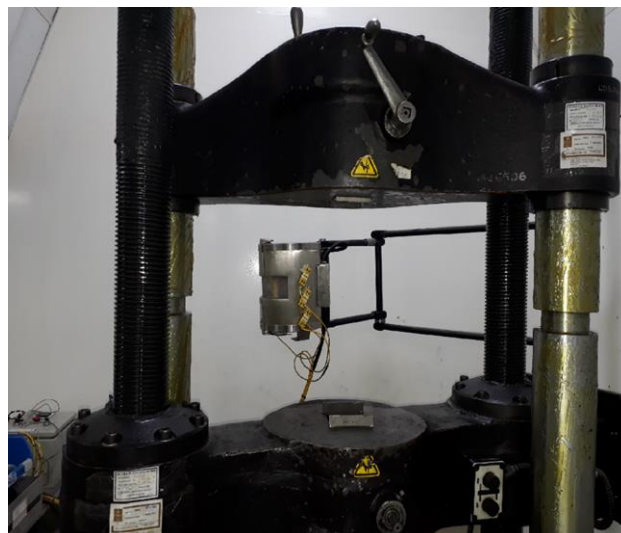
**Figure 4.** Universal machine type Satec 5500R 200BTE.

Tensile test was performed using a universal hydraulic machine, type Satec 5500R 200BTE (fig.4).

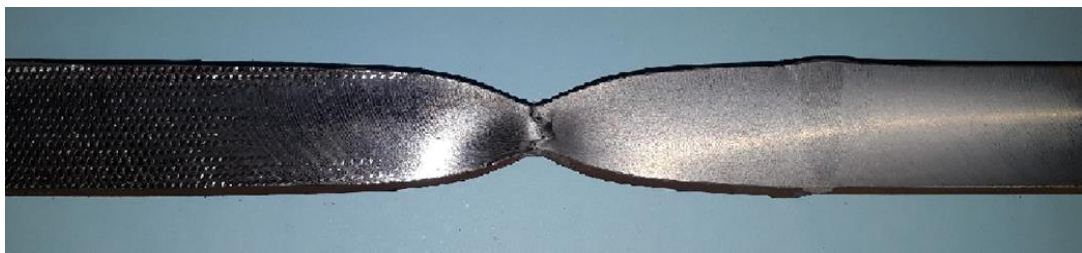
**Figure 5.** Fracture location of the tensile strength test specimen.

The results of the tensile tests are shown in Table 2 and the appearance of a test specimen is shown in fig. 5.

The analysis of the obtained data show that, each time, the fracture occurred in the base material (MB) and the values of the tensile strength for all 4 sets of tensile specimens are superior to the minimum required for the basic material (in accordance with API 5L, 2012), which is 535 N/mm<sup>2</sup>. According with API 1104, 2013, the tensile strength of the weld, including the fusion zone of each specimen has to be greater than or equal to the specified minimum tensile strength of the pipe material.

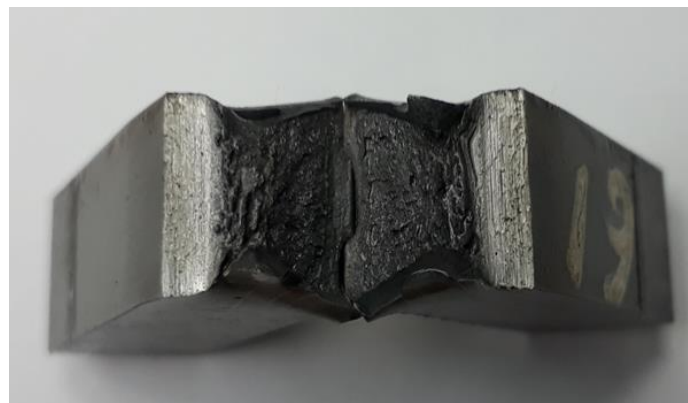
**Figure 9.** Halves of broken Charpy V-Notch Impact specimen.

The appearance of the fracture surface (fig. 9) is matte - fibrous, characteristic of the ductile fracture, which are preceded by large plastic deformations, respectively high values of the absorbed energy for crack propagation.

Towards the edges of the fracture surface where the shear stress is predominant, the fracture develops on the inclined surface to the core of the fracture surface.
