Fracture Behavior of Monolithic Hot-Pressed Posterior Ceramic Dental Crowns

Abstract. Glass ceramic restorations are wide used in dental practice due to their advantages as life-like appearance, excellent biocompatibility, chemical inertness, close abrasion resistance to enamel, but their most common mechanical complications are chipping and catastrophic fracture. The purpose of the study was to evaluate monolithic ceramic posterior crowns with anatomical design, achieved by hot-pressed glass ceramics, without filler Cergo (Degudent) and leucite reinforced Vita PM9 (Vita) by experimental analyses, in order to study their fracture behavior under compressive load. The modes of fracture will be correlated with the type of material, fracture load and displacement magnitude. For the experiments complete crown preparation were made on a first upper molar. The specimens were subjected to failure testing. Digital images of the fractured crowns fragments were used to verify the pieces in all situations. The failure occurred by cracks, splitting into two or more parts, with or without fracture of the die. The correlation of the displacement depending on the load highlights the peaks, which

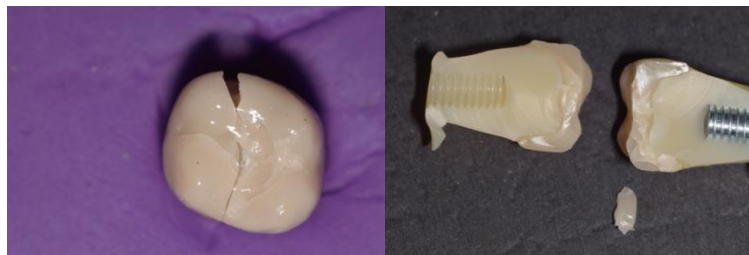
Figure 1. Centric splitting of the crown and underlying die (sample V1).

Digital images of the crowns fragments were used to verify the pieces in all cases. The final fracture occurred after cracks, splitting the crown into two and or more parts, with or without fracture of the composite die. In the majority of cases (samples V1, V4, V7, C2, C3, C4, C5, C7, C8) final fracture occurred by splitting through the crown and composite die into two or more parts. The splitting line was centric or eccentric. The splits deviated slightly from the fissure plane, suggesting that fracture may find a path through the cusps (in case of centric split) (Figure 1) or along the fissure (in case of eccentric split) (Figure 2). In these cases the crown failure appeared to be abrupt at the critical load, with no visible sign of precursor cracking prior to splitting. Other cases are characterized by fractures of the crown associated with fissure in the composite die (samples, V5 and C1) (Figure 3), crown fractures (samples V2, V3, V6, C6) (Figure 4) or only cracks in the crowns, mostly radially (sample V8) (Figure 5). For Cergo samples fractures were more critical.

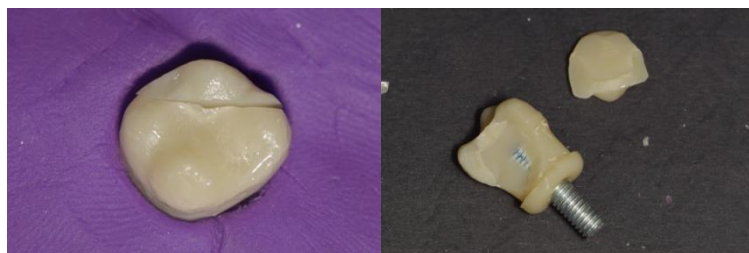
Figure 2. Eccentric splitting of the crown and underlying die (sample C3).

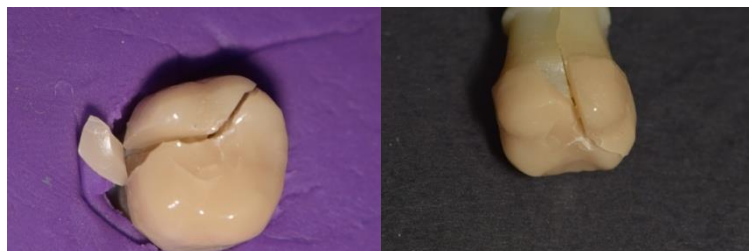
Figure 3. Eccentric splitting of the crown and cracking of the die (sample V5).

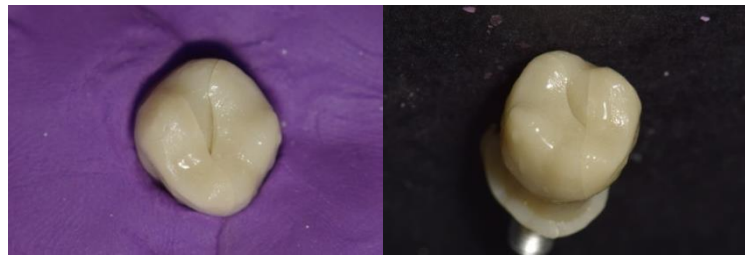
Figure 4. Fracture of the crown (sample C6).

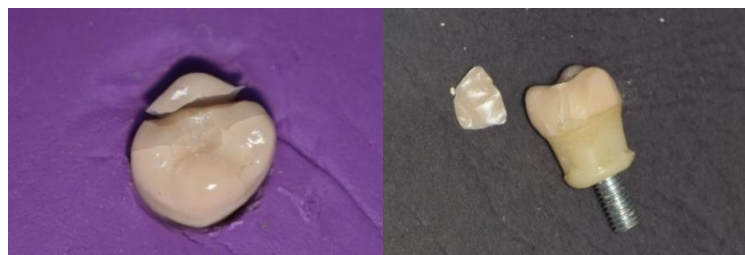
Figure 5. Chipping of the crown (sample V8).
