Performance of Fire-deteriorated Concrete Beams Strengthened with NSM Laminates

A Jadooe ^{1,2}, R Al-Mahaidi ³ and K Abdouka ⁴

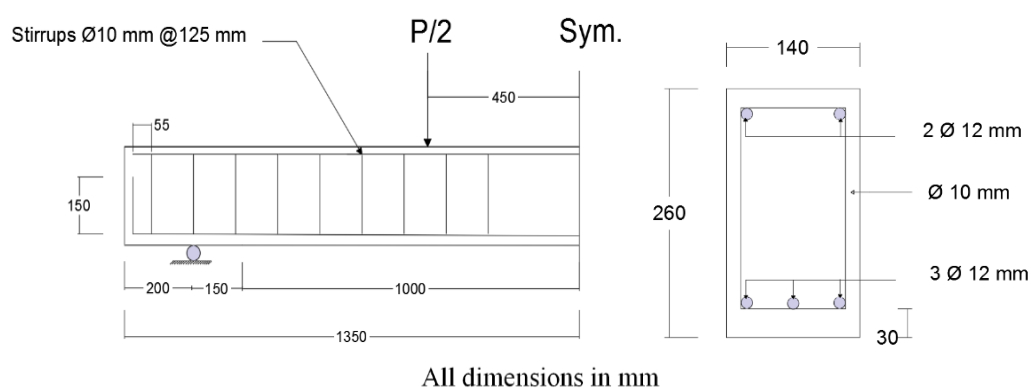
The experimental test program involved nine RC beams, and it aimed to investigate the effectiveness of using NSM CFRP laminate to repair concrete deteriorated by high temperatures. Moulds were prepared and made for the beams using plywood sheets, and the dimensions of each experimental beam were 140 mm wide, 260 mm deep, and 2700 mm long. The beam dimensions in this program were designed to fit the furnace dimensions. All concrete beams were reinforced with steel 3 Ø12 mm at the bottom and 2 Ø12 mm at the top in the form of longitudinal deformed bars, while Ø10 mm deformed bars were used for transverse bars or stirrups (shear reinforcement), with a 25 mm top cover and 30 mm covering the other sides. These beam details are illustrated in Figure 1.

Figure 1. Beam geometrical details

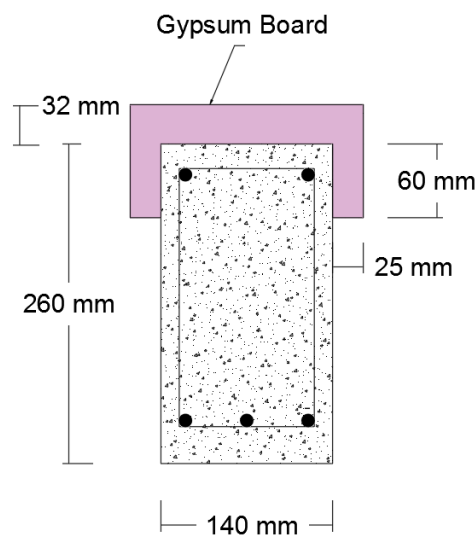
The proportions by weight for the concrete mix were 1 (cement): 1.8 (fine aggregate): 2.4 (coarse aggregate), and the water/cement ratio was 0.42, with a maximum aggregate size of 14 mm. The moulds were removed after 24 hours of curing, and the beams were kept coated with a wax emulsion. The beams were placed in the laboratory at ambient temperature (between 16 to 20 °C) and relative humidity (approximately 65 %), until the test day. The top surface of RC beams was protected from heating to the temperature of the concrete floor slab by using an insulation system formed of gypsum plasterboard. This involves gypsum and a crystalline form of calcium sulphate and water that combined to create calcium sulphate dehydrates, $\text{CaSO}_4 \cdot 2\text{H}_2\text{O}$. The insulation overall consisted of two layers of gypsum plasterboard. The first set of layers was installed on the top surface of the beam, with a total length of 2,300 mm and thickness of 32 mm, where the thickness was 16 mm for each layer. The second layers were installed on the top side, with a thickness 25 mm and depth of 60 mm, as demonstrated in Figure 2.

Figure 2. Layout of insulation layer

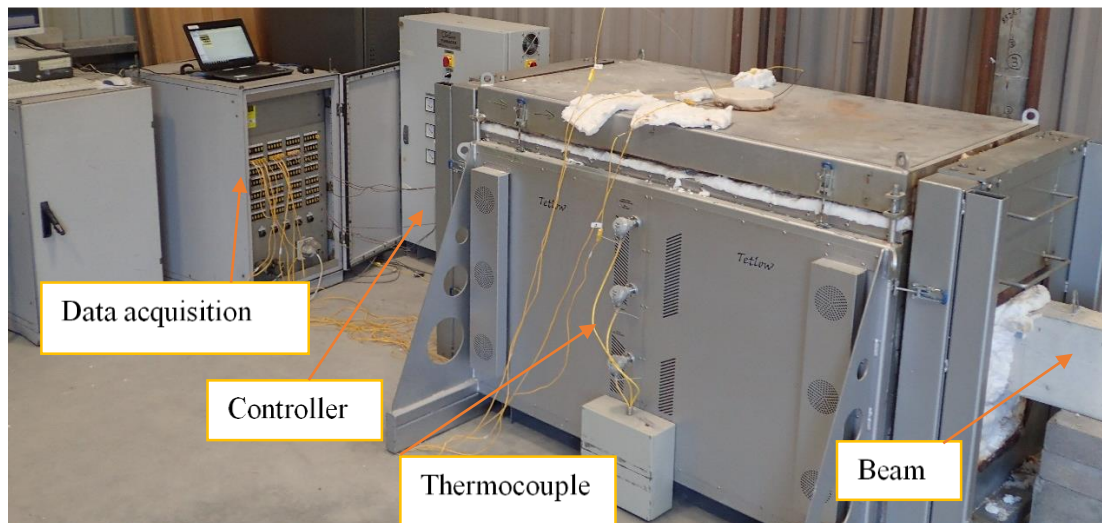
Seven RC beams were heated to temperatures of 600 and 800 °C using a large horizontal furnace. They were kept constant during the test for two hours of exposure and then cooled gradually down to room temperature. Heating rates were based on the time-temperature curve of ISO-834. However, the cooling regime was chosen to represent natural cooling at a rate of 1 to 3 °C/min in the furnace until room temperature was reached. The furnace was supplied with a separate controller, which enabled the temperature to be controlled for the RC beams during the test procedure. The external dimensions were 2,000 mm long and 1,050 mm high. However, the internal dimensions were 1,700 mm long and 800 mm high, as shown in Figure 3.

Figure 3. Horizontal beam test furnace

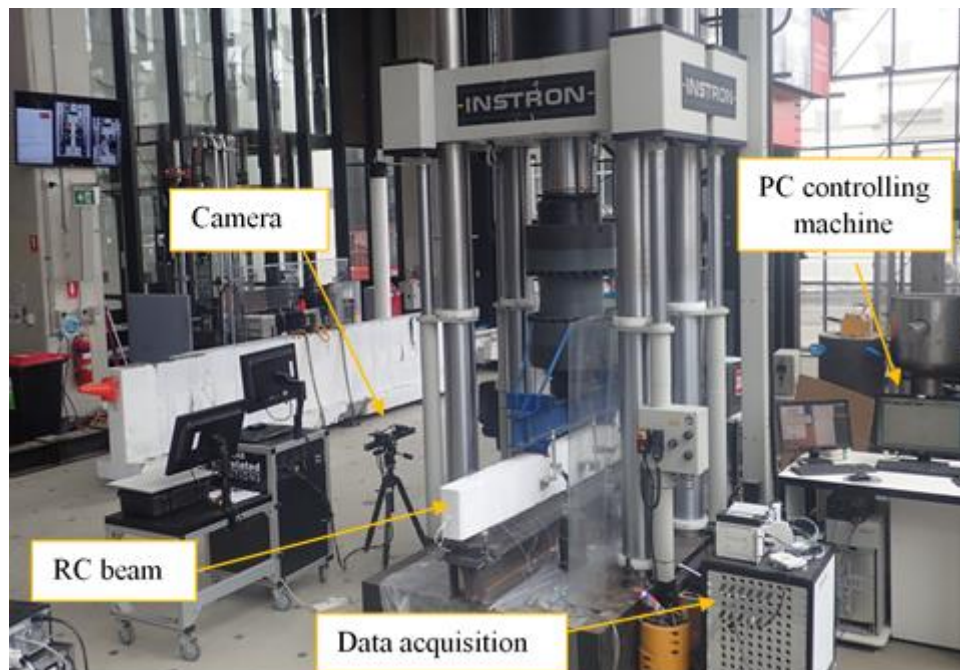
All the RC beams were tested using a 5 MN capacity Instron testing machine. The displacement rate of this machine was 1 mm/min. The setup of a beam in this machine is shown in Figure 4. The load was recorded by the load cell of the 5 MN Instron compression testing machine, and displacement data and strain gauge data were recorded by a data acquisition system which recorded all data every second throughout each increment of the test. The beams were loaded in a four-point bending configuration; the total span was 2,300 mm and the shear span was 700 mm for each side of the beam.

Figure 4. 5 MN Instron compression testing machine and test set-up

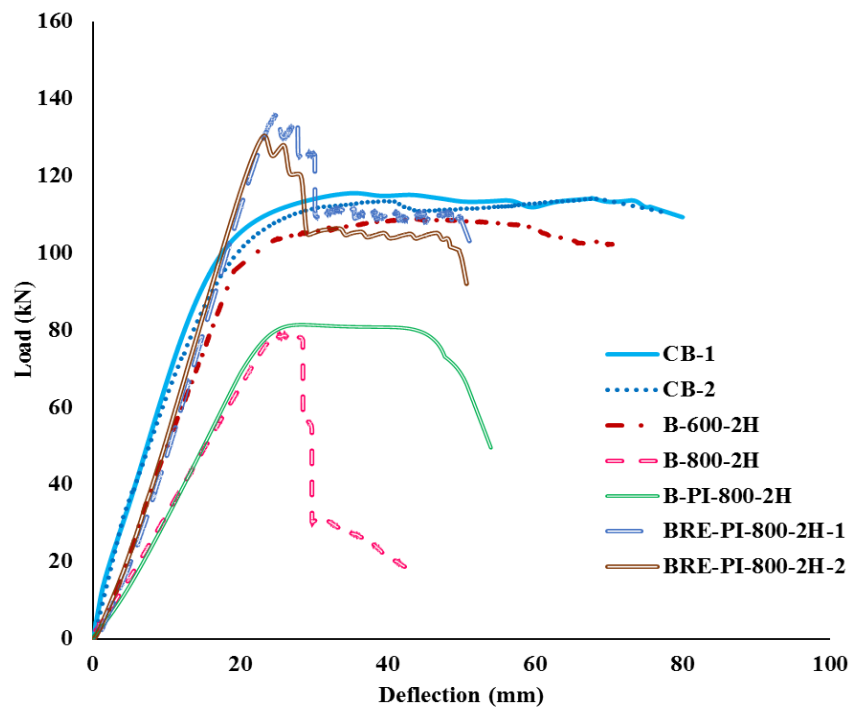
Figure 5. Load vs mid-span deflection using epoxy adhesive after exposure to 600 and 800 °C

The overall behaviours for control and heat-deteriorated RC beams were assessed by studying the load-deflection diagrams. The performance of beams was evaluated using the load deflection curves shown in Figure 5 and Figure 6. The control beams achieved an average ultimate failure load of 115 kN and the maximum deflection was 79 mm. The deflection increased steadily after the steel yielded as the load increased, demonstrating the ductility of the beams. The load capacity of the heat-deteriorated beams without insulation on the top surface of the concrete reduced after two-hour exposure to 600 and 800 °C by 5.2 % and 32 %, respectively. In addition, the load capacity of the heat-deteriorated beams using partial insulation also reduced after two-hour exposure to 800 °C, by 30 %. The results demonstrated that when the beam was exposed to 600 °C, the residual strength, and the stiffness of the beam decreased slightly. It is clear that at 600 °C, the decrease in flexural strength is related to the losses in compressive strength, tensile strength, modulus of elasticity, and tensile strength of steel reinforcement, which drop to about 51%, 63%, 70%, and 6.3% of their original values, respectively. However, at 800 °C, more dramatic losses of 77%, 89%, 91%, and 47% of original values during bending testing of RC beams were seen, respectively. It was noted, that the reduction in strength was very high when the RC beams were exposed to 800 °C due to the fact that the strength is controlled by the yielding of the steel reinforcement; Kigha [13] confirmed experimentally that the tensile strength of steel is greatly affected by heating where the fire temperature is more than 700 °C. Thus, the 800 °C exposure caused significant

reductions in strength and stiffness. The control beam failed at 115 kN, whereas the beams deteriorated by heating to 600 and 800 °C failed at 108 and 78.5 kN, respectively. The load carrying capacities of the heated beams were also lower than that of the unheated beams.

Specimens exposed to 800 °C only were then repaired with NSM CFRP laminates, using epoxy and cement-based adhesives, due to their high reduction in load carrying capacity compared with the unheated beam. The NSM system led to an enhancement in the capacity and stiffness of RC beams when the epoxy and cement-based adhesives were utilised. In general, the post-heated beams strengthened with NSM CFRP laminates regained more strength and stiffness than the unheated beams. This shows the possibility of restoring RC beams deteriorated by elevated temperatures by using NSM systems. For example, the flexural capacity of the deteriorated beams repaired subsequently with NSM CFRP using epoxy and cement-based adhesives increased by an average of 15% and 8%, respectively, compared with the control beam. This also illustrates that the presence of CFRP with cement-based adhesives improves the ductility of heat-deteriorated beams, as shown in Figure 6. This is seen in a comparison of the unheated control beam results with those of specimens exposed to 800 °C.

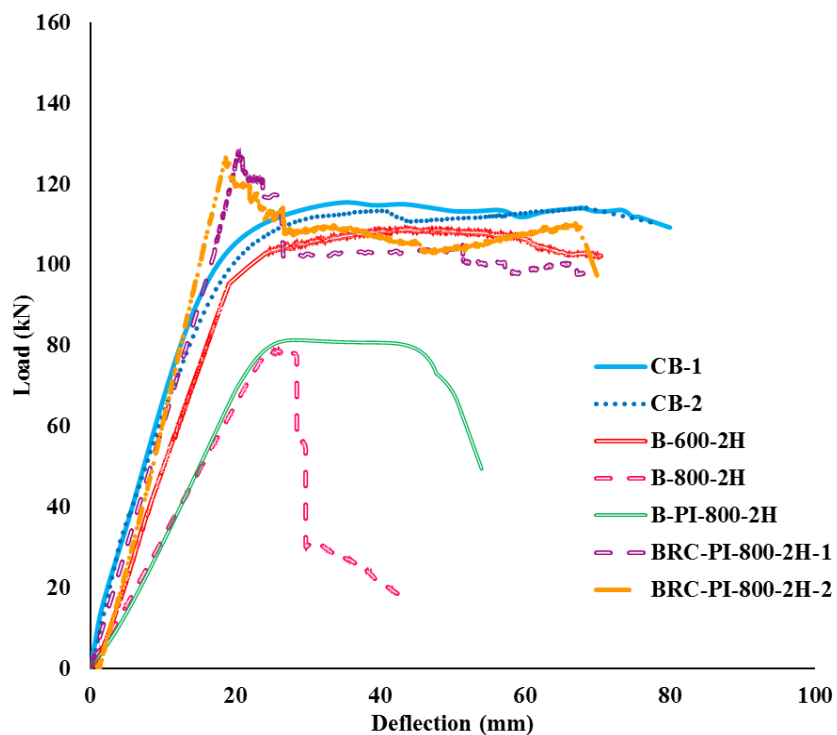
Figure 6. Load vs mid-span deflection using cement-based adhesive after exposure to 600 and 800 °C

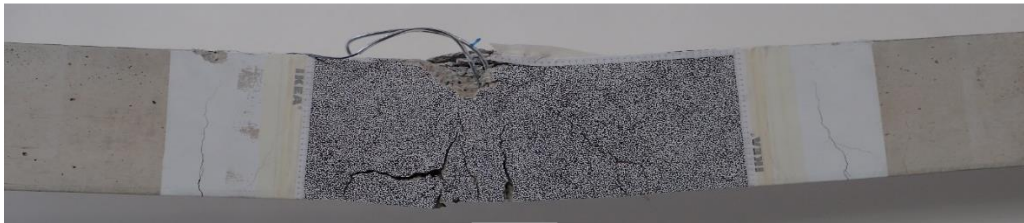
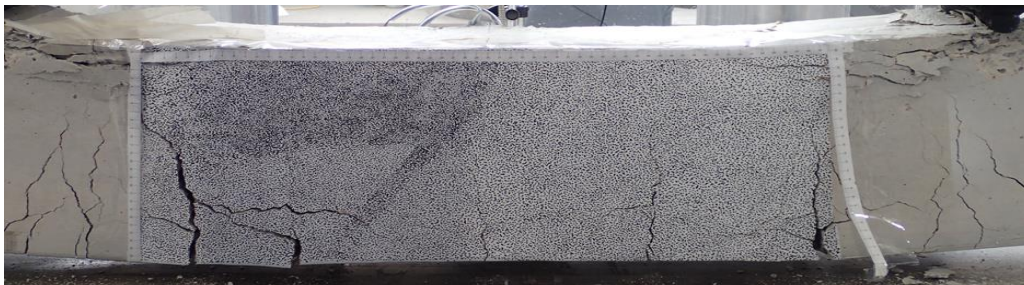
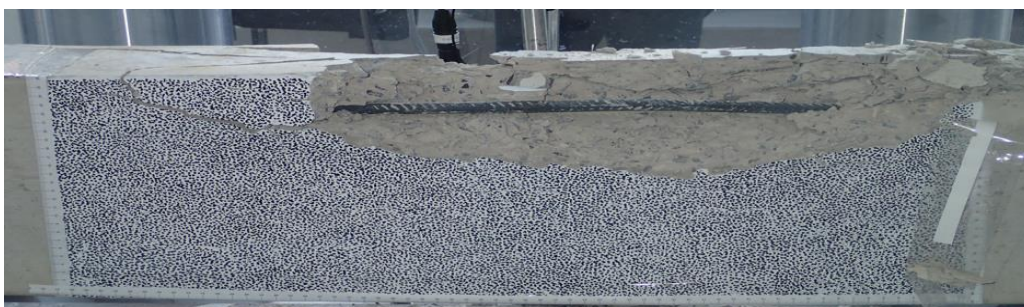
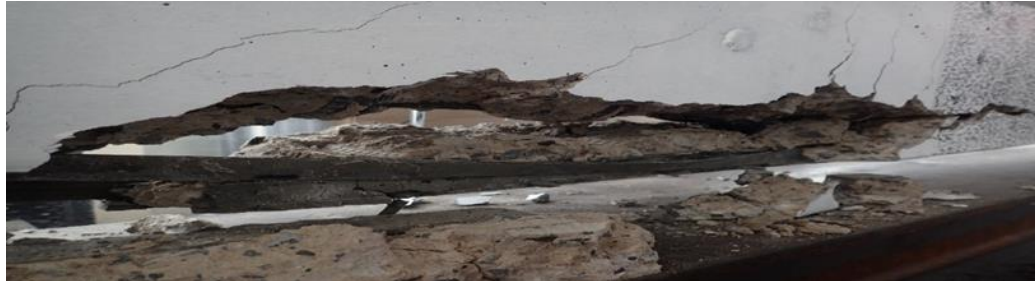
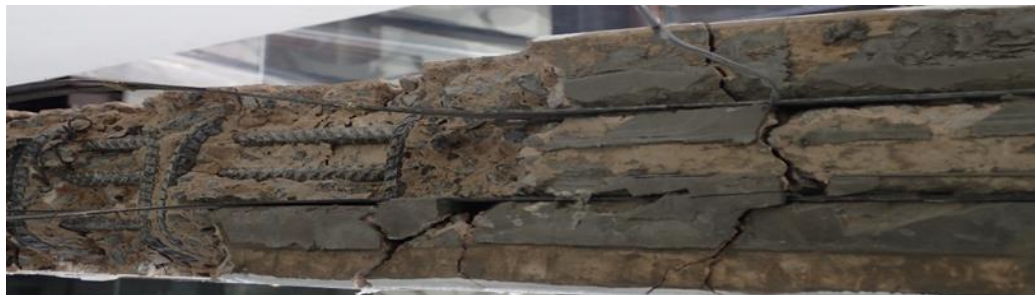
Flexural failure was observed in the control beam and the heat-deteriorated beams exposed to 600 and 800 °C using partial insulation. However, in the beams heated to 800 °C without insulation, sudden failure occurred. The typical failure of the control beam was a yielding of the steel reinforcement, followed by a crushing of the concrete, as shown in Figure 7(a). For the beams heated to 800 °C using partial insulation, the flexural cracks were seen to be widespread throughout the region of pure bending, as shown in Figure 7(b). However, the beams heated to 800 °C without insulation experienced sudden failure due to degradation of concrete properties and the changes in thermal stress of the concrete microstructure [14], as shown in Figure 7(c). For those beams repaired with epoxy adhesives, the failure mode was concrete cover separation, beginning at the cut-off point of the CFRP laminates and propagating to the middle of the beam, followed by compressive failure of the concrete, as shown in Figure 7(d). This failure is similar to those reported by [12 and 15]. However, the beams repaired with cement-based adhesive failed due to partial concrete cover separation followed by large deformations and compressive failure of concrete, as shown in Figure 7(e).

Figure 7. Failure modes of some RC beams
