## Case Report

# Fracturing of revision of a cobalt-chrome femoral head after fracturing of a ceramic femoral head, with diffuse metallosis. Case report

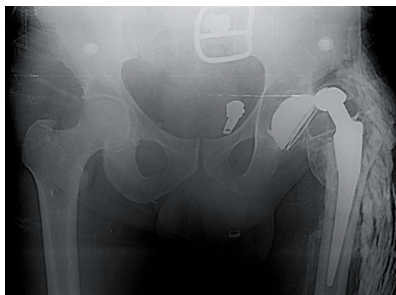
**Fig. 5 - Dislocation of total hip prosthesis with apparent fracturing of the cobalt-chrome femoral head and increased radiological opacity of the muscles of the lateral face of the thigh.**

service presenting pain and functional incapacity of the left leg, with the hip flexed and externally rotated, compatible with posterior dislocation of the total hip prosthesis. Radiologically, dislocation of the total hip prosthesis was confirmed, with apparent fracturing of the cobalt-chrome femoral head and increased radiological opacity of the muscles of the lateral face of the thigh (Fig. 5). Closed reduction of the dislocation was performed under general anesthesia (Fig. 6), and subsequent revision surgery was advised, which was done in November of the same year.

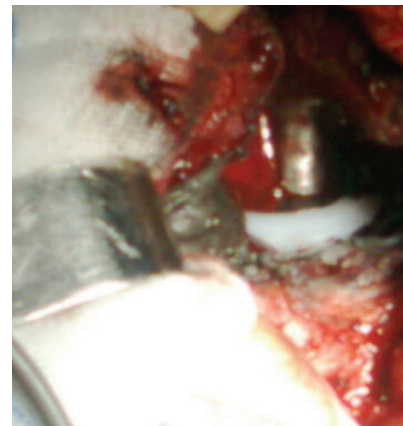
During the operation, diffuse metallosis of the muscle and cartilage tissues was seen (Fig. 7), along with central wear of the

**Fig. 7 - Diffuse metallosis of the periarticular tissues.**

In total synovectomy, the principles of tumor resection should be applied: lavage and surgical debridement with a wide safety margin). In our case, it was not possible to fully remove the metallosis, given that it was very extensive. As much surgical debridement as possible was performed, in order to be able to close the surgical wound and avoid joint instabilities.
