**MOLYBDENUM DISILICIDE COMPOSITES FOR  
GLASS PROCESSING SENSORS**

## **DOE/OIT/GLASS INDUSTRY QUARTERLY PROGRESS REPORT April – June 2001**

**Los Alamos National Laboratory  
Los Alamos, New Mexico 87545**

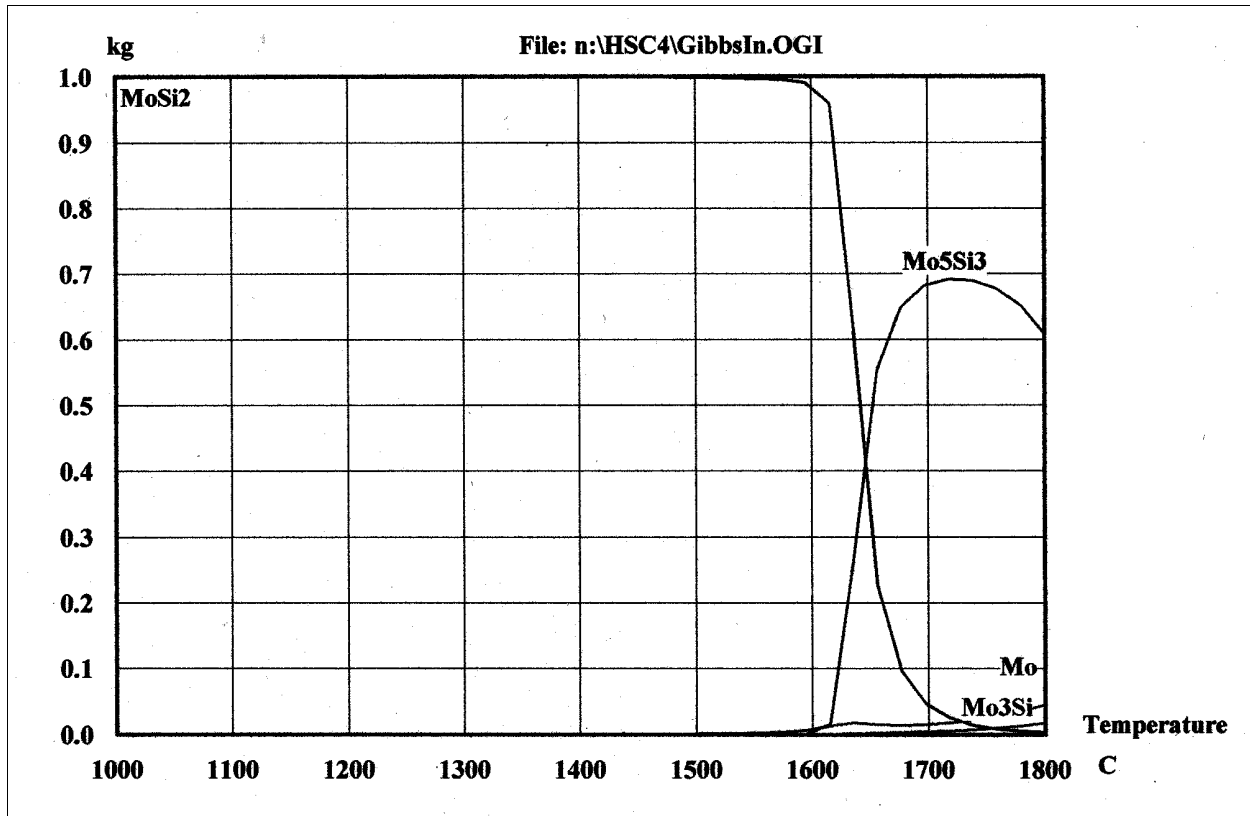
**Figure 2:** Thermodynamic analysis of equilibrium stability of  $\text{MoSi}_2$  in TCE Funnel Glass composition, as a function of temperature.

Results of the thermodynamic calculations for the TCE Funnel Glass are shown in Figure 2. These results show that the  $\text{MoSi}_2$  is very stable in the Funnel Glass up to a temperature of 1600 °C, where  $\text{Mo}_5\text{Si}_3$  begins to form extensively, with minor formation of  $\text{Mo}_3\text{Si}$  and Mo.

These thermodynamic calculations are consistent with the macroscopic and microscopic observations of the  $\text{MoSi}_2$ -coated  $\text{Al}_2\text{O}_3$  sheath, which indicated little or no reaction with the Funnel Glass. This result shows that  $\text{MoSi}_2$  is stable in high lead molten glass compositions.

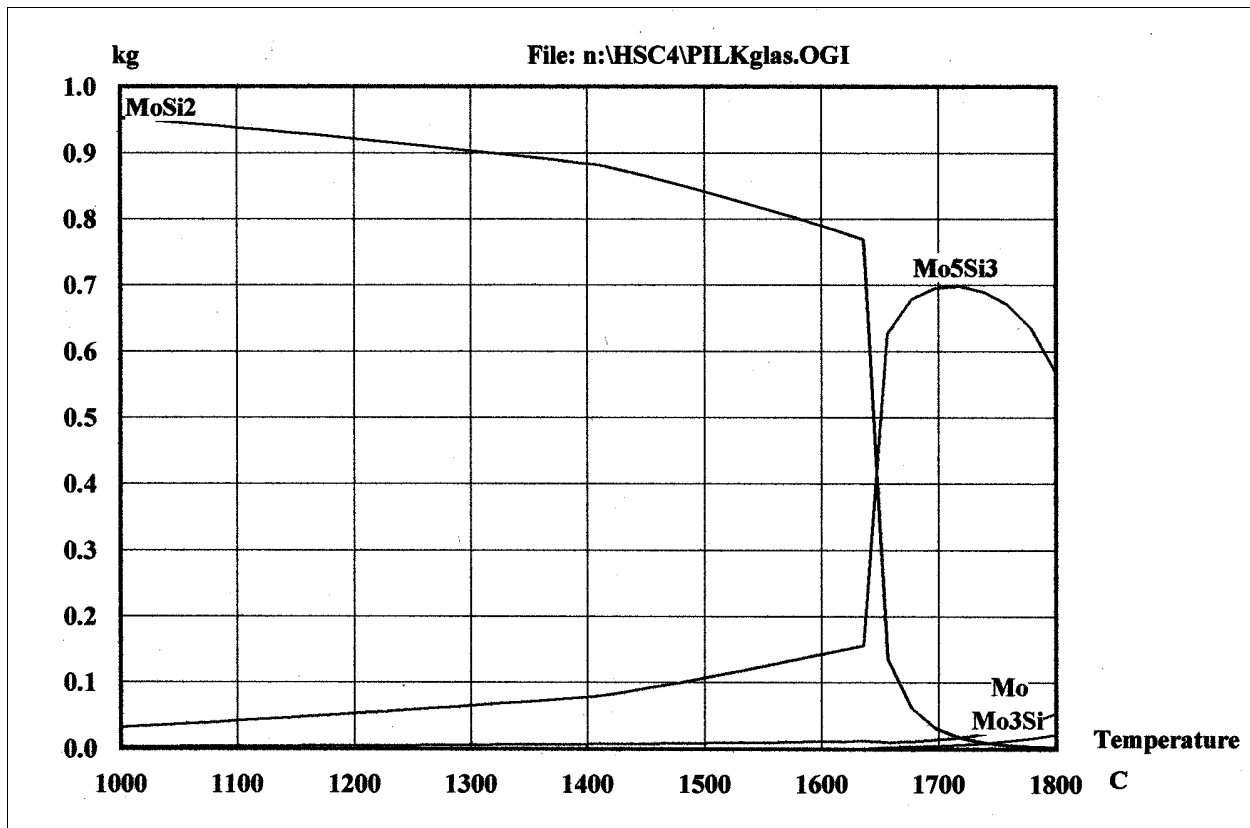
**Figure 7:** Thermodynamic equilibrium calculation of  $\text{MoSi}_2$  in the LOF-Pilkington glass composition, as a function of temperature.

Equilibrium calculations of the stability of  $\text{MoSi}_2$  in the molten LOF-Pilkington glass are shown in Figure 7. The equilibrium formation of a small amount of  $\text{Mo}_5\text{Si}_3$  in this glass composition is observed for temperatures of 1000 °C and above.
