DECOMMISSIONING OF SHIELDED FACILITIES AT WINFRITH USED FOR POST IRRADIATION EXAMINATION OF NUCLEAR FUELS & OTHER ACTIVE ITEMS

K.D.Miller, S.J.Parkinson, R.M.Cornell

RWE NUKEM Limited

Winfrith Technology Centre, Dorchester, Dorset, United Kingdom

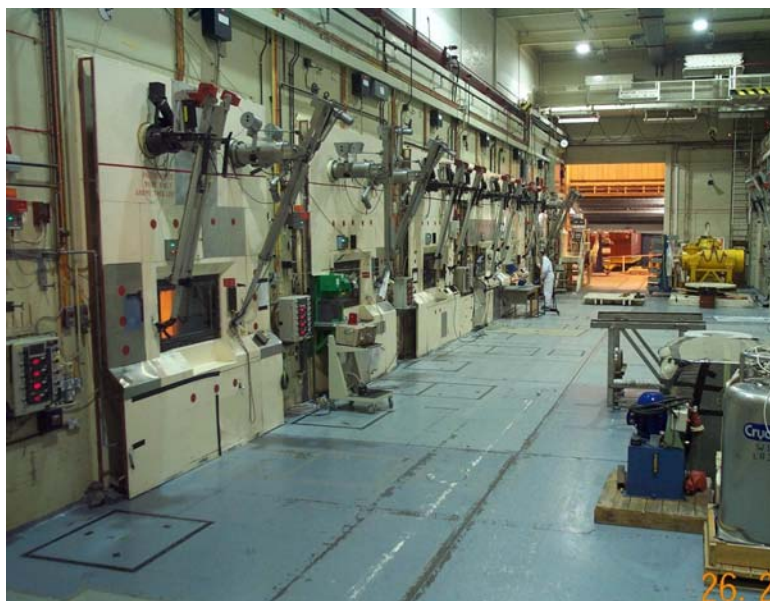
The North Cave Line (NCL) comprises a suite of seven caves, Figure 2, and this facility has currently reached a fairly advanced stage of decommissioning. A second smaller suite of caves (SCL) constructed in an almost identical way is located adjacent to the NCL and is in the process of being decontaminated and decommissioned in a similar manner.

Fig. 2. View of South Face of North Cave Line at Building A59

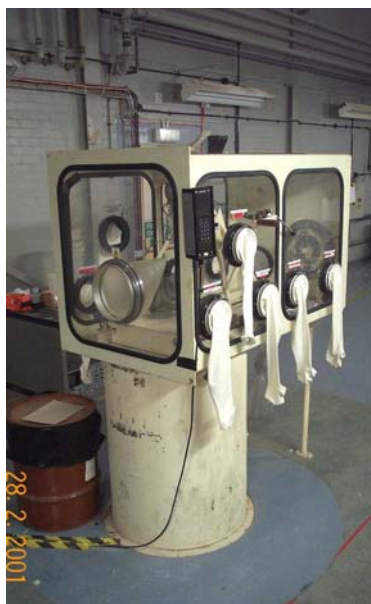
Once the individual caves had been cleared of equipment and other loose items, the heavy in-cave bench and support structure could then be remotely dismantled using relatively simple techniques and size reduced to facilitate removal for disposal. The bench top comprised 6mm thick steel plates and these were secured to the underlying steel support structure with cap head screws. These screws were removed using a pneumatically-operated impact screwdriver held down by a master-slave manipulator. This worked well and the tip of the tool was guided into position on the screw heads using a remotely operated in-cave TV camera, which was used to support all the work. The camera had an auto-focus zoom lens, enabling both close-up and long distance images to be readily viewed out-of-cave. The availability and flexibility of this camera system made a great difference to the ease of carrying out many of the subsequent tasks. Any screws that could not be removed had their heads ground away using a simple air-operated grinding disc, but the process was slower than the unscrewing operation. Once freed from the securing screws, the bench top was cut into smaller sections using an electrically operated slitting wheel supplied with hardened tips to cut steel or stainless steel as appropriate. The NCL had a mild steel bench top and the SCL a stainless steel unit. Blade exchanges were required occasionally and these were carried out in a dedicated glovebox located at waist height on the cave roof, Figure 3.

Fig. 3. Glovebox on Roof of NCL used for Tooling Maintenance

This facility had originally been provided to support the introduction of small consumable items into the caves during its long period of work on fuel-based PIE operations. Once the decommissioning operations started, the facility was used to support the maintenance of many items of in-cave tooling on both cave lines. As such, the facility was invaluable since it provided close control of contamination yet allowed manual access to the tools to provide a quick and easy means of maintenance.

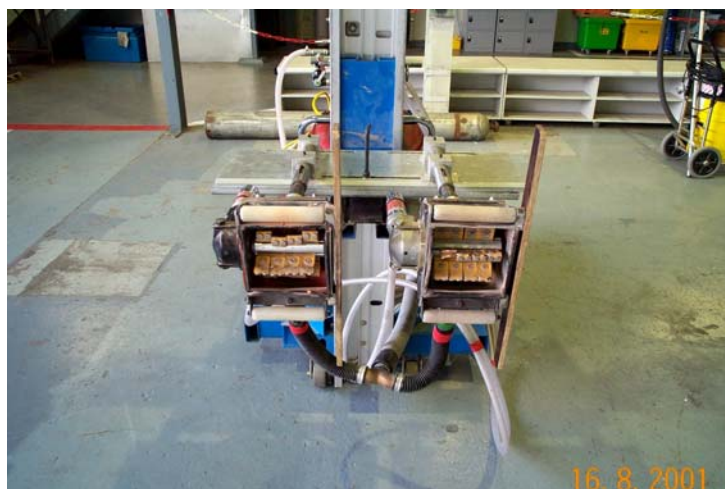
Once the cleaned surfaces were dry, they were then abraded using a range of suitable tooling that had been found effective for the purpose. The cave surfaces were both painted steel and concrete and 'Trelawny' units were used with suitable inserts to abrade them. These tools, Figure 4, comprise a series of hardened steel inserts connected to a central rotatable spindle by narrow leather strips.

Fig. 4. View of Trelawny Surface Scabbling Unit used in PSA Facility

The units are located inside a semi-circular housing from which a vacuum cleaner draws the air, dust and contamination freed by the abrasive action of the inserts. They can be operated either electrically and pneumatically but the operators developed a preference for the electrically driven units, which tended to be more powerful. In each cave, the removal of all the paint from the walls, floor and ceiling led to a significant reduction in activity levels with dose rate reduced to around $20\mu\text{Sv/h}$ in caves 4-7 and around $100\mu\text{Sv/h}$ in Caves 1-3. At this point the surfaces were resealed with various paints to protect them into the next stage of the cave decontamination and decommissioning process. This allowed the cave windows to be drained of their zinc bromide and then removed from the structure. The means of carrying out this routine task lies outside of the scope of the paper, but it should be noted that each window comprised three items, a concrete framed tank holding ~ 920 litres of zinc bromide, a 100mm thick lead glass attenuator block and finally a 30mm thick piece of lead glass to seal the internal face of the cave.
