A COMPLETE HISTORY OF THE HIGH-LEVEL WASTE PLANT AT THE WEST VALLEY DEMONSTRATION PROJECT

Lawrence L. Petkus, James Paul, Paul J. Valenti, Helene Houston,
West Valley Nuclear Services, WVNSCO
and
Joseph May
U.S. Department of Energy

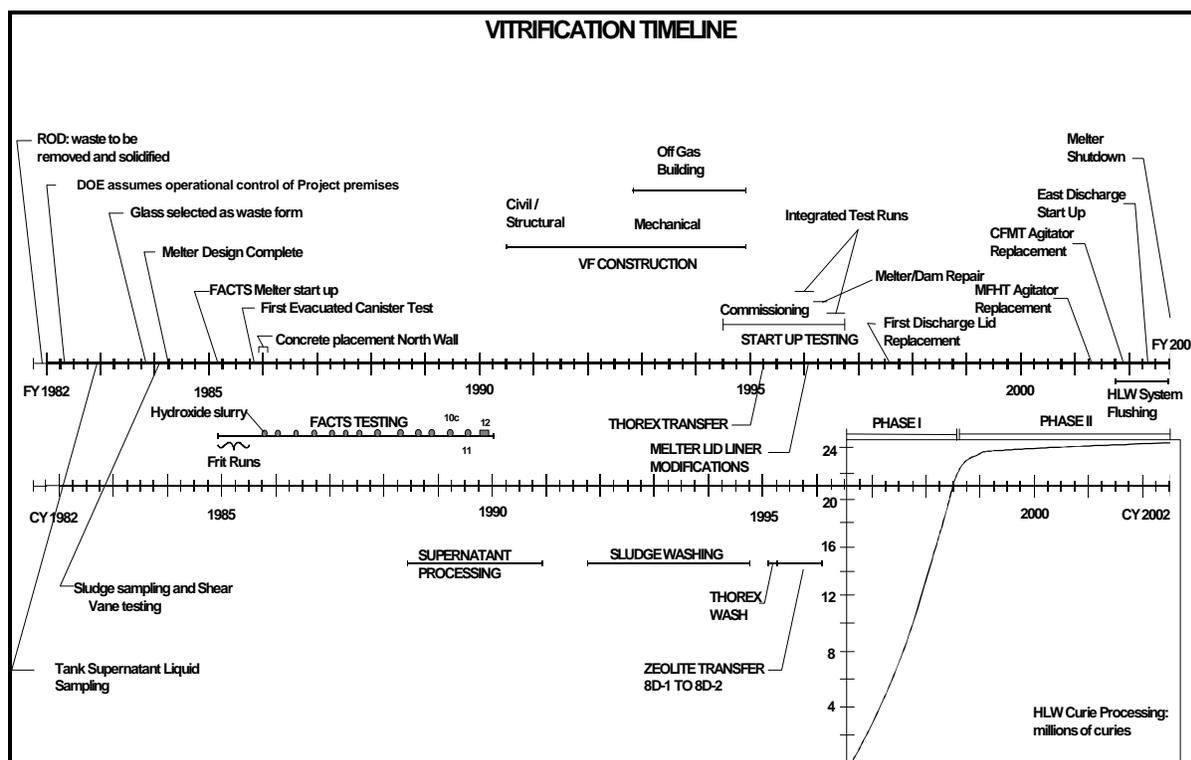
Fig. 1 Timeline

Based on analyses of the first HLW samples taken, the decision made was to use a chemical method to separate HLW from the liquid, combine it with sludge, and vitrify the resulting HLW mixture into a glass waste form. The proposed approach to chemically separate (pre-treat) the HLW also involved developing a method to process the resulting decontaminated liquid into an approved low-level waste (LLW) form. By taking this approach, it was possible to significantly reduce the amount of glass that needed to be produced while also ensuring the integrity of the final glass product. Once this processing decision was made, efforts got underway to select the best methods to achieve decontamination, process LLW, and produce a final HLW glass form. The general progression of events following this early process development decision is shown on the timeline in Fig. 1.

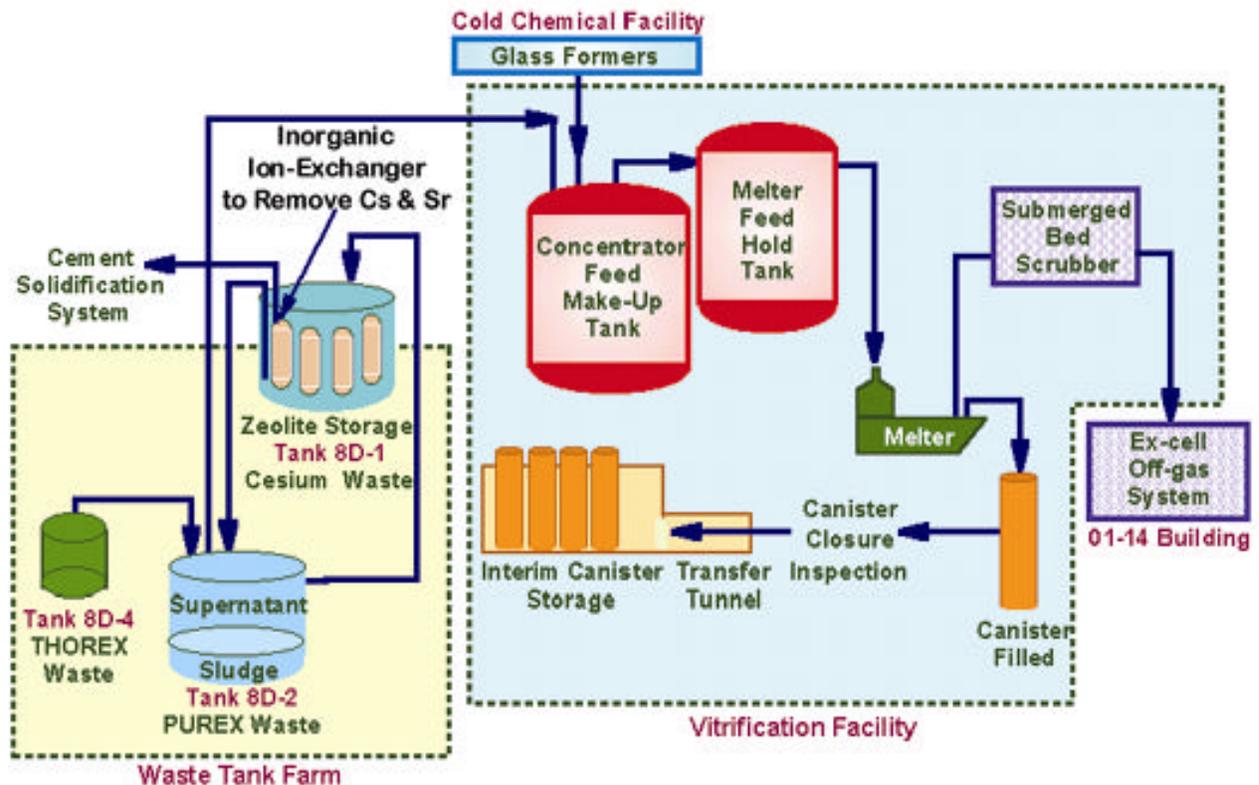
Fig. 2 HLW Process

The overall method developed for processing HLW involved preparing the HLW for processing by separating (removing) the majority of the radioactive species (Cs-137 and Sr-90) from the waste liquid, combining the resulting HLW with the waste sludge, and processing the HLW mixture into the approved glass waste form. After removing HLW from the waste liquid, the resulting low-level waste (LLW) liquid also was processed into an approved waste form, cement encapsulated LLW. The basic overall method and systems used to process liquid HLW into approved HLW and LLW forms are illustrated in Fig. 2.

HLW Processing Flow Sheet

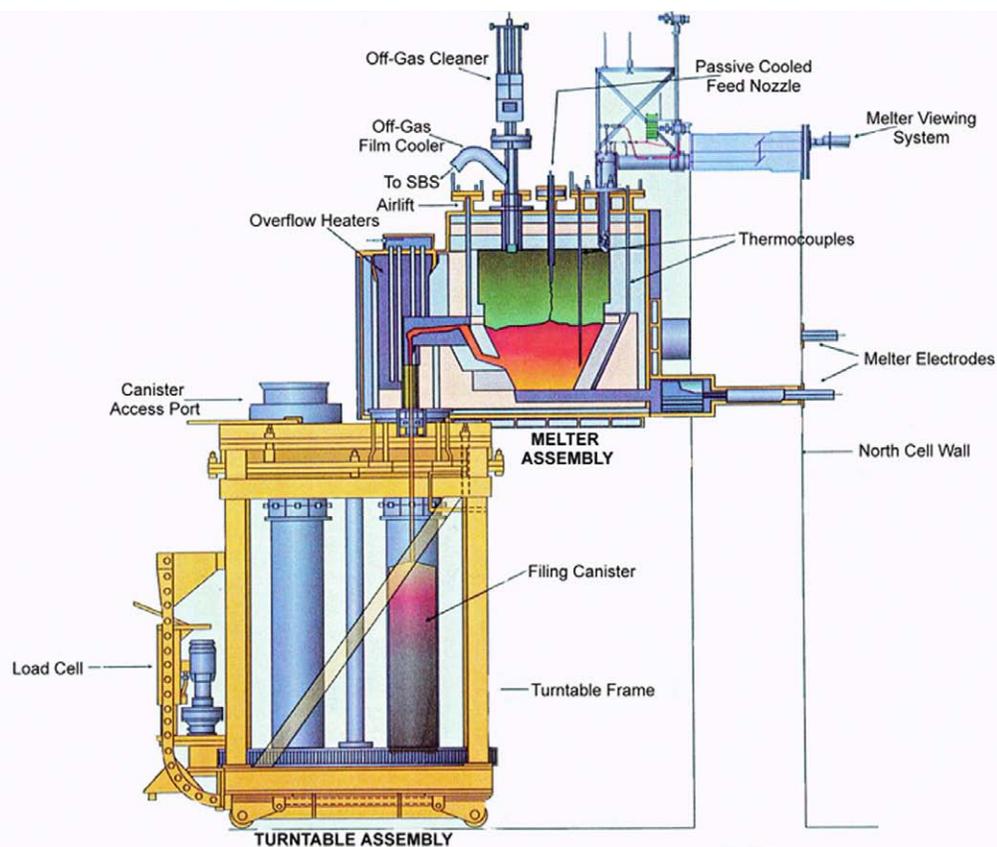
Fig.3 HLW Melter and Turntable

Melter Discharge: The melter is designed to discharge molten glass by pulling homogenized bulk glass from the main melter cavity through an under flow drain (as illustrated in the cut-away view of the melter and turntable shown in Fig. 3). Glass is directed from the under flow drain up a sloped channel that rises to a trough. The high point of the channel is the melter overflow. Normally the melter is operated at a glass level of one to two inches below overflow, using the airlift to raise glass up to the trough where it then flows by gravity to the canister. The cavity holding the trough is independently heated to maintain glass temperature during pouring. Glass discharge from the melter is a recognized point of potential failure.

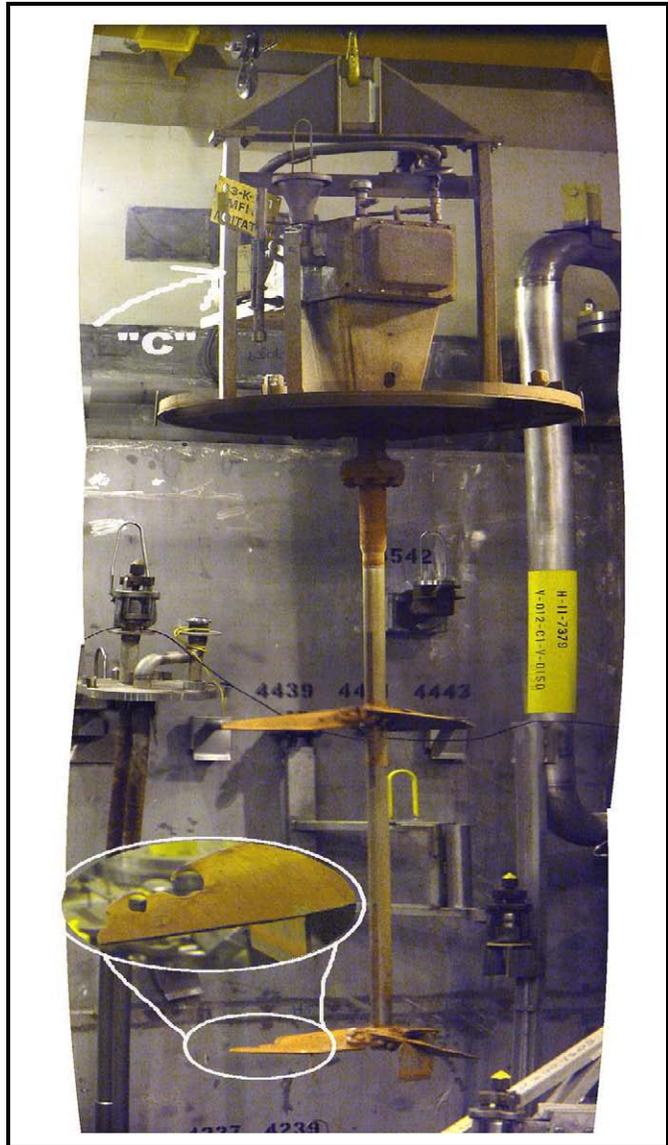
Fig.4 MFHT Agitator

for both agitators. Failure occurred within the flexible coupling, located between the motor and the gearbox, the metal grid holding the two mating hubs together (see Fig.4, "C"). The agitator manufacturer did indicate that grid failure occurs if the coupling is not greased periodically. When the motor housing was remotely removed from the coupling, a broken grid and hardened grease was found. As no method was available to replace the grid or the coupling, the entire agitator assembly had to be replaced. Blade wear was noticed on all blades after the agitators were removed from each tank. MFHT agitator failure occurred first because it was used on a full 24 hour cycle to keep feed slurry suspended during melter feed operations. Its blades showed the greatest amount of wear (see Fig.4 inset). Although the CFMT was used steadily, it was shut off when new batches of glass forming chemicals were being prepared.

Agitators: The homogeneous slurry mixture needed to make HLW glass was prepared and fed to melter using two slurry tanks, the Concentrator Feed Make-up Tank (CFMT) and the Melter Feed Hold Tank (MFHT). Homogeneity of slurry mixtures held in each tank was maintained by using commercial agitators that had been modified for remote service. Although the Vit Cell was not equipped to perform preventive maintenance on these agitators, it was possible to add oil to the agitator gear box using in-cell equipment. Radiation resistant lubricants were specified for periodic additions of oil. Generally one frame size larger than standard motors, the agitator motors were specified with a 1.15 service factor but were not radiation resistant. Both agitators failed after five years of radioactive service. Failure mode was identical
