PLASTIC DEFORMATION AND FRACTURE OF STEELS UNDER DYNAMIC BIAXIAL LOADING

C.K. Syn, J. Moreno, D. M. Goto, J. Belak, D.
Grady

July 9, 2004

Materials Science and Technology 2004
New Orleans, LA, United States
September 26, 2004 through September 29, 2004

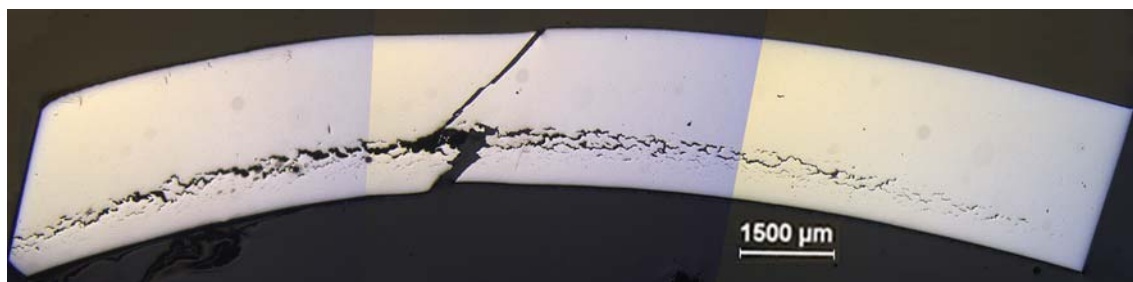
Figure 7: Cross-sectional micrograph of internal crack and pores developed in an unhardened AerMet 100 target impacted at 1.55km/sec shown in Figure 6.

Cross-sectional metallography of the unhardened AerMet100 target impacted at 1.55 km/sec clearly revealed internal cavitation within the material; see Figure 7. Unlike traditionally spalled flyer-plate targets, where the spall plane is centered within the target, the current spall-plane is located near the buffer-target interface (rear surface of the target plate). The region of internal cavitation extended approximately 25 mm (~1.0 inch) in diameter. The presence of this cavitation (or spall) plane clearly gives rise to an apparent thickening of the target plate. The degree of thickening is roughly equal to added thickness of the target plate due to the porosity. Subtracting the porosity-thickness from the overall target plate thickness, and calculating a porosity-compensated thickness strain, a strain value of roughly -0.25 is obtained. Albeit this value does not agree, exactly with that expected based on the in-plane surface strain estimation, it is an improvement over the earlier estimating based on the overall target plate thickness, and is probably well within the experimental error characterizing the measuring methods.

Also evident in Figure 7 are inclined cracks that intersect either (inner or outer) surface of the target and both intersect the spall plane. The presence of inclined cracks may be expected considering the imposed biaxial stress-state and the tendency of thin plate material to exhibit localized shear deformation in the through-thickness direction. The nature and origin of the inclined cracking, however, was not investigated in detail. The dog-leg shaped kinking of the inclined crack at the spall plane suggests the spall plane was formed, initially, followed by the formation of the inclined crack.
