# A Systems Approach to Retrofitting Residential HVAC Systems

*J.A. McWilliams and I.S. Walker*

**Environmental Energy  
Technologies Division**

**May 2004**

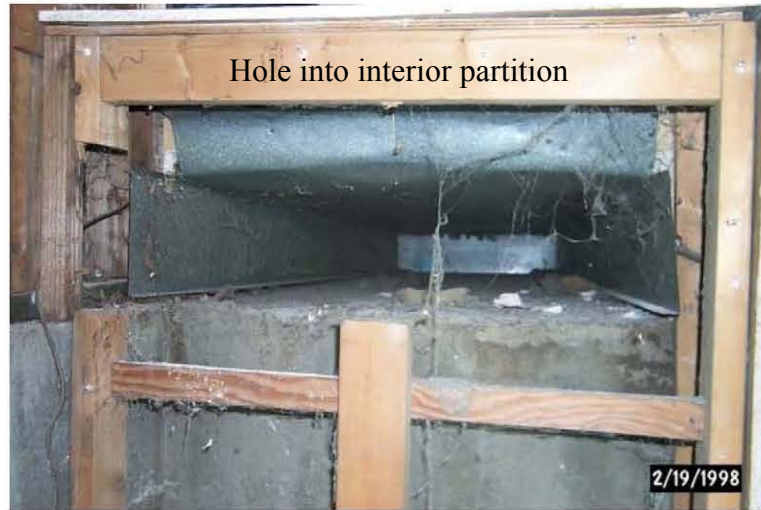
**Figure 1. Very leaky building cavity return that was removed during the retrofit**

Cracks between  
concrete  
foundation and  
sheet metal

attic, with RSI 4.5 (R-26) glass fiber insulation between the 50 mm by 200 mm (2 by 8 inch joists) on 40 cm (16 inch) centers. The house had the following combination of problems: low-efficiency heating and cooling equipment, leaky (see Figure 1) and poorly insulated ducts (see Figure 2), low air handler flow, low refrigerant charge, and a leaky exterior envelope. In addition, the air handler, furnace, cooling coils and most of the duct system were located outside the conditioned space in the garage and attic. A few major components of the shell leakage were easily identified in this house: several large mechanical chases were open to the attic, and a building cavity return was open to the garage and the attic. The HVAC system was undercharged and operating at only two-thirds of its rated capacity. Lastly, the homeowner reported problems in cooling the upstairs of the house.

The existing return was closed off because it was very leaky and there was no reasonable way to seal it. A larger upstairs return was installed in a new location (upstairs hallway ceiling) to assist in reducing temperature stratification. A second downstairs return was installed in a new location (in the wall at the stairway landing).

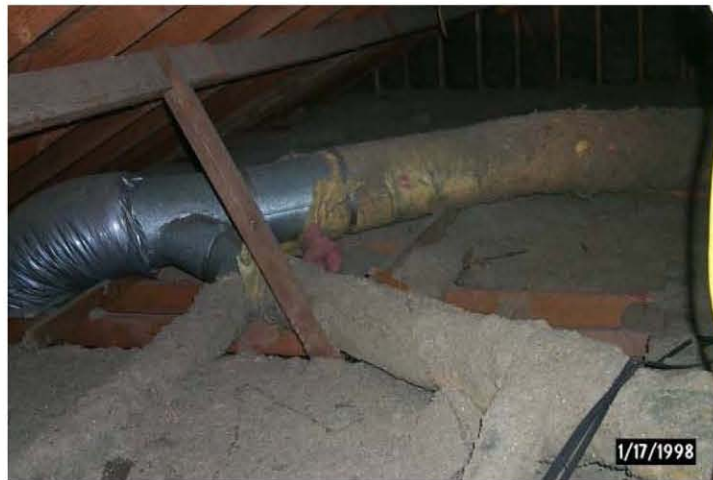
**Figure 2. Poorly insulated sheet metal ducts and blown-in insulation in the attic before retrofit**

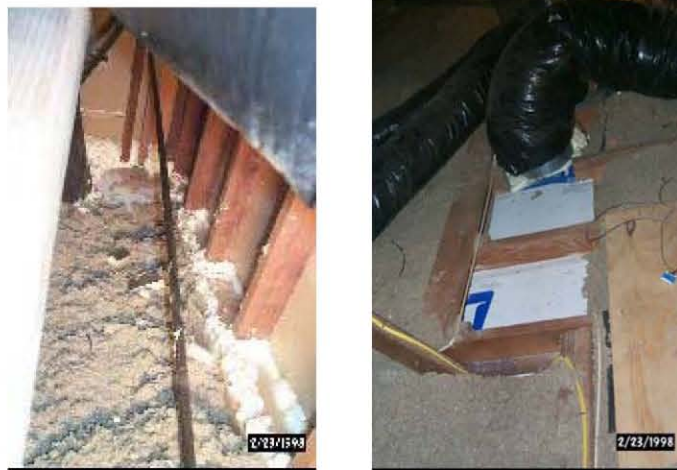
**Figure 3. Sealing cavities connecting the house to the attic. Foam was used for sealing small holes and cracks at building component intersections (left). Duct board insulation was used to block off large open areas (right)**

The sealing of the envelope was very successful – mostly because this particular house had significant large leaks that we were able to access. We sealed over 570 L/s (1200 cfm) of leakage at 50 Pa (0.2 in. water)) - about one-quarter of the total leakage. The sealing included: air-sealing the attic floor plane (2 large chases) as shown in Figure 3, leaks between the old cavity return (which communicated with the garage) and the conditioned space, and plumbing penetrations in the conditioned space.

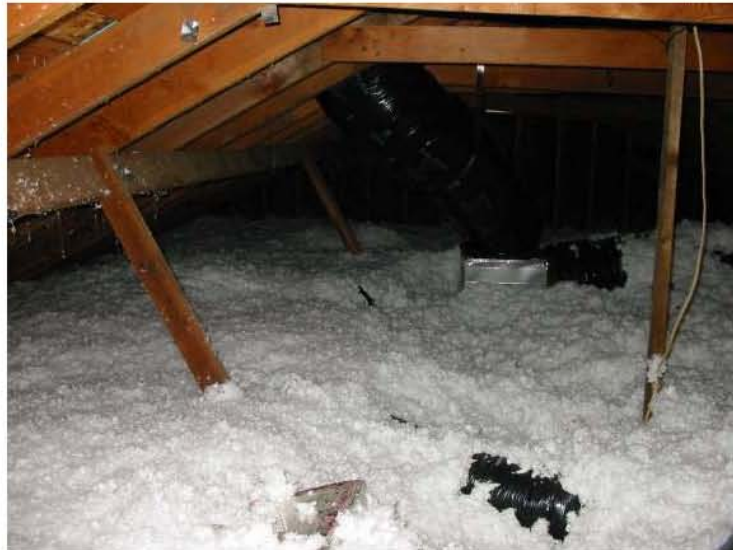
**Figure 4. New flex ducts in attic covered by additional blown-in insulation.**

Because the ducts, furnace, and air handler were located in the attic, the original retrofit plan was to seal and insulate the attic to bring the system inside conditioned space. Unfortunately, it was not possible to obtain code approval for this retrofit in the available time. As an alternative, it was decided to place the ducts on the attic floor and cover them with blown-in insulation (as illustrated in Figure 4), thus increasing the effective insulation of the ducts and protecting them from the radiation from the underside of the roof deck. Thus, the added attic insulation served two purposes: it increased the envelope insulation and improved the distribution system performance. With sufficient time and resources, it may have been possible to persuade the code authorities to allow a sealed attic. However, as in most real retrofit situations, limits of time meant that the vented attic was retained and the ducts were buried in additional ceiling insulation. Given the strict conservatism of code officials, it is unlikely that these issues can be dealt with on an individual project basis without extensive advance planning. Hopefully, research projects like the current study will mean that innovative building changes will become more widely accepted.

- The metal ducts in the attic were replaced with new R-4 flexible ducts (despite clear and repeated instruction to retain the original ducts) because the contractor thought they were undersized. Initially the contractor hung the flex-ducts from the attic ceiling with smooth bends. However, to allow covering the ducts with insulation the contractor then placed the new ducts on the floor, but unfortunately did not take the time to lay the ducts with smooth bends.
