Inspection of Fusion Joints in Plastic Pipe

Reporting Period:
October 1, 2004 through March 31, 2005

DOE Award No.: DE-FC26-03NT41882

Submitted By:
Edison Welding Institute
1250 Arthur E. Adams Drive
Columbus, OH 43221

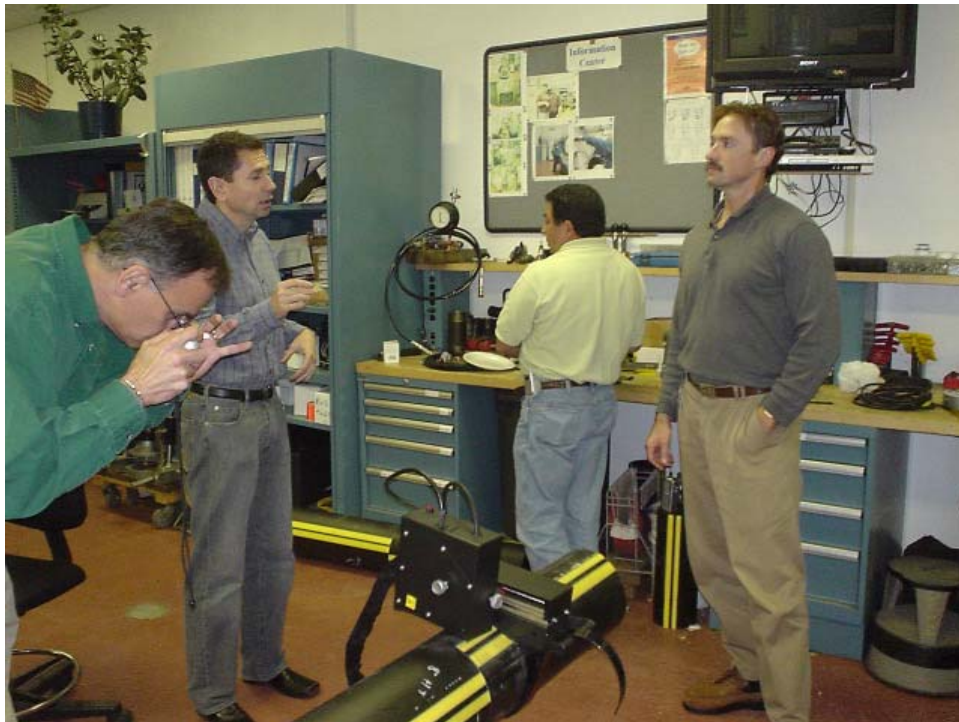
Figure 13 Inspection System on Pipe at Demonstration

Please see Figure 13 through Figure 15 for pictures taken during the Field Prototype Demonstration. Since the demonstration, EWI has improved upon the inspection tool by implementing the suggestions of the Field Test facility personnel as well as project partner NYSEARCH.
