## **SPENT FUEL MANAGEMENT AT THE SAVANNAH RIVER SITE**

P. R. Vormelker and R. L. Sindelar  
Savannah River National Laboratory  
Washington Savannah River Company  
PO Box 616  
Aiken, SC 29808

### **ABSTRACT**

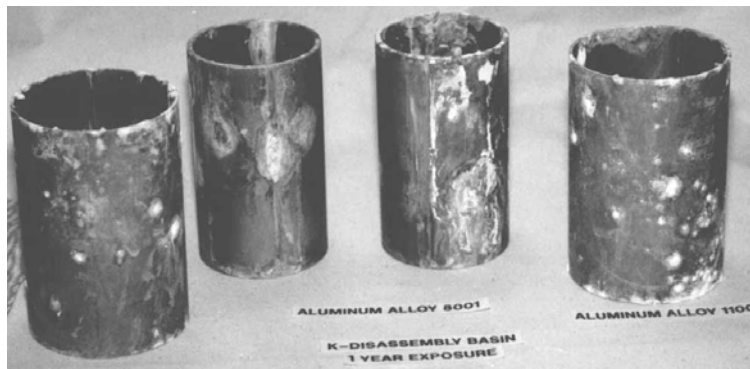
Figure 1. Aluminum clad full size target tubes after immersion in K-Basin.

Component immersion tests were conducted in SRS basins from 1992-2000. Pitting through a 30-mil clad target tube occurred in as little as 45 days when conductivity was 180  $\mu\text{S}/\text{cm}$  with a chloride level of 8 ppm (Figure 1). This was a warning sign that increased use of deionizers was necessary to eliminate aggressive water conditions.

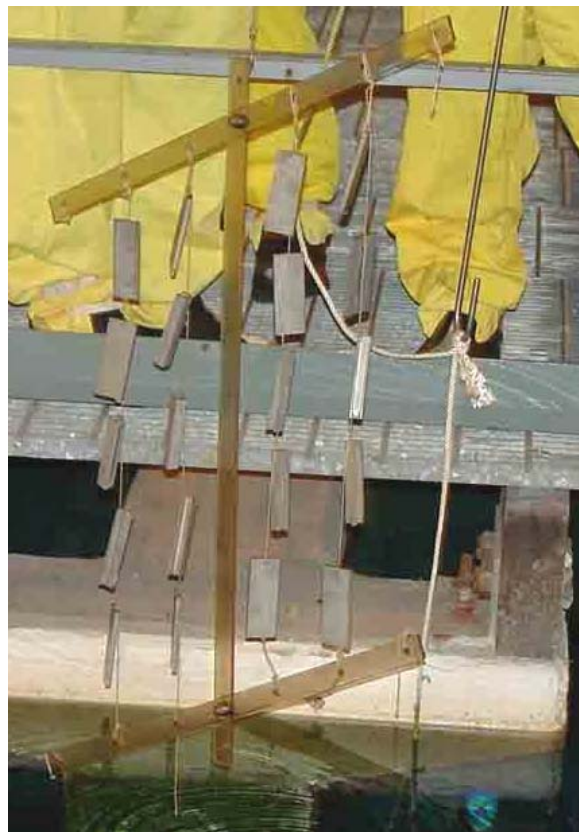
Figure 7. Hanging furniture rack coupons removed from L-Basin.

Ray Gun" coupon assembly has 36 coupons, and does not contain the 70 mm disk stainless steel coupons on the Ray Gun assembly, but does contain the 1:1 (area ratio) stainless steel to aluminum coupon galvanic couple specimens. A sketch showing the configuration of the galvanic coupons on the Ray Gun and Junior Ray Gun is shown in Figures 5 and 6. Additional specimen types in the surveillance program include "furniture rack" specimens that are flat plates and U-channel specimens of 6061-T5 and 6063-T5 (fuel storage rack) materials, respectively with R4043 weld beads which are shown hanging above the basin in Figure 7.
