DESTRUCTIVE EXAMINATION OF SHIPPING PACKAGE 9975-00600

Savannah River National Laboratory
Materials Science & Technology

DESTRUCTIVE EXAMINATION OF SHIPPING PACKAGE 9975-00600 (U)

Revision Log**Document No.** WSRC-STI-2007-00558 **Rev. No.** 0**Document Title** Destructive Examination of Shipping Package 9975-00600

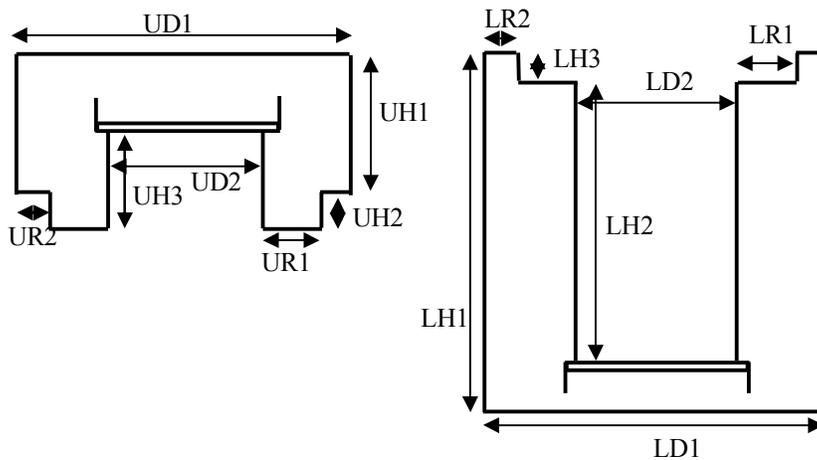
Table 1. Fiberboard physical measurements and calculated density

The air shield was cut and peeled back at four locations to permit accurate measurement of the top fiberboard subassembly dimensions. In order to calculate the density of each subassembly, nominal dimensions were assumed for the aluminum bearing plate and air shield. The calculated densities (0.25 g/cc top subassembly, 0.29 g/cc bottom subassembly) exceed the minimum value for the criticality control function, 0.20 g/cc [4]. The volume and density were calculated using the following equations (refer to the Table 1 sketch for dimension nomenclature).

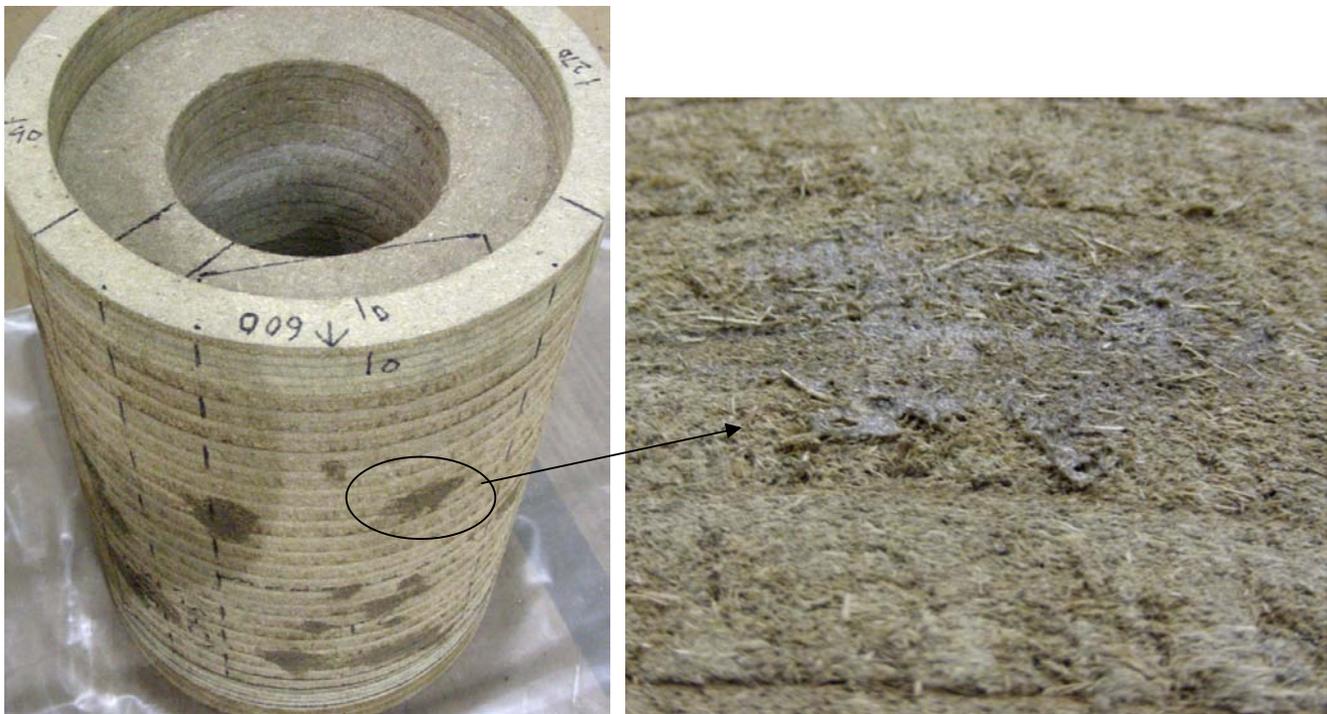
Following removal of both the top and bottom fiberboard subassemblies from the outer drum, both were inspected visually. Several regions on the ID surface of the fiberboard contained white deposits from rubbing against the lead shield. The lower fiberboard assembly contained several dark spots on the OD surface (Figure 1), which appear consistent with dried patches of the glue used to laminate the assembly.

Figure 1. Dark regions on the OD surface of the lower fiberboard assembly

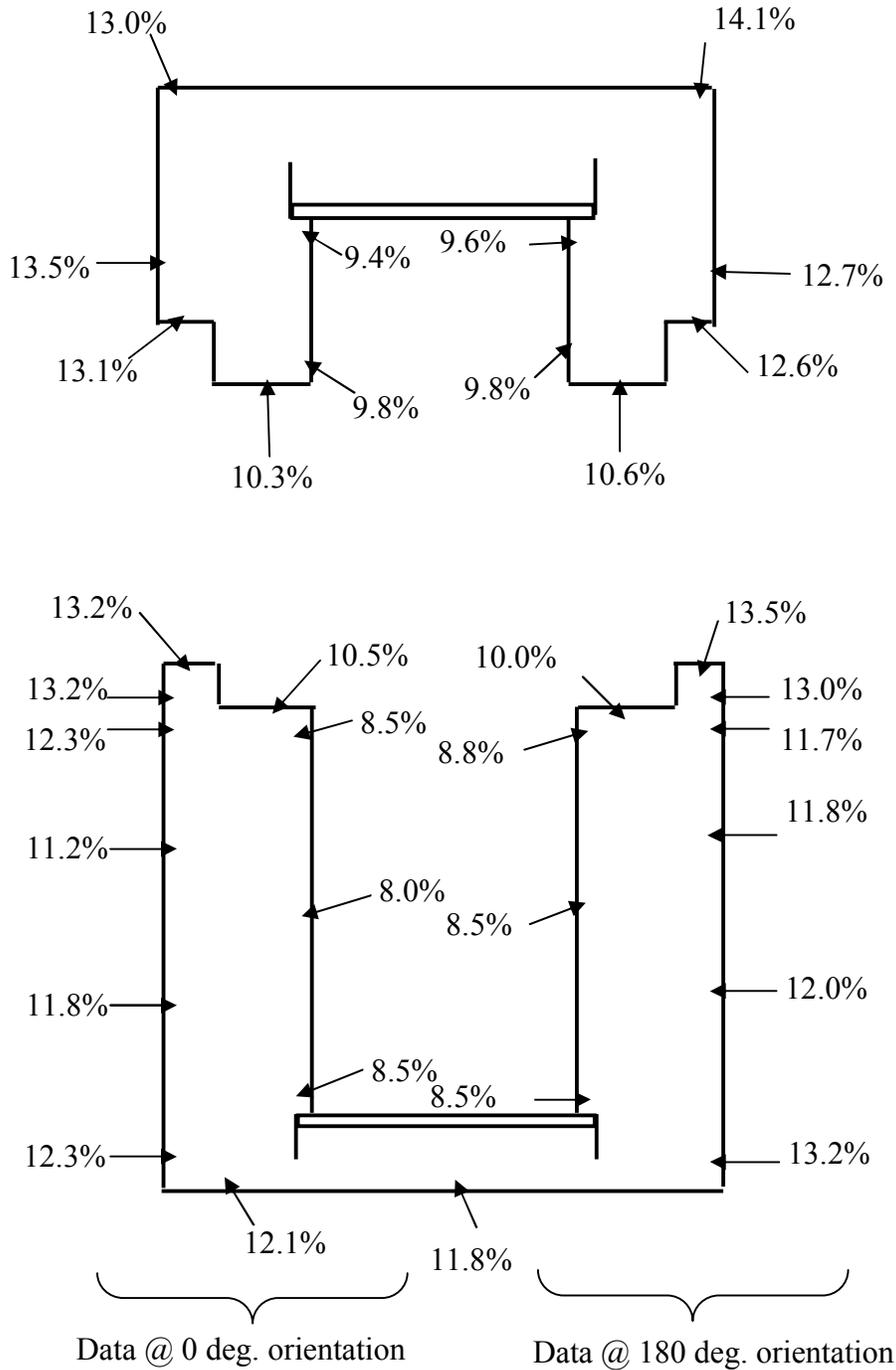
A GE Protimeter Surveymaster moisture probe was used to measure the relative moisture content of the top and bottom fiberboard subassemblies. This probe identifies the wood moisture equivalent (WME), or the weight % of moisture that would produce the same electrical conductivity in wood. Moisture measurements of both the upper and lower subassemblies were made soon after opening the drum. Moisture content data are presented in Figure 2.

Moisture measurements were compared to those taken on packages 9975-02234 and 9975-00826 during previous destructive examinations [8,9]. The readings on 9975-00600 were similar to those on 9975-00826, and lower than those on 9975-02234. Of the three packages, 9975-00600 had the largest difference in moisture content between the ID and OD surfaces. For the current package typical ID values were 8.0 to 9.8 %WME, while typical OD values were 11.2 to 13.5 %WME.

Figure 2. Fiberboard moisture content data. All values are % wood moisture equivalent.

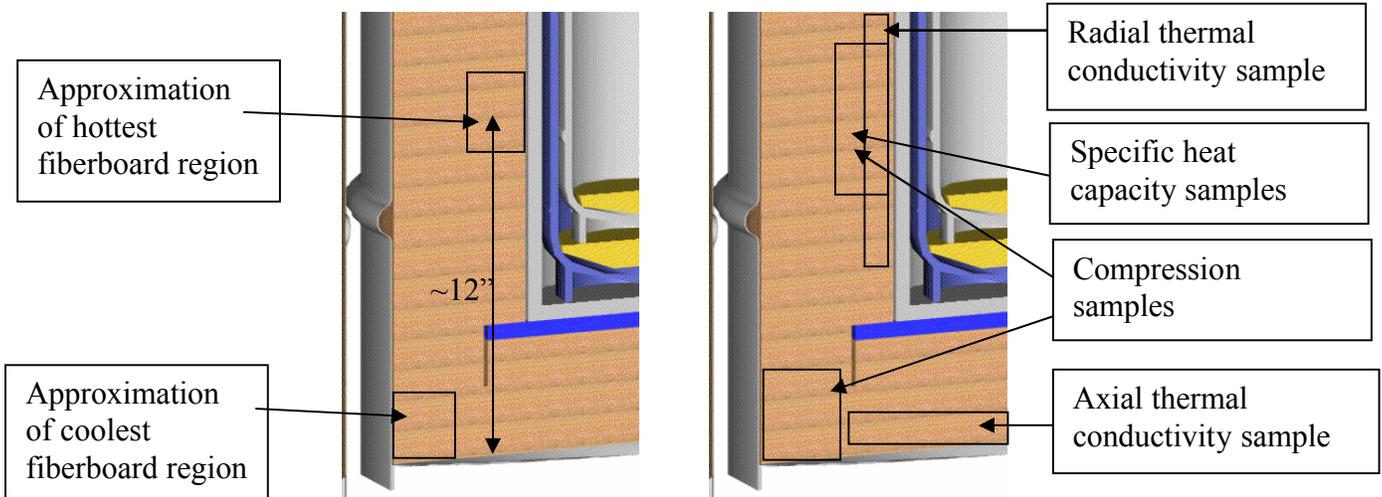
Samples of fiberboard were removed from the bottom fiberboard subassembly to measure compressive strength, specific heat capacity and thermal conductivity. The source location(s) of these samples is illustrated in Figure 3. The thermal conductivity sample from the bottom center of the subassembly is oriented for heat flow in the axial direction (perpendicular to the glue joints). The thermal conductivity sample from the side is oriented for heat flow in the radial direction (parallel to the glue joints). Testing

Figure 3. Illustration of fiberboard regions of the bottom subassembly to be tested. Multiple samples (where used) were removed from the illustrated locations at different circumferential positions. Not to scale.

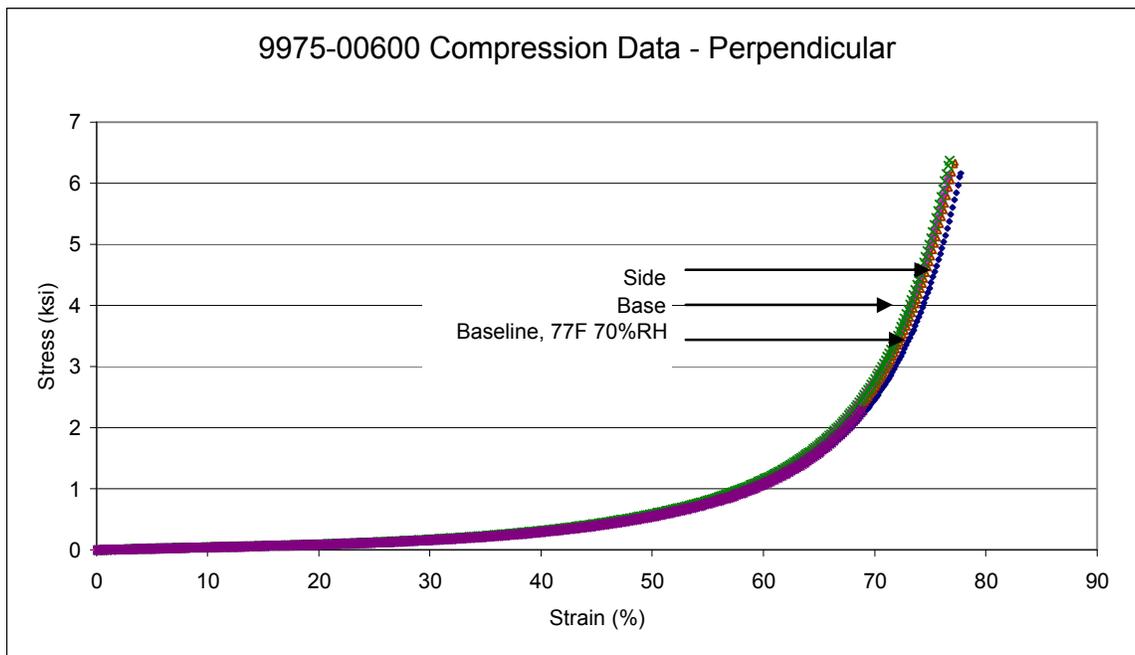
The compression test data are shown in Figures 4 and 5, along with select baseline data. For both the perpendicular and parallel orientations, the compression strength of the 9975-00600 samples is similar to the baseline samples conditioned at 77°F and 70% RH. A series of photographs showing typical compression behavior under parallel loading is shown in Figure 6.

Figure 4. Fiberboard compression test data, compared with typical baseline (77°F, 70% RH) data, in the perpendicular orientation (i.e. load applied perpendicular to the fiberboard layers).

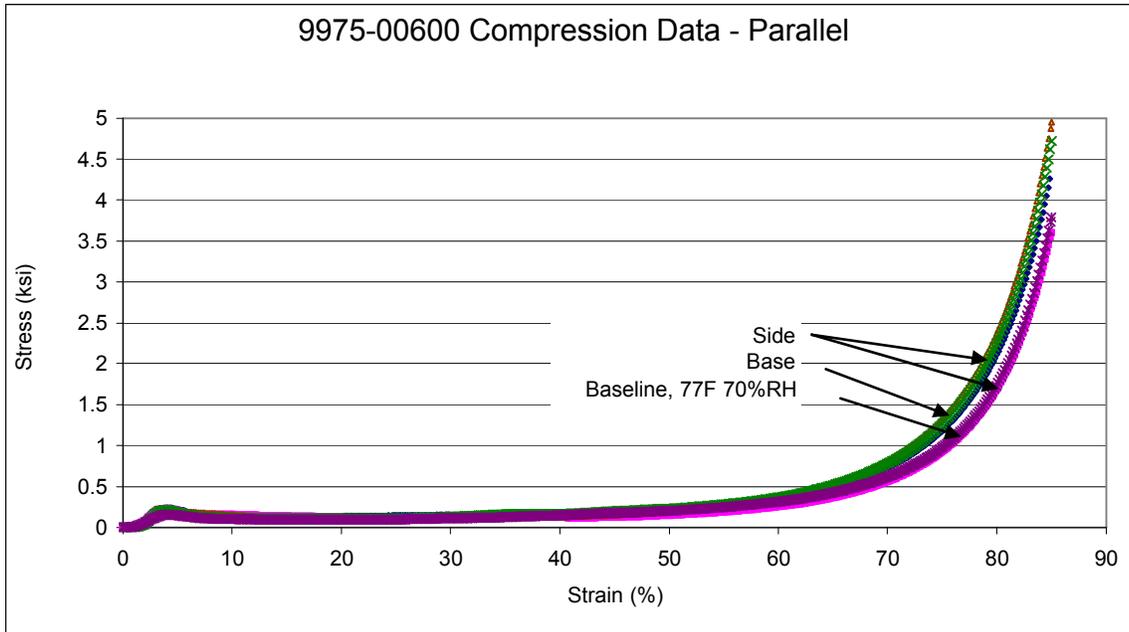
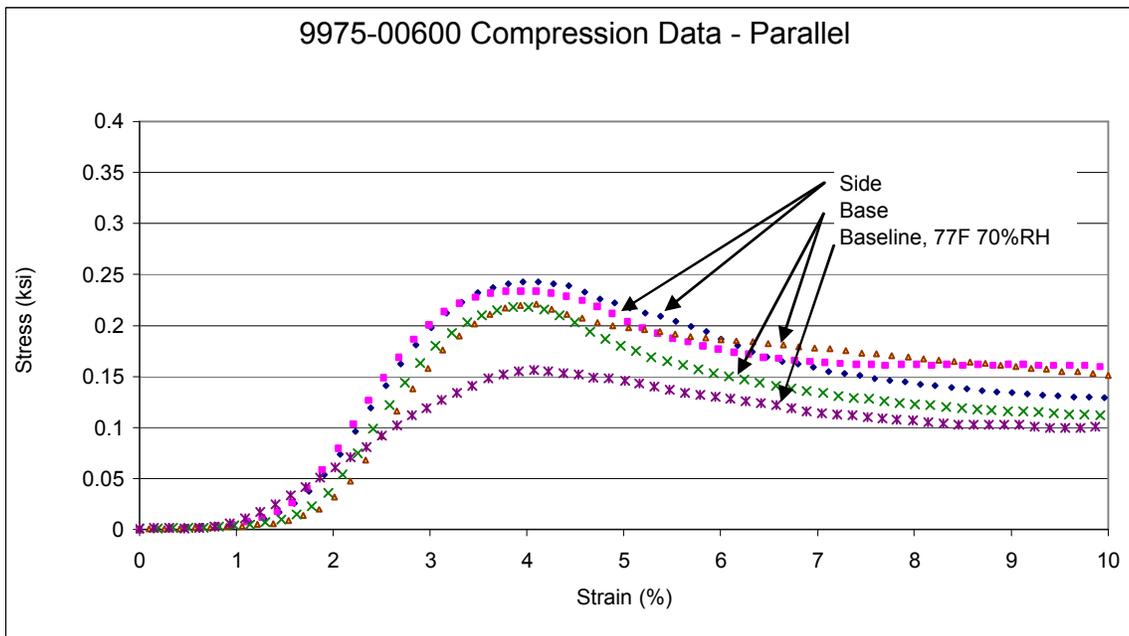
Figure 5. Fiberboard compression test data, compared with typical baseline (77°F, 70% RH) data, in the parallel orientation (i.e. load applied parallel to the fiberboard layers). The full curves are shown in (a), while the initial buckling region is expanded in (b).

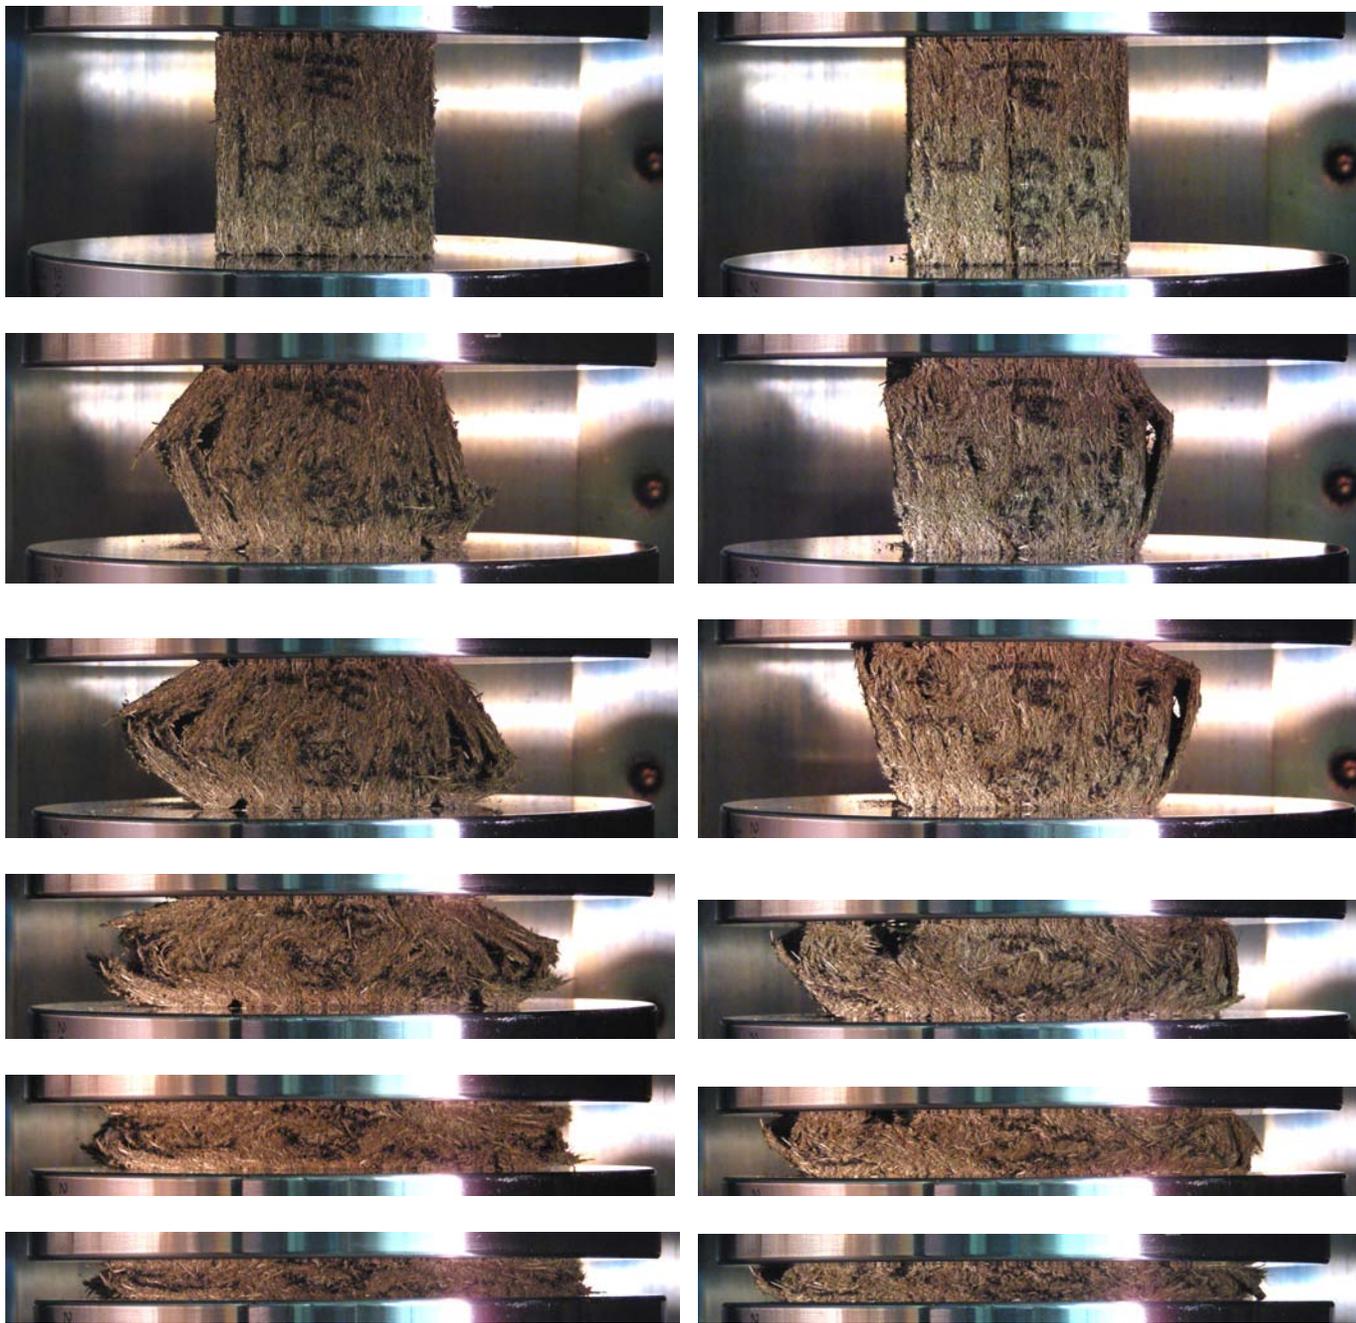
(a) Sample B1 from base of assembly

(b) Sample S1 from side of assembly

Figure 6. Photographs of samples during compression testing, parallel orientation

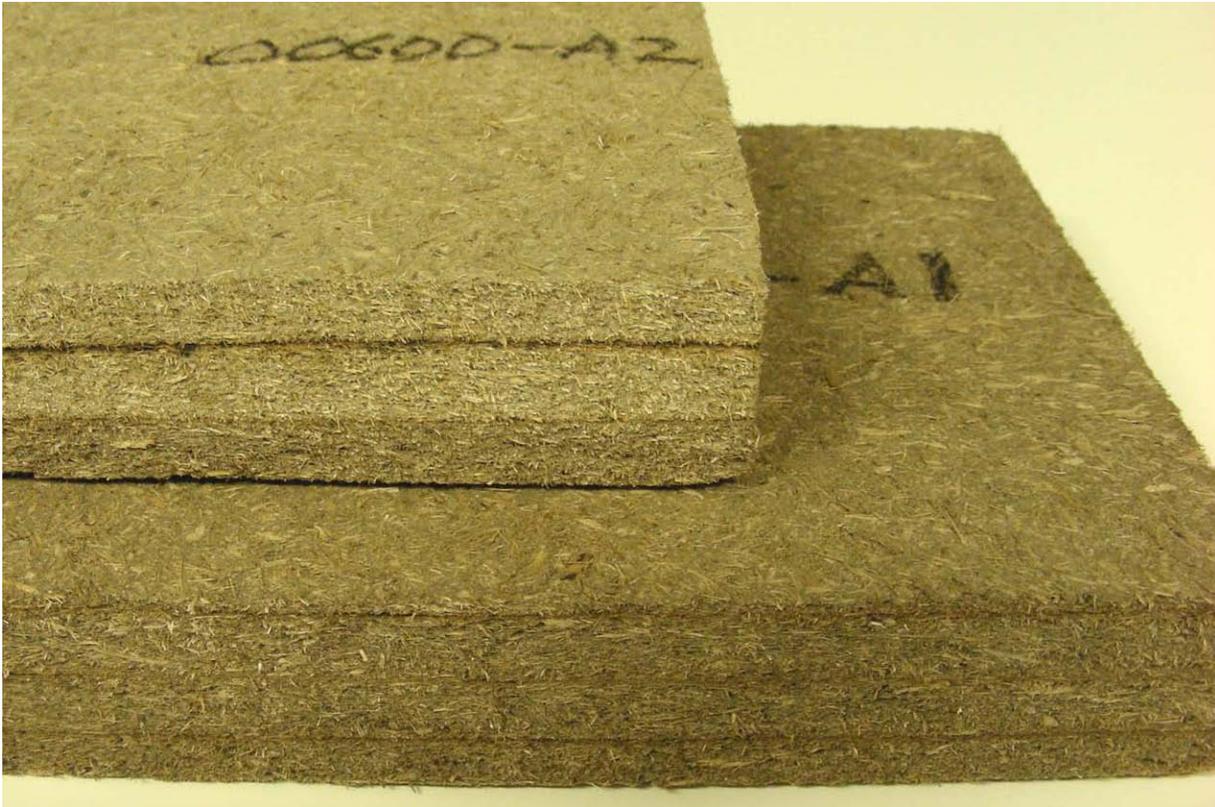
The thermal conductivity of the fiberboard was measured with a Lasercomp Inc. Fox 300 thermal conductivity instrument at a mean temperature of 25°C (77°F). For the sample with axial heat flow (perpendicular to the fiberboard layers), the measured thermal conductivity is 0.0646 W/m-K (0.0373 Btu/hr-ft-°F). This value falls outside the acceptance range identified for destructive examinations (0.025 – 0.035 Btu/hr-ft-°F [4]). It was noted that a region of fiberboard immediately above the axial sample was significantly lighter in color (Figure 7). A second axial sample was removed from this region and tested. The measured thermal conductivity for this second sample is 0.0604 W/m-K (0.0349 Btu/hr-ft-°F), which falls within the identified range. For the sample with radial heat flow (parallel to the fiberboard layers), the measured thermal conductivity is 0.1060 W/m-K (0.0612 Btu/hr-ft-°F). This value falls within the identified range of 0.053 – 0.067 Btu/hr-ft-°F [4]. The thermal conductivity values are consistent with typical baseline laboratory data.

Figure 7. Two axial thermal conductivity samples, showing the difference in appearance of layers in the second sample (on top).

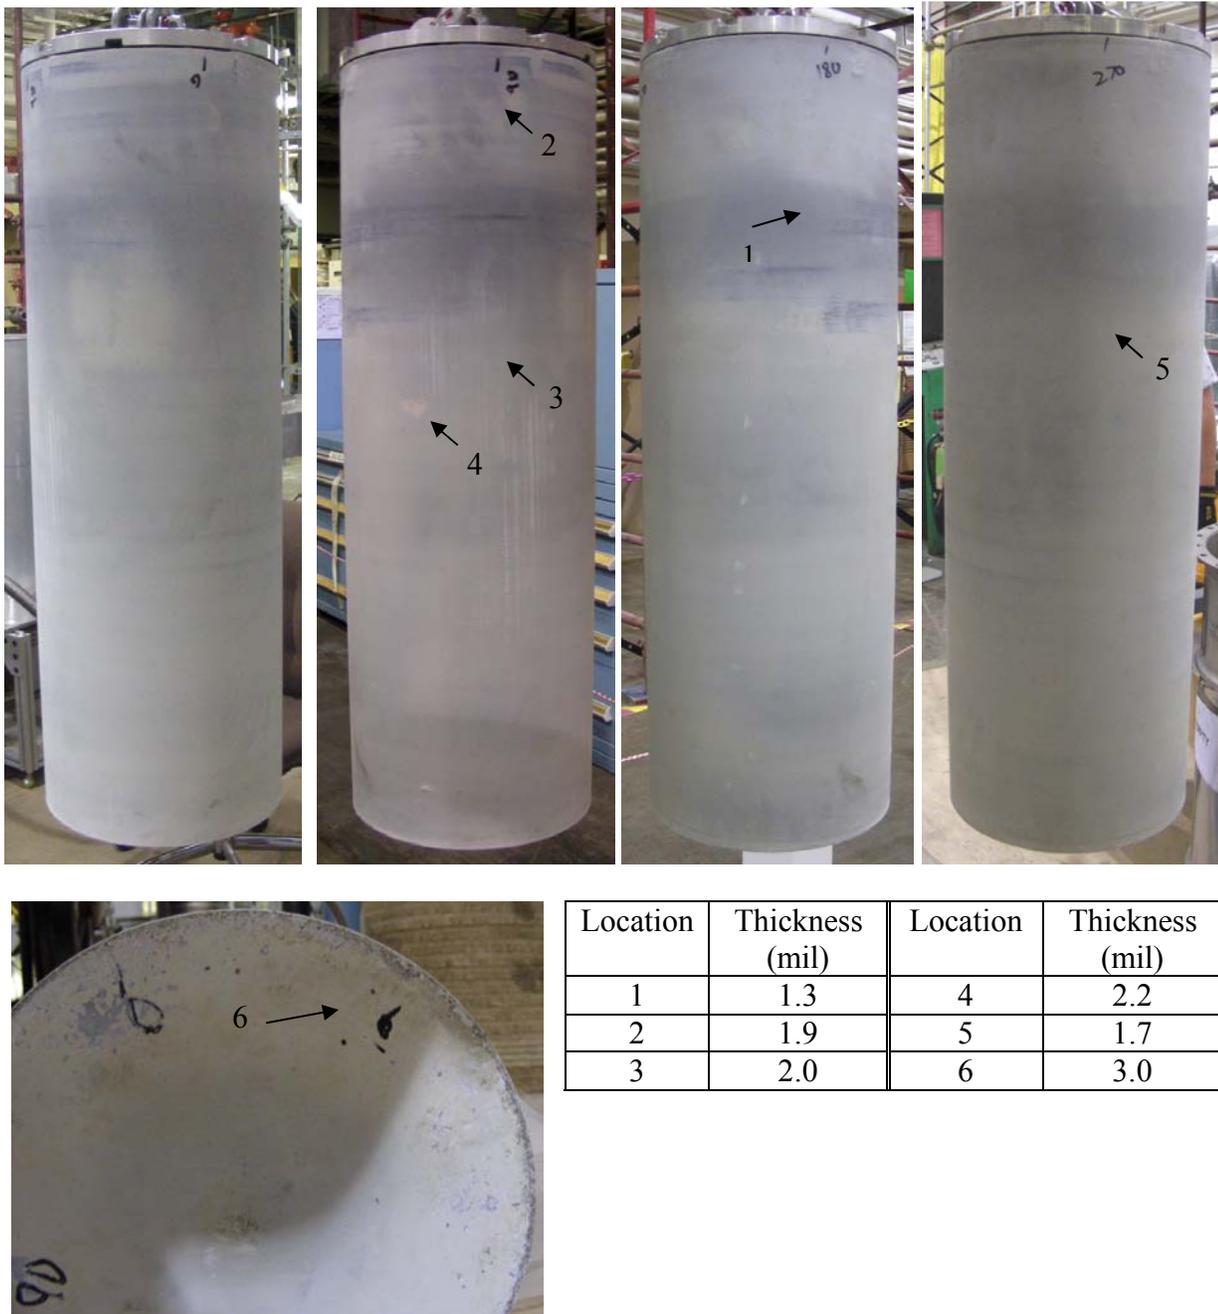
The entire surface of the lead shield was visually examined. It was found to be free from significant deformation and physical damage, but the side was covered with a white corrosion product. From the prior examination of the shield from package 9975-02234, the corrosion product was identified as basic lead carbonate (hydrocerrusite), Pb₃(CO₃)₂(OH)₂.

Due to the presence of corrosion on the shield, additional testing was performed. The thickness of the corrosion layer was measured in a number of locations with an Elcometer 345FN coating thickness gage. This gage uses an eddy current technique. The gage was calibrated using shims ranging in thickness from 22.9 microns (0.00090") to 981 microns (0.0386") on the lead container. Measurements were made at a number of locations with a range of apparent layer thicknesses. Measurements ranged from 1.3 to 3 mils thick, and are summarized in Figure 8. These nondestructive measurements were made by SRNL / Materials NDE & Consultation Group.

Figure 8. Lead shield with corrosion product. The arrows identify locations of corrosion thickness measurements, which are summarized in the chart.

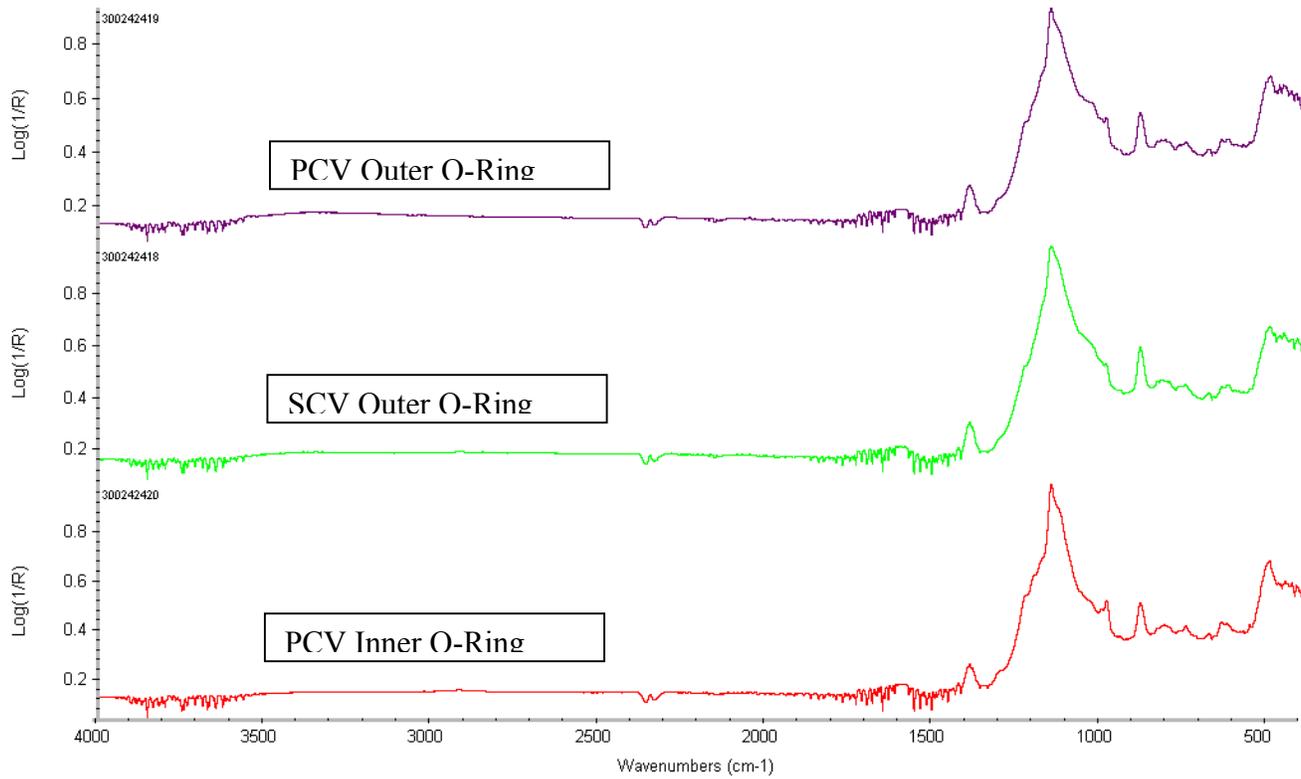
FT-IR spectroscopy generically identified the composition of each O-ring as consistent with a Viton[®] type fluoroelastomer (Figure 9). Viton[®] A produces a spectrum nearly identical to Viton[®] GLT, the base polymer for the specified O-ring compound (Parker Seals V0835-75) and the two are difficult to distinguish by FT-IR analysis alone. Additional test techniques (e.g. dynamic mechanical analysis, DMA) would be required to uniquely verify the GLT composition. These results are similar to those from previous destructive examination packages [8,9] and are consistent with baseline data [10].

Figure 9. FT-IR spectra for the three tested O-rings. Each spectrum is consistent with a Viton® type fluoroelastomer.

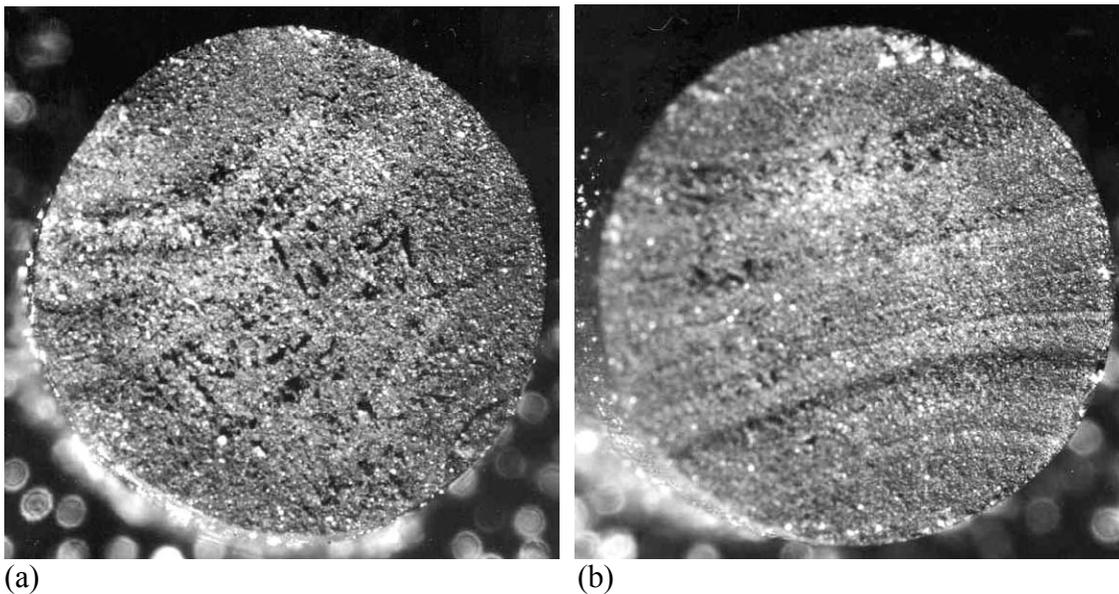
Visual (Figure 10) and SEM (Figure 11) examination of the cross sections identified a distribution of very small particles throughout each O-ring. Each O-ring had a faint but distinct transition between the inner and outer regions of the cross section, with the center region being slightly lighter in appearance. X-ray analysis on the SEM identified no significant variation in element distribution across this transition. Aside from carbon and fluorine (which are the primary constituents of Viton[®]) the SEM identified aluminum, silicon, calcium, oxygen, and zinc. These elements are present in small amounts, and are generally associated with the particles. Though the actual compound is proprietary, the elements detected are consistent with Viton[®]-type fluoroelastomer compounds, which typically contain MgO, CaO, Ca(OH)₂, ZnO or lead compounds as acid acceptors and heat stabilizers [11]. Aluminum is generally not added to fluoroelastomer recipes, but may be present as a trace contaminant.

(a) (b)
Figure 10. Visual cross section of the (a) PCV outer and (b) SCV outer O-rings.

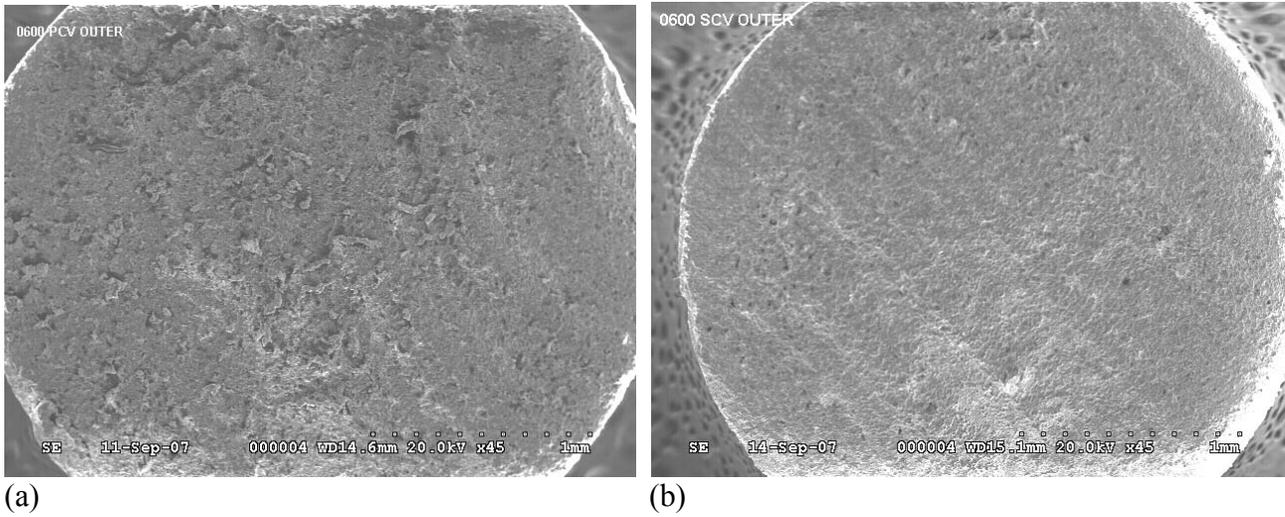
(a) (b)
Figure 11. SEM cross section of the (a) PCV outer and (b) SCV outer O-rings.

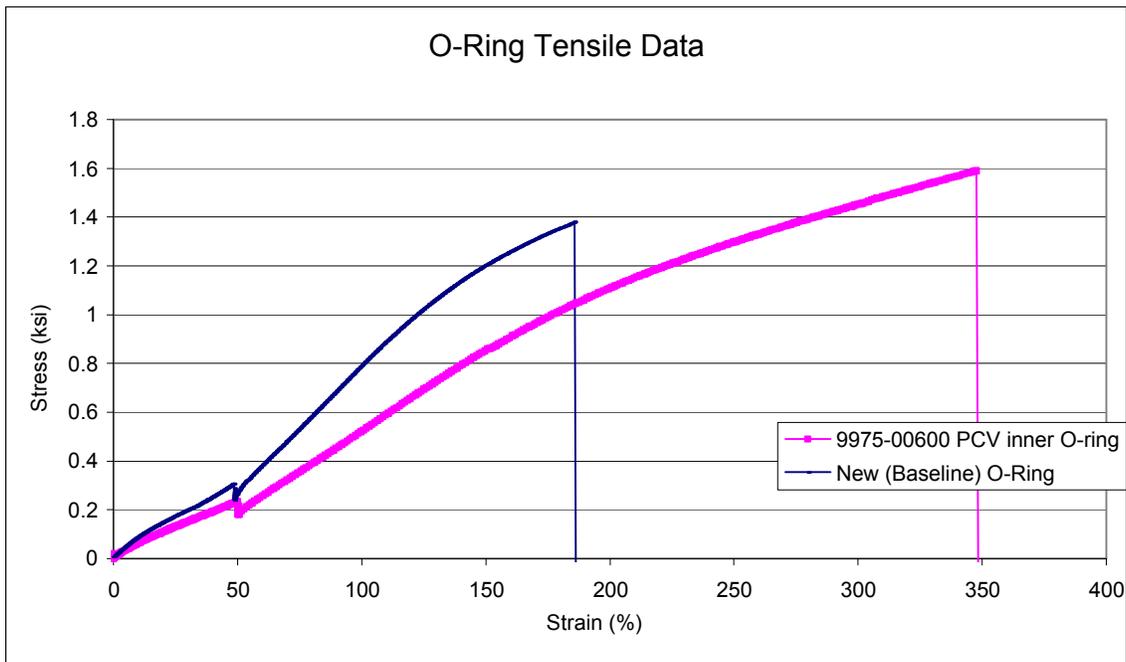
The PCV inner O-ring was tensile tested in accordance with ASTM D1414, using a cut (single strand) sample. The test was interrupted at 50% strain to visually examine the O-ring for signs of cracking or other degradation. None were observed. The stress-strain curve for the PCV inner O-ring is shown in Figure 12 along with that from a new O-ring tested during the previous destructive examination. The O-ring from package 9975-00600 displayed a greater tensile strength and significantly greater elongation than the new O-ring. The tensile strength of this O-ring (1.6 ksi) equals the minimum value specified in AMS-R-83485 for new O-rings, while the elongation (348%) significantly exceeds the minimum value (120%) specified in AMS-R-83485 [10]. While Parker Seals does not change the formulation of these O-rings, there are batch variations.

Figure 12. Tensile data for PCV inner O-ring and a new O-ring.

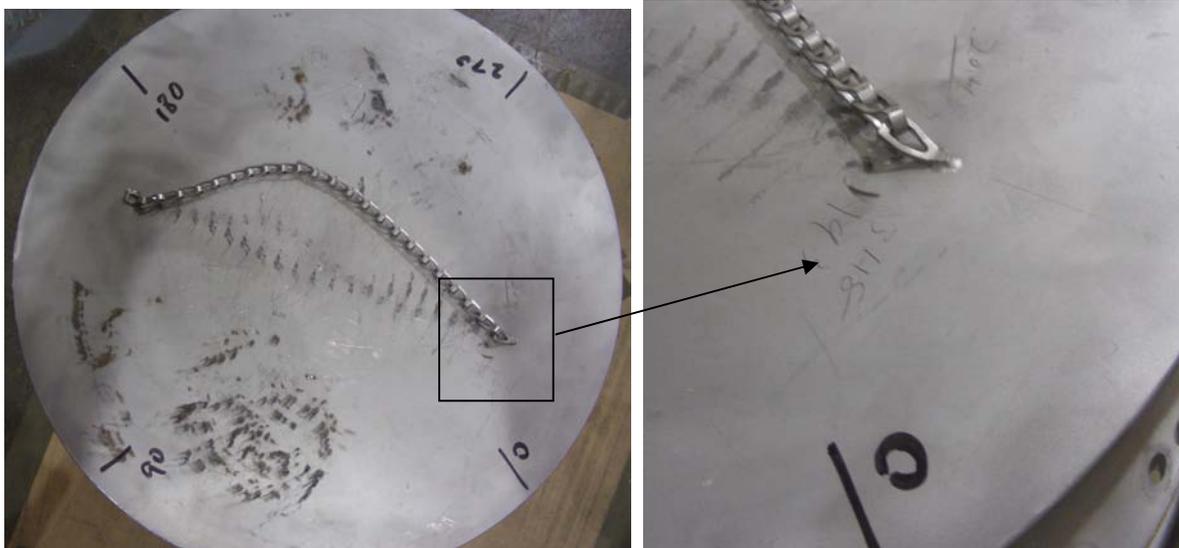
A general visual examination was performed on all metallic components. Aside from the corrosion of the lead shield (discussed above) no significant damage or degradation was observed. Several components were observed to have unexpected markings. Several numbers were written on the top of the air shield (Figure 13), and various markings were engraved, stamped, scratched or written on the containment vessels and shield lid (Figure 14). Most of these markings appear to be identification numbers used during manufacture, prior to association of the parts with a final package number.

Figure 13. Top fiberboard subassembly, with detail showing writing on air shield.

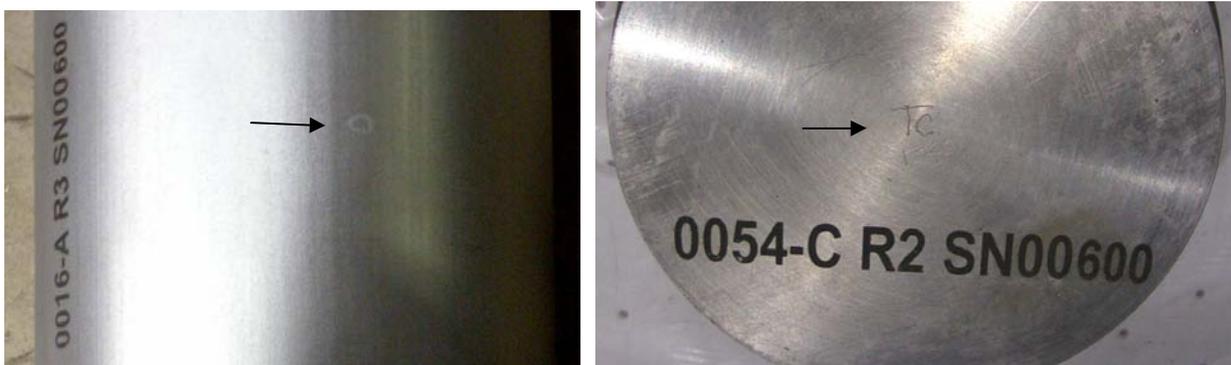
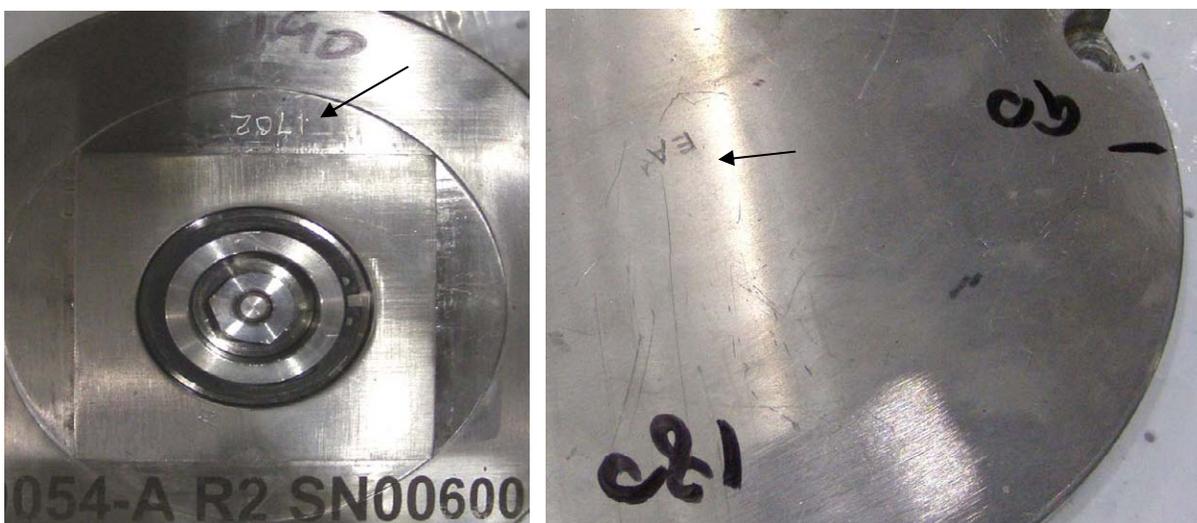
Figure 14. Markings (at arrows) on various components in addition to the package ID: (a) SCV exterior side, (b) PCV lid bottom, (c) PCV lid top, (d) shield lid.
