# **Nondestructive Evaluation of the VSC-17 Cask**

January 2006

**Idaho National Laboratory  
Idaho Falls, Idaho 83415**

**Prepared for the  
Central Research Institute of Electric Power Industry  
and the U.S. Department of Energy  
Under DOE Idaho Operations Office  
Contract DE-AC07-05ID14517**

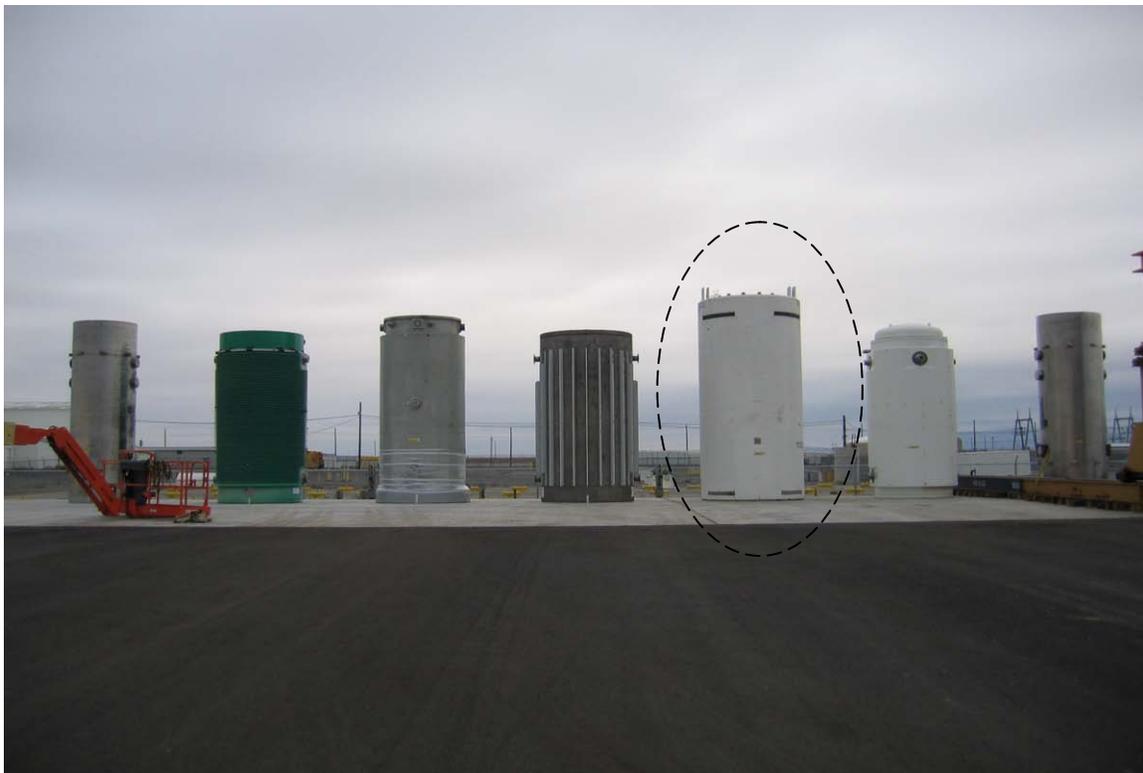
Figure 2. The VSC-17 is the third cask from the right as it is currently stored on the CPP-2707 pad at INTEC. The view of this picture faces to the west.

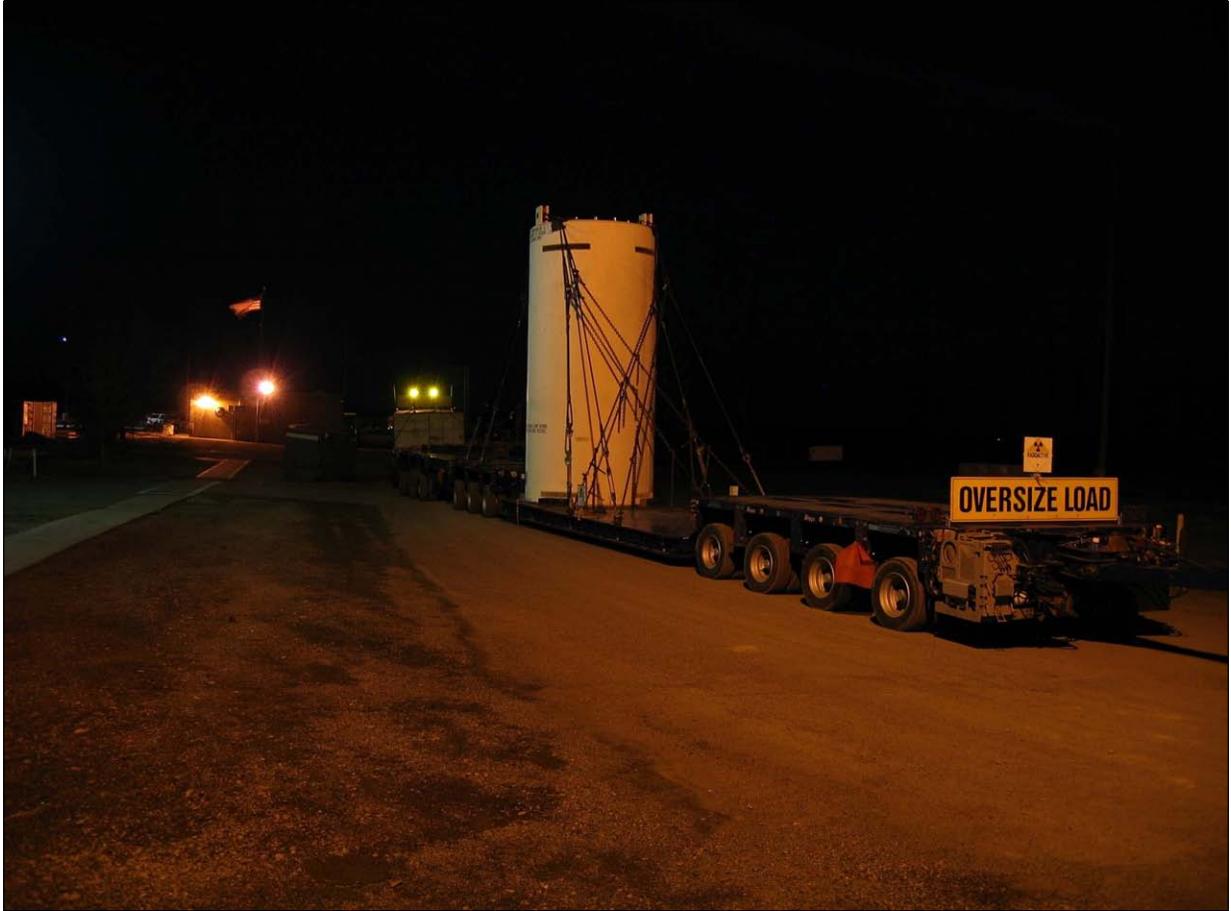
Figure 3. VSC-17 cask transported to INTEC in October 2004 (additional pictures on enclosed CD in Appendix A).

The cask was moved from TAN to the CPP-2707 pad at INTEC in October 2004. The move was executed by heavy-lift specialist subcontractor Shaughnessy & Company, a division of Bigge Crane and Rigging Company. The cask was lifted approximately 2 ft (61 cm) using a portable gantry crane system, and placed on a multi-axle lowboy trailer. The loaded trailer was then driven the 18 miles (29 km) from TAN to INTEC at speeds not to exceed 5 mph (8 kph). Because the road had to be closed during these transports, all road transits occurred at night (Figure 3). The cask was unloaded from the trailer using the same gantry crane system at INTEC and placed on the concrete pad in the same orientation as it was at TAN. The nominal zero reference point was positioned due south at TAN and remains due south at INTEC. Additional pictures of the move are presented on the enclosed compact disc in Appendix A.

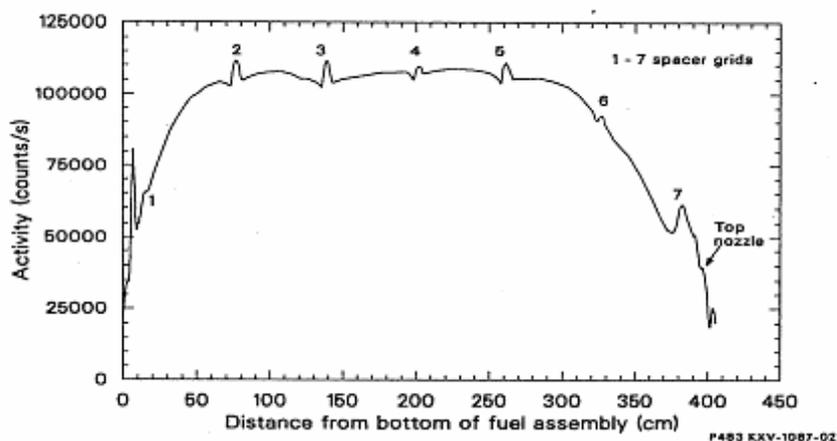
Because the stainless steel end boxes and skeleton were removed, the cobalt-60 activation product associated with those components is not present in the DRCT fuels. The profile exhibited in the gross gamma scan of Assembly D01 (Figure 4) shows the expected high plateau of activity (100,000 to 110,000 counts/sec) in the middle of the assembly, tapering off to the ends (50,000 to 75,000 counts/sec).

Figure 4. Gross gamma scan of fuel assembly D01 (Reference 1).

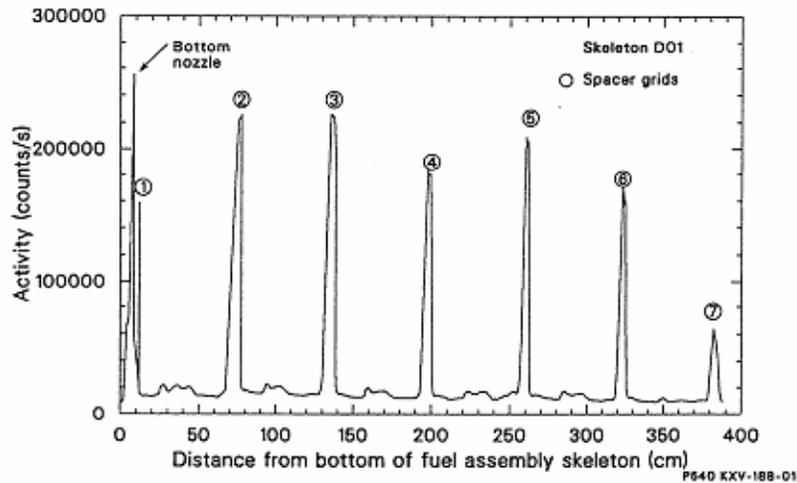
The profile of the activity in the skeleton of Assembly D01 indicates highest activity at the bottom nozzle and peaks at each of the spacer grids. The nozzles and spacer grids were constructed of stainless steel, which became activated with cobalt-60, with proportionally higher activity than the primary fission product cesium-137, as seen in Figure 5. Neither the skeleton profile nor the assembly profile suggests that there is a reason for a step change in activity measured on the exterior of the VSC-17 cask. Because the fuel is packed with minimal void space, the radiation source is maximally shielded by the fuel mass itself. This shielding nullifies source peaks. Elimination of the peaks from cobalt-60 containing spacers yields a relatively smooth curve of activity. If the peaks shown in Figure 5 (skeleton D01) are removed from the curve shown in Figure 4 (D01 assembly), a relatively uniform activity value, which decreases at the ends of the assembly, results.

Figure 5. Gross gamma scan of the fuel assembly skeleton D01 (Reference 1).

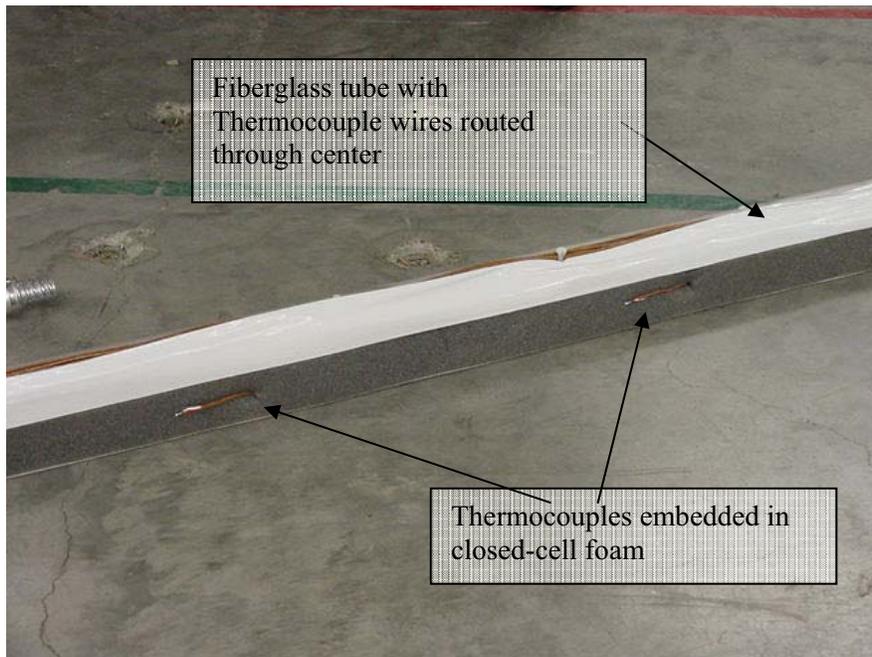
The project team removed the thermocouples from the aluminum support and mounted them on a square fiberglass tube. The individual thermocouples and leads were insulated by embedding them in closed cell foam rubber. Further isolation and insulation was performed by installing the terminal covers on the data acquisition unit and positioning the unit in a box surrounded by polystyrene foam. The result achieved by this modification is an improvement in data stability with a consistency level of 1.5 to 2°F (for measurements taken when the thermocouple rake was laid on the floor in the remote operations laboratory) (Figure 6). When measuring the temperature of the outside wall of the laboratory building (Figure 7), the largest max-min delta was 4°F. Temperature comparison using a Raytek Minitemp MT4 noncontact infrared thermometer showed consistency within 0.1°F and confirmed that variation in the temperature of the laboratory wall due to wind convection was indicated by both instruments. The building wall is nominally 28-gauge corrugated steel sheet, which loses and gains heat rapidly. Data from the exterior wall test are contained in attached file 01-c\_appendtest4-13-05.xls in Appendix C. Data from the static test on the interior floor are contained in attached file 02-c\_appendtctest~2.xls also in Appendix C.

Figure 6. Insulated thermocouple configuration on fiberglass pole.

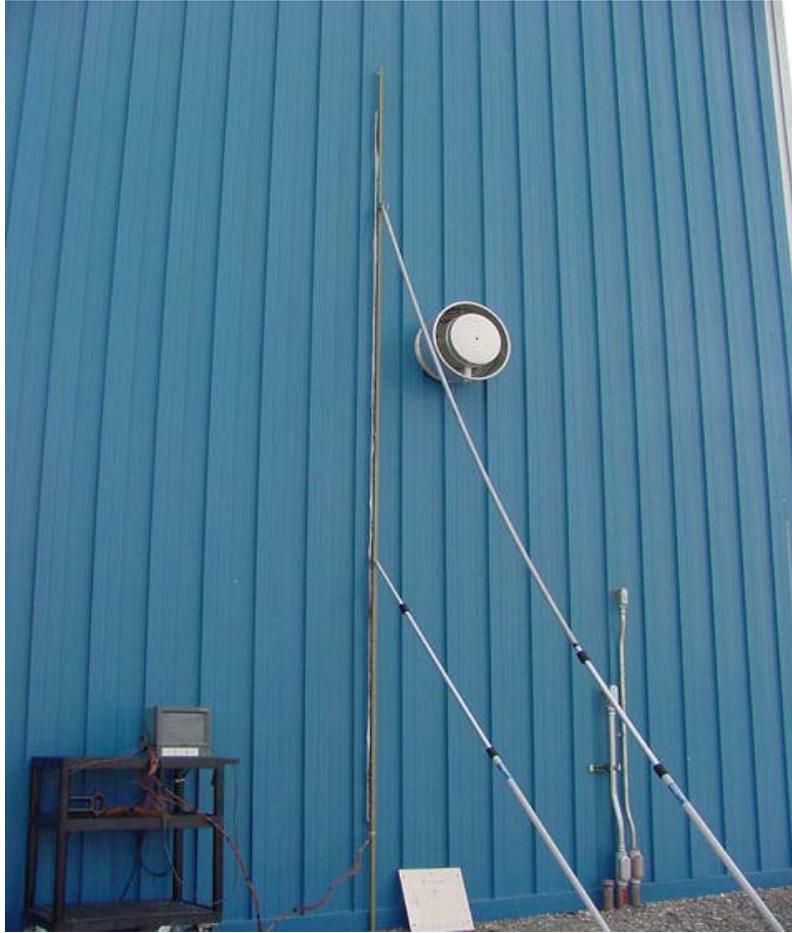
In later testing of this thermocouple rake arrangement, the project team noted a lesser but consistent (3 to 5°F) variation under essentially static conditions (i.e., the system was laid against a concrete floor inside the remote operations building). This was clearly a problem, because there was neither substantial airflow nor radiant heating to affect the system. This variation is believed to be due to convection and conduction around points of incomplete thermal insulation at the terminals and leads of the thermocouples. Conduction was occurring as heat was transferred away along the aluminum mast.

Figure 7. Laboratory building wall test of insulated thermocouple rake.

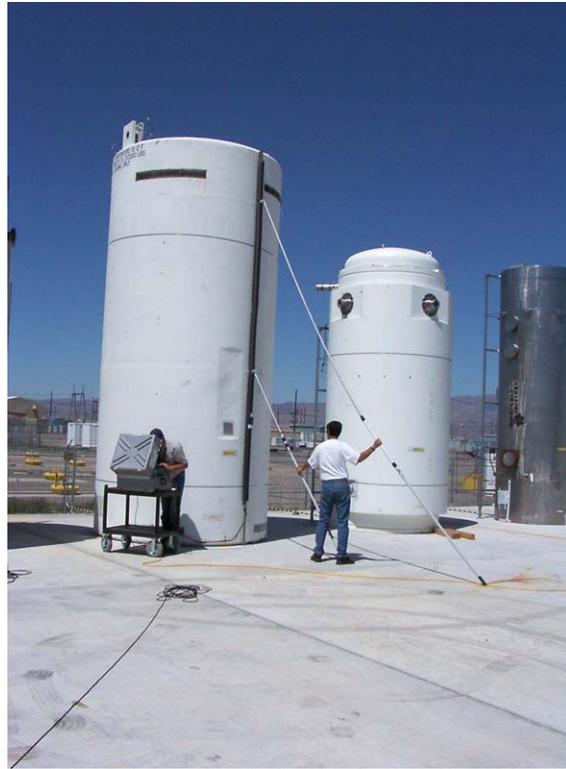
Thermocouple testing was performed on July 27, 2005, from 10:56 to 13:59 MDT. The data acquisition system recorded values every second and reported the maximum and minimum value for that period. Data were taken as three sets of 30-second periods for each radial position. The test was performed operationally as shown in Figure 8. This image shows the thermocouple rake being supported against the cask surface by extension poles.

Figure 8. Surface temperature measurements were obtained using a thermocouple rake.

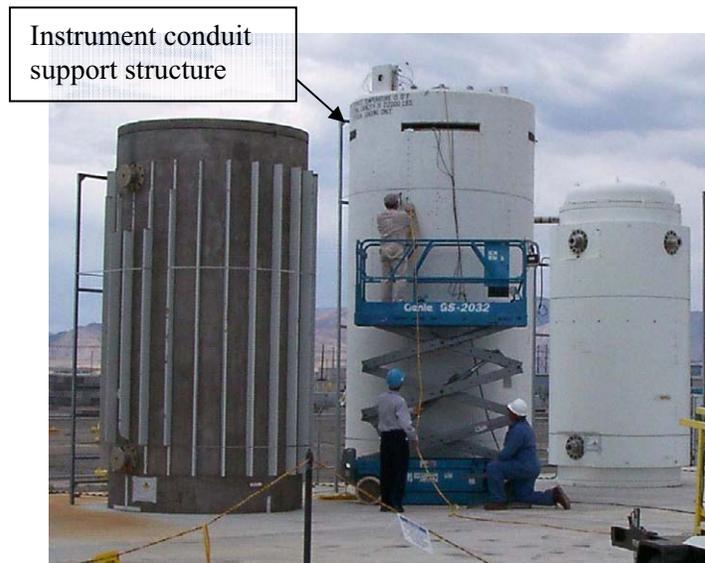
Since being moved to the CPP-2707 pad, the cask was fitted with a structure that supports an electrical conduit to connect wires to the intact internal thermocouples that are accessible through the top weather cover. This conduit support structure consists of a square tube frame that is attached to the cask with stainless steel straps. The structure and the straps extend out sufficiently to interfere with making thermocouple contact readings on the west side of the cask. The portion of the cask that is effectively obstructed is between 210 degrees to 340 degrees. Therefore, rather than taking 41 radial measurements, only 27 were accessible. The frame is visible in Figure 9.

Figure 9. Electrical conduit is visible from behind the VSC-17 cask, which prevented obtaining surface temperature measurements on the west side of the cask.

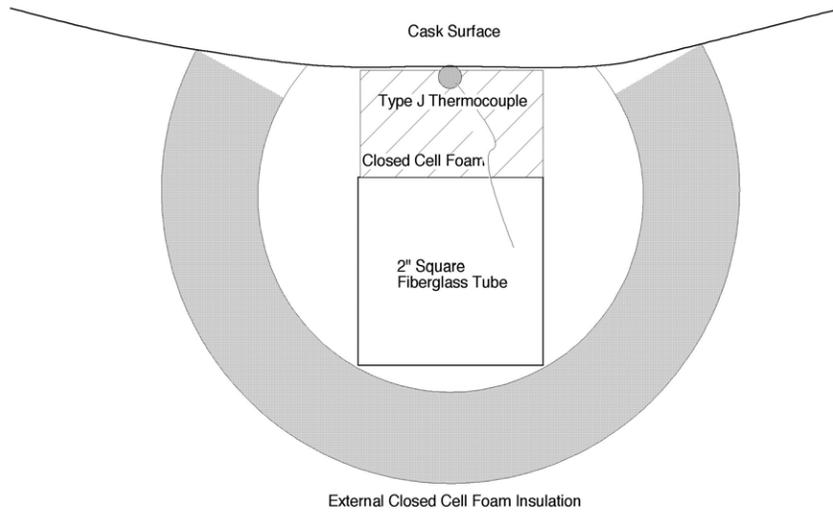
As discussed in Section 2.3, the modified thermocouple rake included mounting the thermocouples in closed cell foam and surrounding the support mast with additional insulation. A cross section of the rake is shown in Figure 10. The closed cell foam in which the thermocouple is embedded conforms to surface variations and provides spring pressure to maintain contact with the surface. The external closed cell foam provides an additional barrier to airflow between the thermocouple and the surface.

Figure 10. Cross section of thermocouple rake.

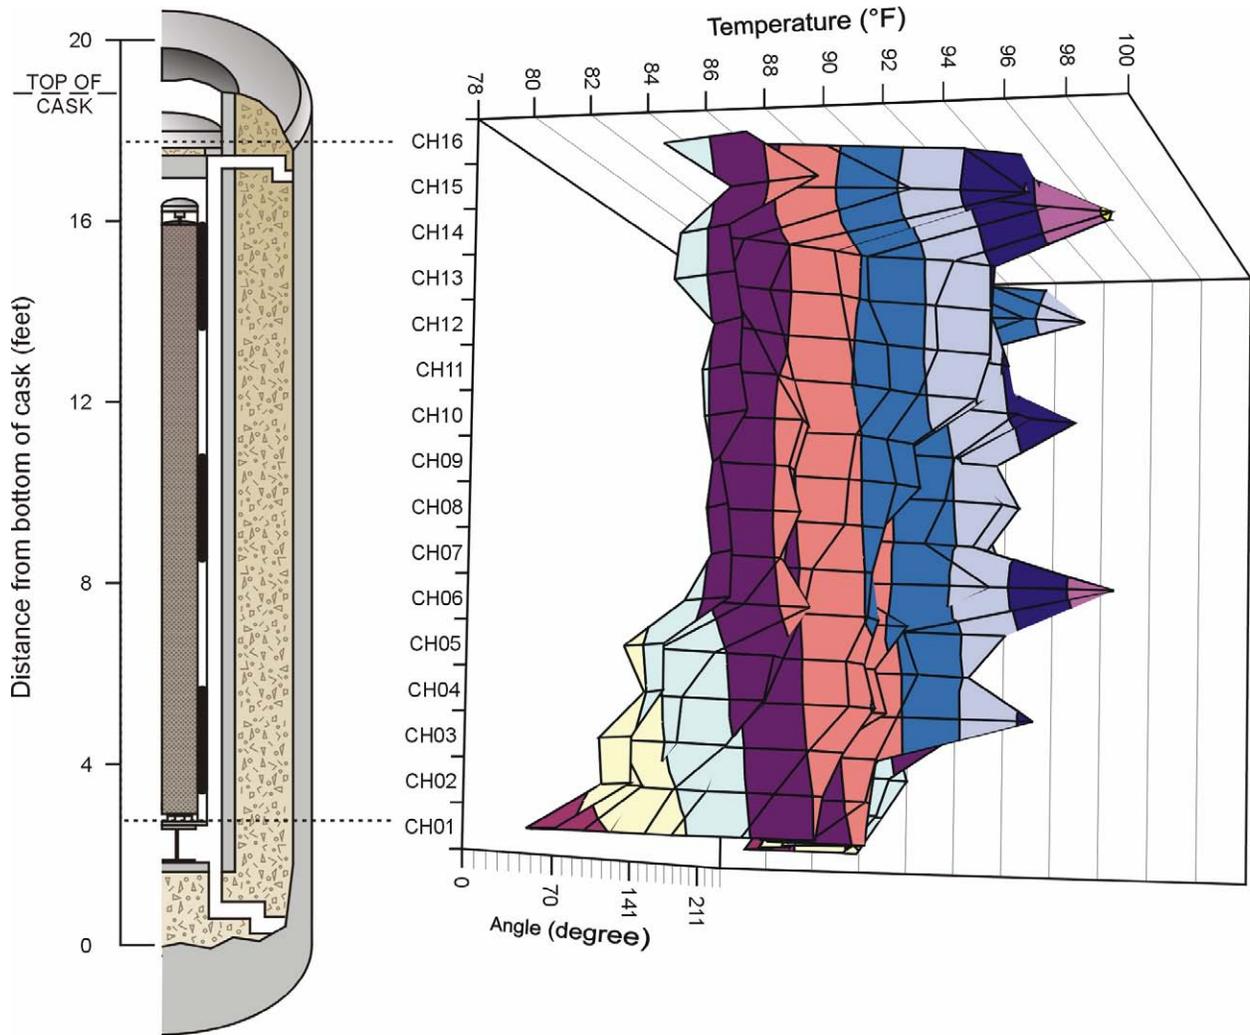
Graphical representation of the temperature data is shown in Figures 11 and 12. The data are shown for the two sections that cover the areas measured. Temperatures shift to higher values as external ambient temperature increases. The data shown in the graphical representation do not include the ambient thermocouples from positions 17 and 18.

Figure 11. Temperature readings for 0 degrees to 210 degrees.

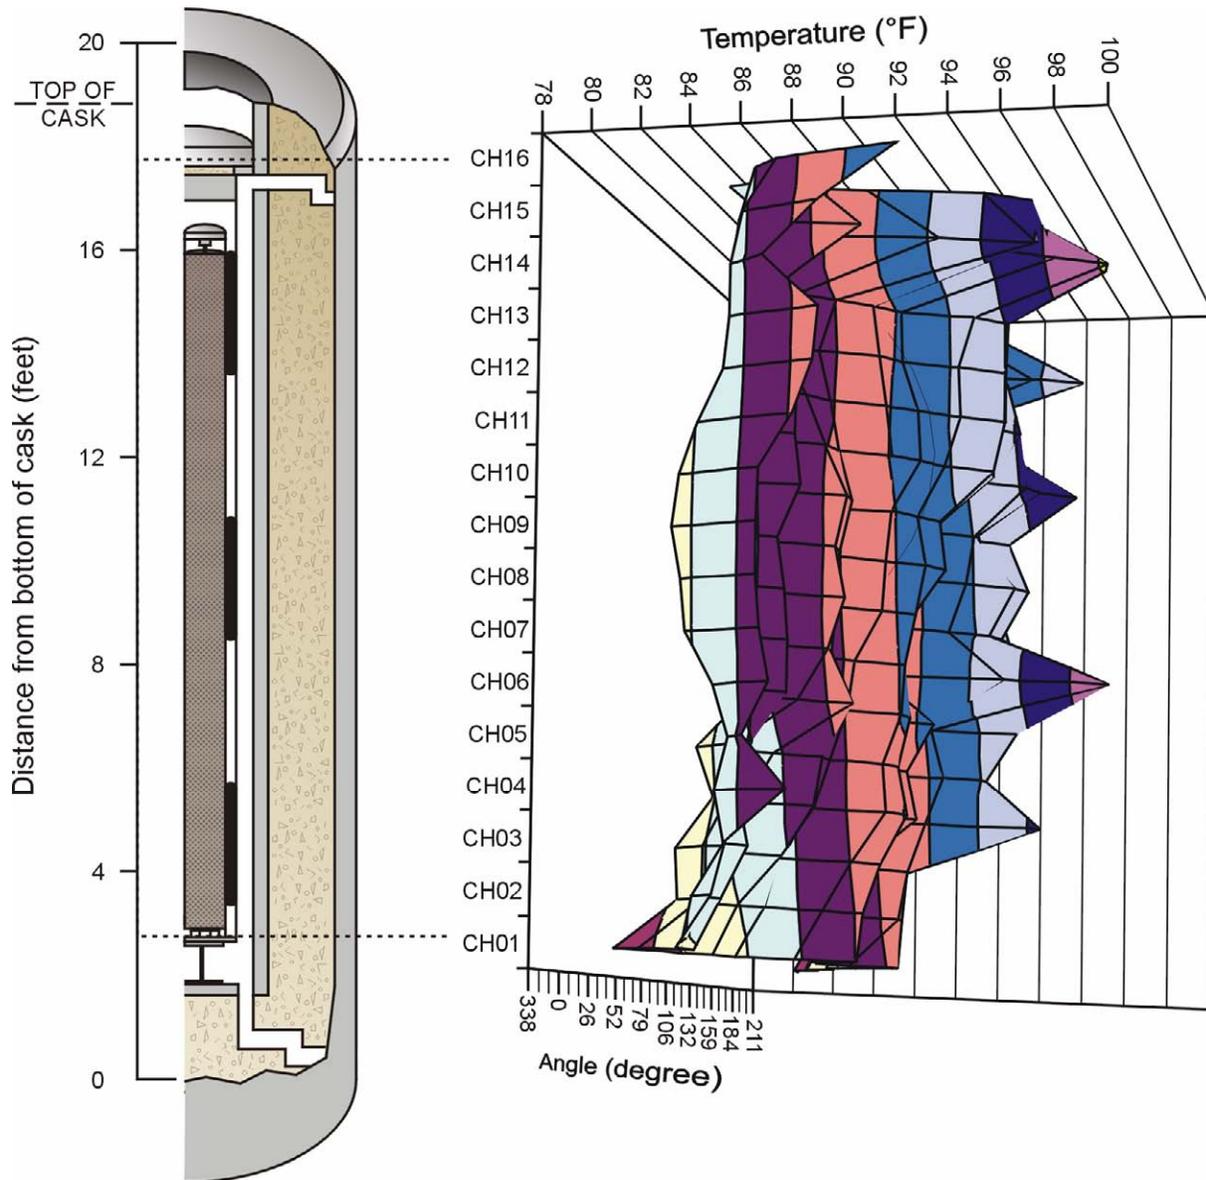
Figure 12. Surface temperature data from the radial 340 degrees through 210 degrees locations.

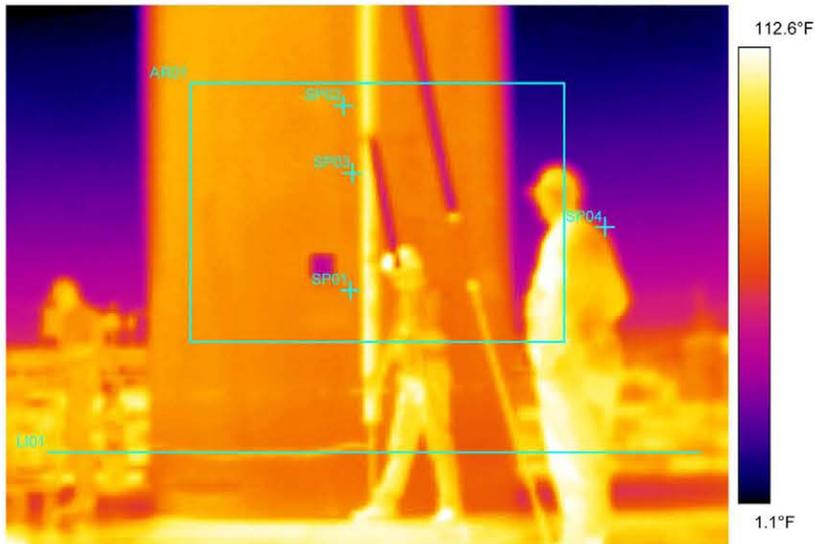
The following image and data were produced using a FLIR Systems digital thermal imaging unit. The person in the center of the Figure 13 image is holding the thermocouple rake against the cask at the nominal 90-degree position.

Emissivity has been adjusted to correlate the indicated value at SP02 (88.9°F) with the measured value reported on the second 30-second data segment of Channel 05 of the thermocouple rake.

Figure 13. Thermocouple rake measurements and corresponding adjusted emissivity (image by Jerry Bingham).

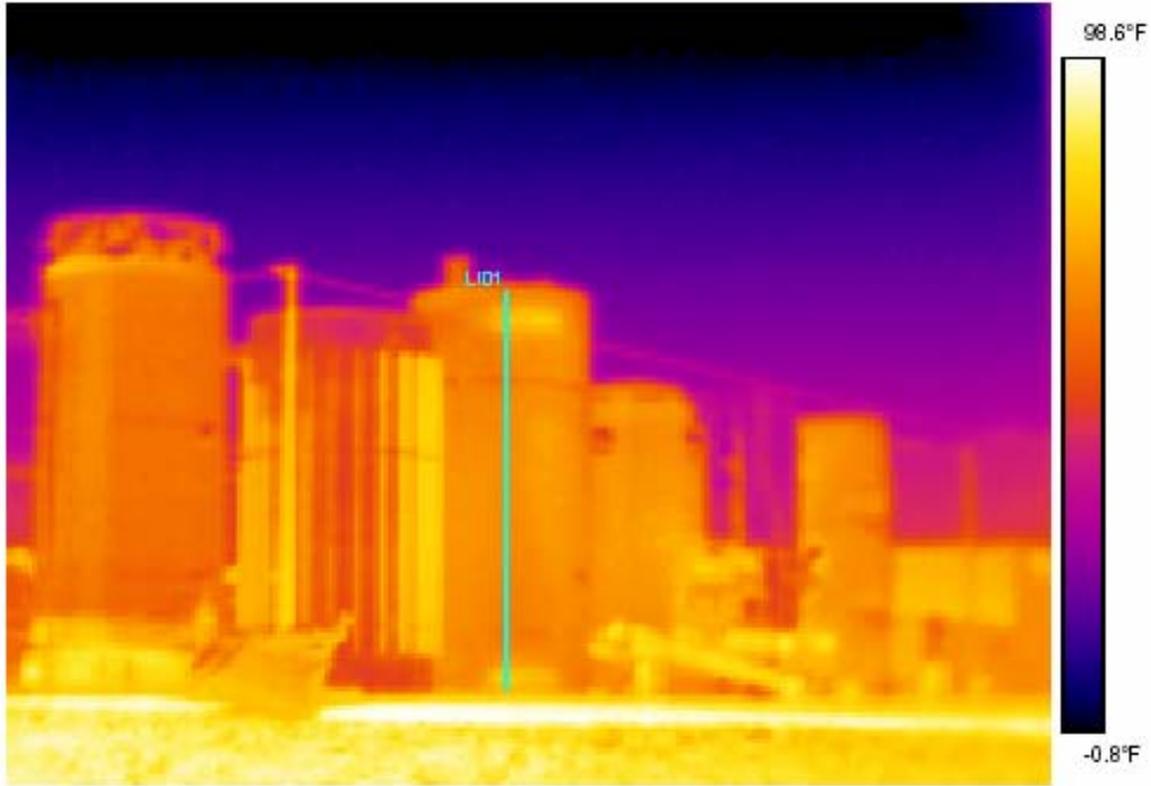
The image in Figure 14 provides a reference with an unadjusted emissivity value and lower ambient temperature. This shows that the external temperature of the cask varies consistently with atmospheric conditions.

Figure 14. Infrared image of casks taken at INTEC (photo by Darrell Johnson).

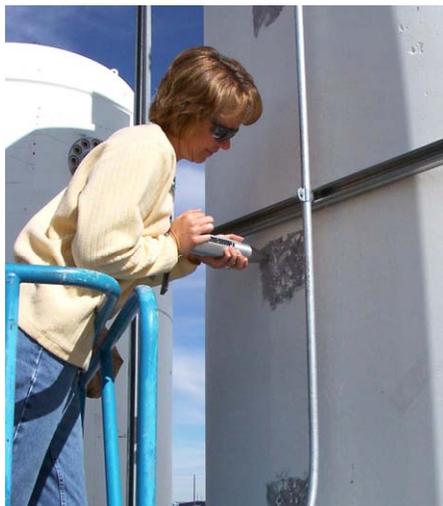
The INL project team performed hammer testing of the VSC-17 on October 5 and 10, 2005, following removal of paint from selected radial and vertical locations. Figure 15 shows testing being performed at the 270-degree position. What may appear to be residual paint in the work areas is actually exposed aggregate. The 90 and 270-radial locations have flat areas that were ground off to provide space for nameplate installation. Grinding the 1-ft (30-cm)-wide × 3-ft (90-cm)-high flats exposed the larger gravel aggregate.

Figure 15. Schmidt rebound hammer testing on the VSC-17 cask.

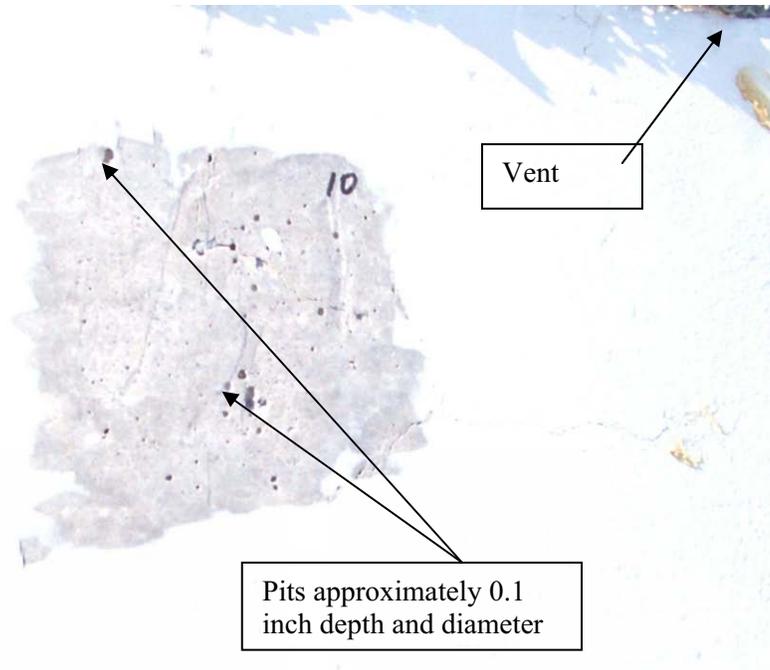
There were some small surface defects (approximately 0.1 in. diameter and depth) discovered when the paint was removed for impact testing. The degree of pitting seen here was not typical of other areas tested. Avoiding these as directed by the ASTM method, the relative compressive strength of concrete at this location was consistent with the remainder of the test areas. Figure 17 shows the surface of the cask concrete 4 in. below the upper vent following paint removal.

Figure 17. Pits at position 10, below the 45-degree vent.

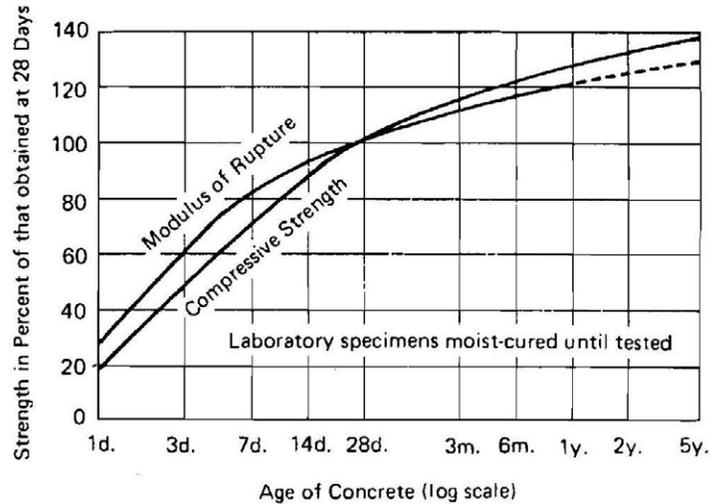
To gauge the readings received by hammer testing, a standard concrete test specimen was rebound tested and then broken at the INL Materials Testing Laboratory. The adjusted average rebound value for the first specimen was 37.1, while the second was 35.3. These specimens broke at 4,895 and 4,570 psi respectively; see Table 5. When extrapolated, the average value indicated for compressive strength of the VSC-17 shield concrete is approximately 6,600 psi. In typical circumstances, concrete gains compressive strength as it ages, but the expected increase is typically about 20%. For the concrete used to construct the VSC-17 shield, that value should be on the order of 5,400 to 5,500 psi. In moist cured concrete, the value may increase by as much as 40%, which would project the 28-day average values from the cask fabrication pour from 4,509 psi to 6,312 psi at 5 years (Figure 18).

Figure 18. Age-strength relationships for moist-cured concrete.<sup>3</sup>

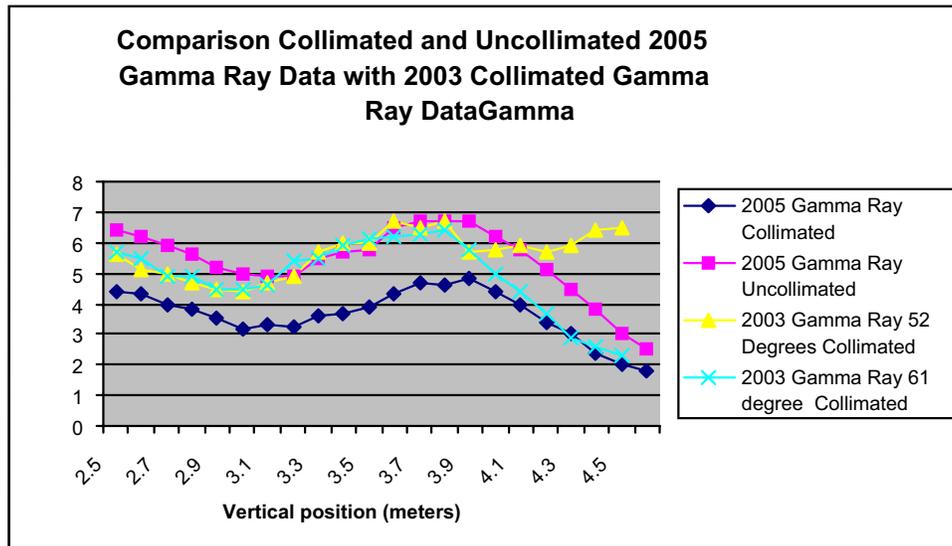
Because of a need to reconcile the 2004 data with the 2003 measurements, collimated and uncollimated gamma ray measurements were made at the 52-degree position for vertical positions from 3 to 18 ft. The measurements made in 2005 suggest that the progressive increase of dose rate above 4 m is anomalous, the result of either incorrect recording or incorrect positioning of the detector during the 2003 measurements. Inconsistent values are believed to have been recorded due to problems getting all the equipment mounted on the lift platform to function simultaneously. The 2003 values from the 61-degree position appear to be consistent with the 2005 data. (The comparisons are shown in Figure 19.) Data are provided in tabular form as Table 6.

Figure 19. Comparison of 2003 and 2005 collimated measurements.

Review of the 2003 log book for data acquisition indicates that inconsistent positioning of the detector with the value recorded resulted in the apparent increase in values above the 4-m position. On a less readily explained note, it appears that the 2005 measurements do not show the same step change at 2.4-m vertical position as seen in all 41 measurements in 2003.

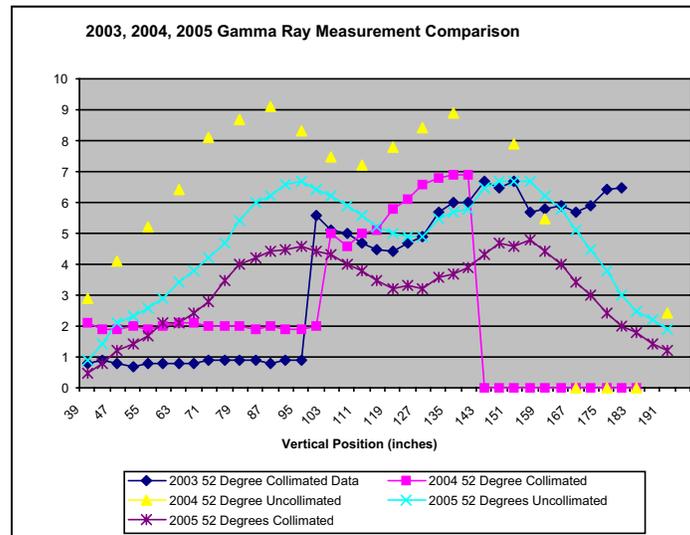
The data shown graphically on page 12 of the 2004 report (Reference 2) have been combined with the 2003 and 2005 data to provide a comparison. The background values for radiation at the TAN-791 boundary rope (approximately 10 ft [300 cm] from the cask) were 0.6 mR/hr in 2003 and 2 mR/hr in 2004. This difference was due to excavation and removal of tanks containing radioactive waste in an area adjacent to the cask pad. All sets of measurements were taken at the sixth 8-in. interval (48 in.), corresponding to the 52-degree position. The increased background appears to be the biggest single

Figure 20. Comparison of 2003 and 2005 gamma radiation data.

contributor to the difference in both the collimated and uncollimated 2004 data. However, it is not immediately apparent why the uncollimated response varies in a manner consistent with the rise in activity seen in both collimated and uncollimated 2005 data. The high activity at the bottom of the cask appears to be due entirely to background, because it was identified with both the TBM-232 and the Eberline RO-20 ion chambers.

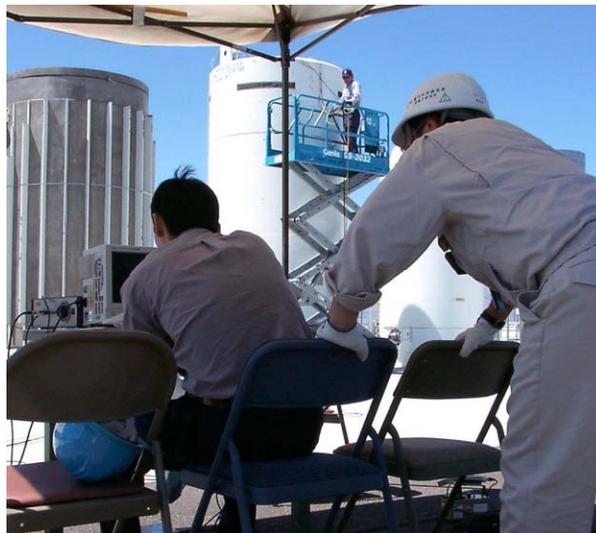
In August 2005, CRIEPI and their subcontract team from LAZOC Sensing Technology joined the INL project team to perform ultrasonic testing on the VSC-17. Figure 21 shows the CRIEPI team applying sensors to the VSC-17 and gathering data. A second revision of this report will be published to provide details of this testing and its conclusion.

Figure 21. CRIEPI and LAZOC Inc. representatives performed ultrasonic testing in August 2005.
