**ANNULUS CLOSURE
TECHNOLOGY DEVELOPMENT
INSPECTION / SALT DEPOSIT CLEANING
MAGNETIC WALL CRAWLER**

Robotics, Remote & Specialty Equipment Section
Engineered Equipment and Systems Directorate
Savannah River National Laboratory
Aiken, SC 29808

EXECUTIVE SUMMARY

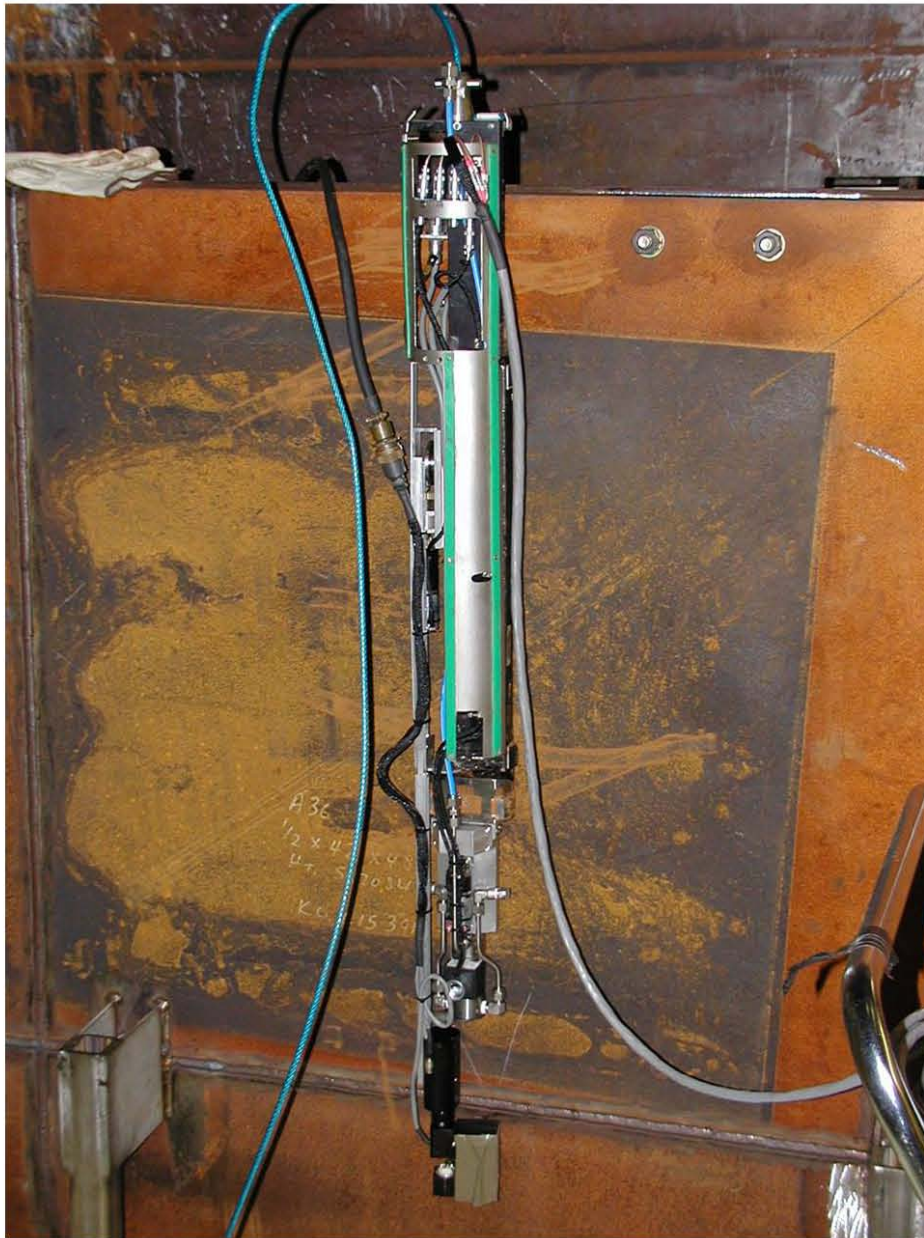
Figure 2-5 Modified Wall Crawler on Tank Mockup Wall

If the brush is used to remove salt from the annulus wall there could be residual salt particles remaining on the brush or shield that need cleaned prior to extracting the crawler from the annulus. The brush can be cleaned by operating the brush while spraying water on the wall directly above the rotating brush. The brush end of the crawler could also be sprayed with a separate wand below the riser as part of the wall crawler removal process.

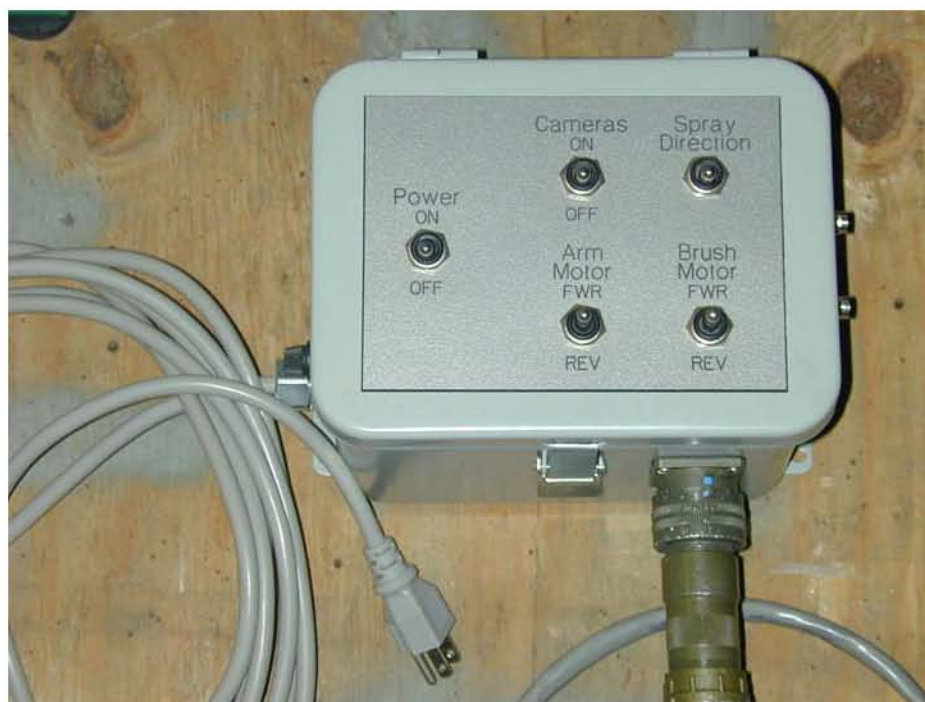
Figure 2-6 External Control Box

The Force Institute Wall Crawler is manipulated by its own computer based control system. The existing control system is used to operate the original functions of the wall crawler. The new features that were added are controlled by a separate self contained control box. This strategy kept the control system development simple and leaves the wall crawler control intact so it can continue to be used with unmodified crawlers. The camera arm assembly is raised and lowered by a motor axis built into the commercial crawler and normally used for positioning UT probes.

The new control box provides the ability to raise and lower the camera arm by rotating it 90°, turn the brush motor on and off and select the nozzle for spraying the salt nodules. The electrical design uses a simple set of toggle switches to provide either 12 or 24 VDC to the onboard robotics tools. All functions are labeled on the panel of the electronics enclosure, which is designed to be splash proof. The external power supply requirement is a standard 120 VAC plug. Additional 100ft cable extensions (with 1/4 turn quick release bayonet connectors) allow the user(s) to increase the distance up to a few hundred feet as required for remote deployment.

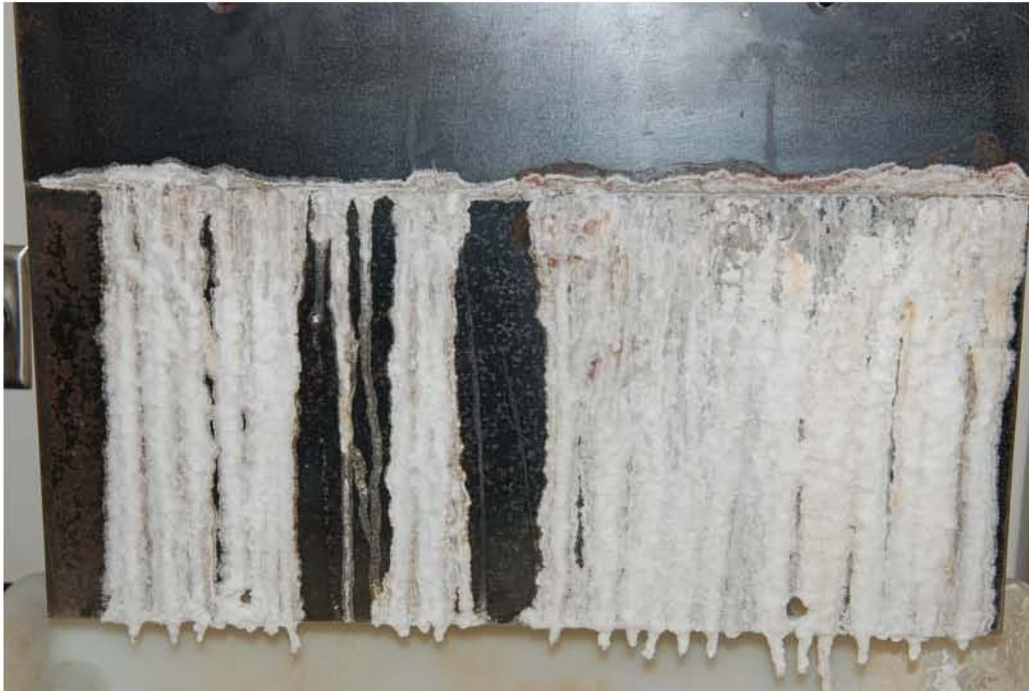
Figure 2-7 Typical Salt Deposit Produced on a Vertical Plate

The salt deposits were produced using carbon steel plates mounted in two different positions. The least massive deposits were produced by mounting the steel plates vertically and allowing the salt solution to weep through a horizontal seam on the upper portion of the plate. The plate was heated by hot air blowers to accelerate evaporation. Deposition by this process was slow since liquid drained off the plate before all of the water had evaporated. The second position for the carbon steel plate was a slightly inclined position (10-15 degrees) and the supernate was added slowly near the top of the plate. The steel sheet was heated by large heating pads mounted on the reverse of the plate with a controlling thermocouple mounted between the pad and the steel plate. The heated pad was maintained at 90° C while the air flow in the chemical hood carried the evaporated water away from the deposits. This approach deposited much larger quantities of solids.

The salt deposits produced on the vertical plates were probably mostly sodium carbonate with some aluminum hydroxide. The aluminum hydroxide would be generated by the reaction between carbon dioxide in the air and sodium aluminate in the liquid as shown below.

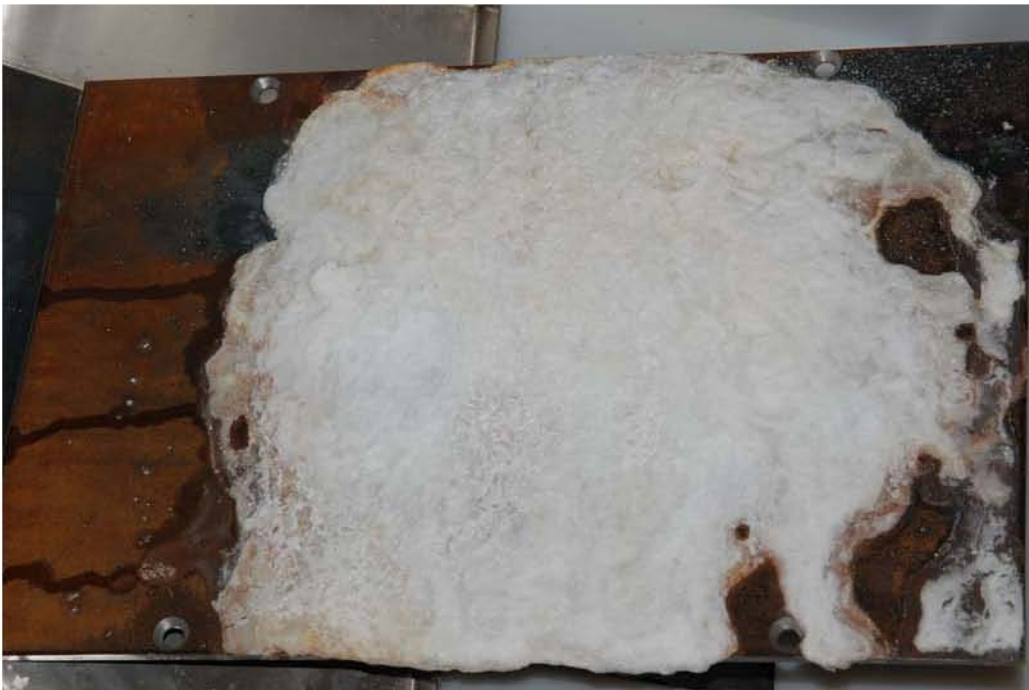
Figure 2-8 Typical Salt Deposit Produced on an Inclined Plate

The more massive deposits are more likely to contain not only sodium carbonate and aluminum hydroxide but also more of the other salts due to the greater degree of evaporation achieved with the low angle plate position. The other salts include sodium nitrate, sodium nitrite and possibly sodium aluminate. Sodium hydroxide is another salt that may be present although less likely.
