Walla Walla River Basin Fish Habitat Enhancement Project

Annual Report
2001 - 2002

**WALLA WALLA RIVER BASIN
FISH HABITAT ENHANCEMENT PROJECT**

**ANNUAL REPORT OF PROGRESS 2001
(February 1, 2001 to January 31, 2002)**

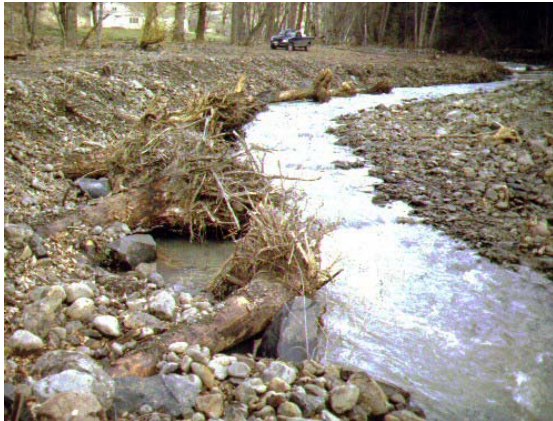
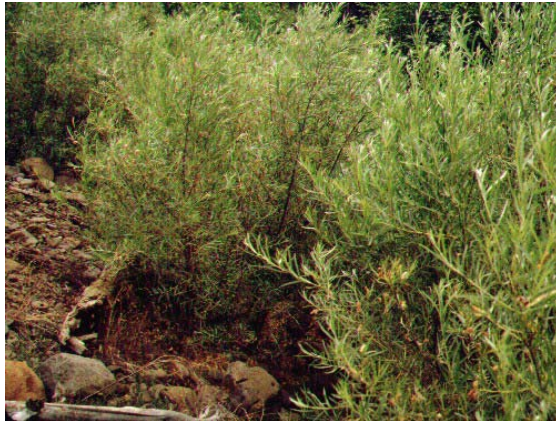
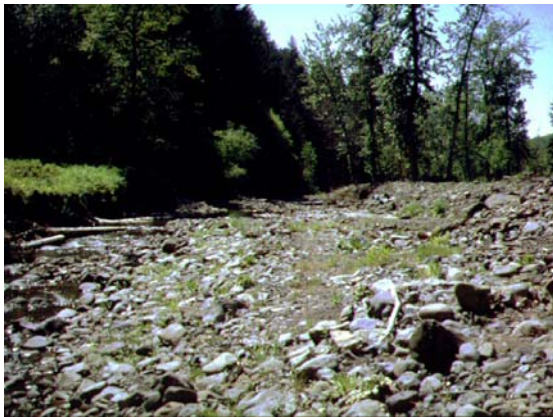
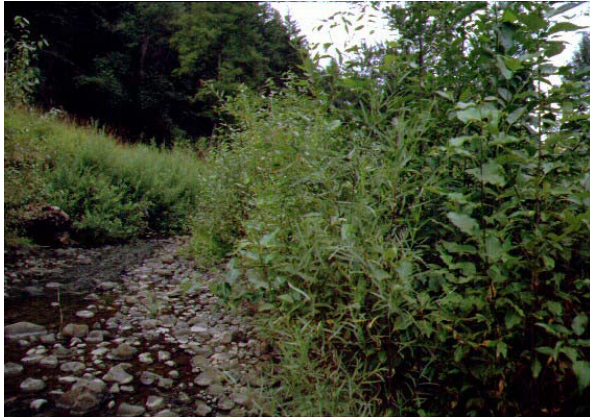
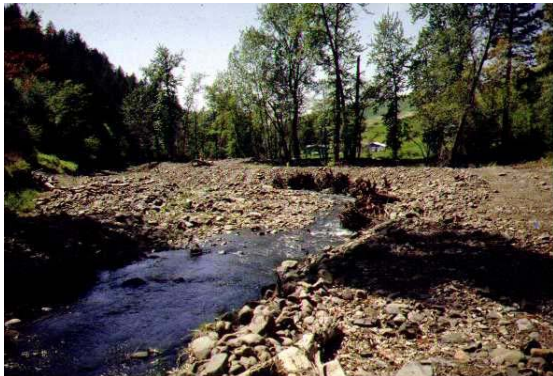
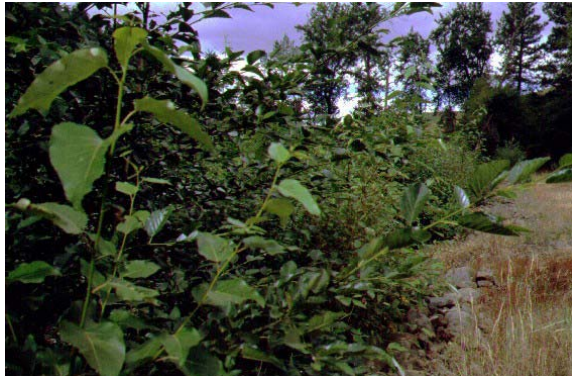
The following photo points portray the significant vegetative recovery that has occurred at this project site.

May 1998

July 2001

Native plant restoration efforts have been very effective. Nearly all of the willow cuttings placed during excavation and subsequent planting efforts of rooted stock plants have survived. It's worth noting that the riparian corridor of this project area is almost exclusively river rock (please see 1998 photos below) and virtually no soil can be observed whatsoever. The project did hand-water the rooted stock plants the first two years following reintroduction.

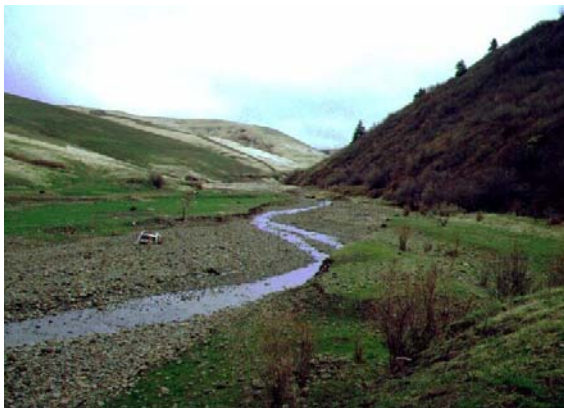
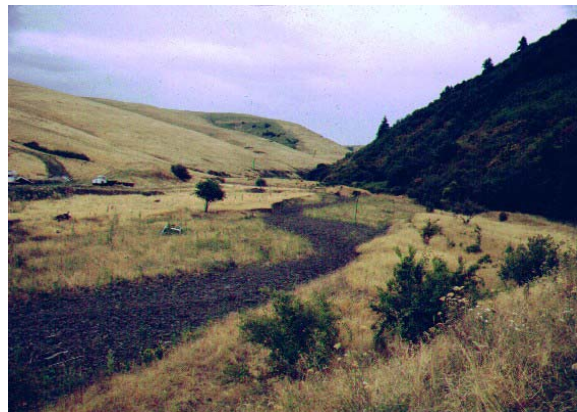
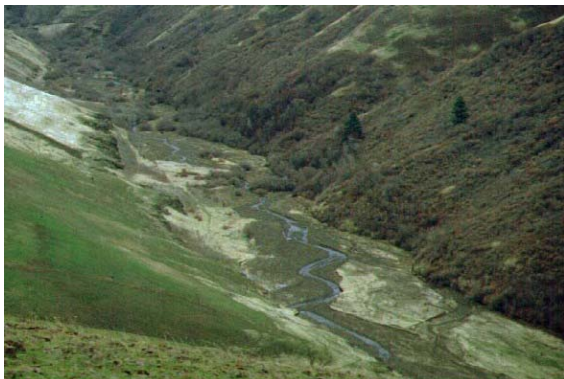
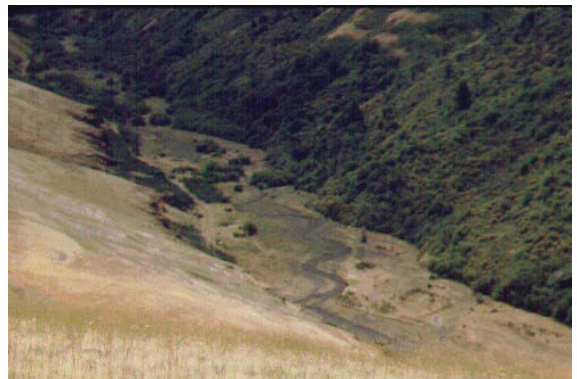
December 1999

July 2001

A 15 year riparian easement was signed with the landowner in December of 1999 and in February of the following year a livestock exclusion fence was constructed. It was decided to forego the use of any bare-root stock plants at this site because of the poor soil conditions, and the harsh summer environment. Instead the project chose to hasten recovery through the installation of willow cuttings within the floodplain. Several thousand native willow cuttings were collected nearby on the North Fork of the Walla Walla River and placed with an excavator during the 2000 reporting period. Survival of the cuttings was higher than 80% the following spring but as summer progressed many of the plants began to die. Today, survival of the cuttings is estimated at 15% and we expect that most of all these plants will survive.

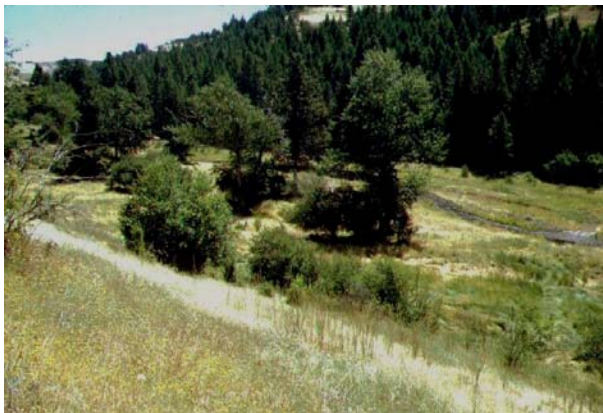
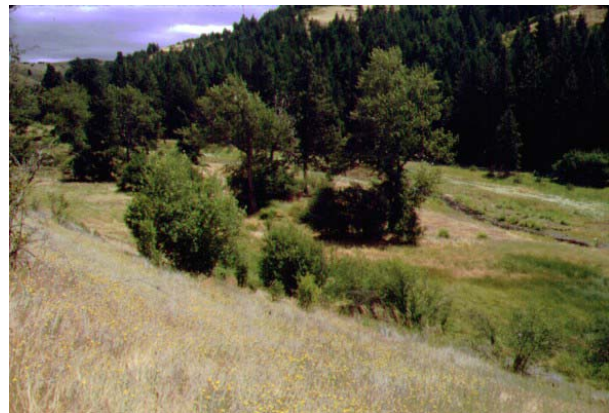
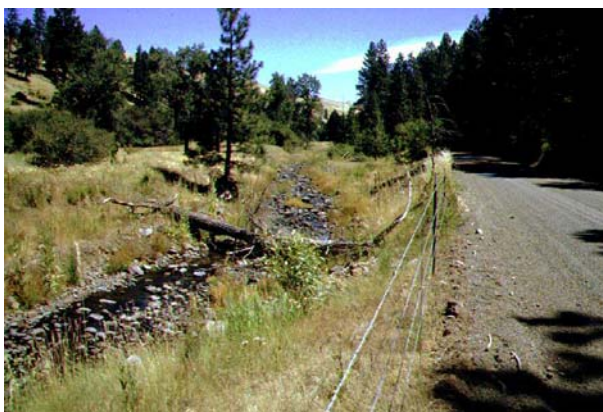
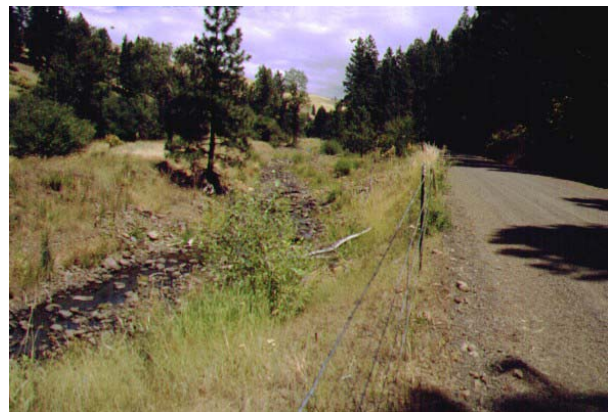
July 2000

July 2001

Today the channel is functioning as we had designed and the willow cuttings placed during implementation are thriving. Some additional floodplain planting was done within the reporting period. The list of species included ponderosa pine, willow, and cottonwood among others. These plants were hand watered several times during the months of August and September. We will report on the success of these efforts and all other monitoring parameters in 2002.
