# **IMPROVEMENT OF WEAR COMPONENT'S PERFORMANCE BY UTILIZING ADVANCED MATERIALS AND NEW MANUFACTURING TECHNOLOGIES: CASTCON PROCESS FOR MINING APPLICATIONS**

Final Scientific/Technical Report

Xiaodi Huang and Richard Gertsch

**DE-FC26-01NT41055**

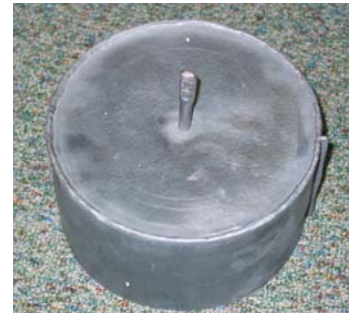
Figure 5. HIP can for disc cutters

A sand mold needs to be encapsulated in a metal container for HIPping in the CastCon process. We prepared two types of steel containers for making small samples and large parts in this project. The first container was small and consisted of a piece of 3" or 5" pipe with a bottom and a top covers. The bottom cover was welded on the middle pipe first. The sand mold was loaded into the uncovered container and closed with the top cover. The top cover was then welded on the container. The top cover had a steel stem welded on its center to provide access to the inside of the container. The second, larger container was made of 1/16" thick steel sheet. The steel sheet was cut, rolled and welded. It also had a stem welded on the top cover, as shown in Figure 5.

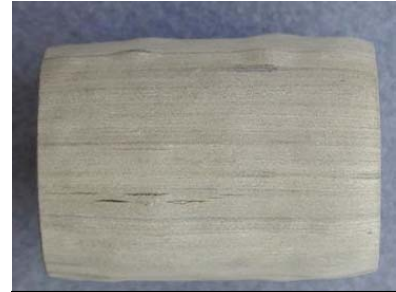
Figure 14. Cracking, delaminations, and bloating resulting from binder burnout and sintering.

Serious cracking, delamination and bloating occurred during binder burnout and sintering (Figure 14). Although cracking, delaminating and bloating was seen in the smaller specimen, the defects in the larger specimen were much more profound. Container HIPping should be able to close internal voids such as cracking and delaminating, but is not effective in closing surface cracks. It is necessary to solve the burnout problem to make the FM material useful.

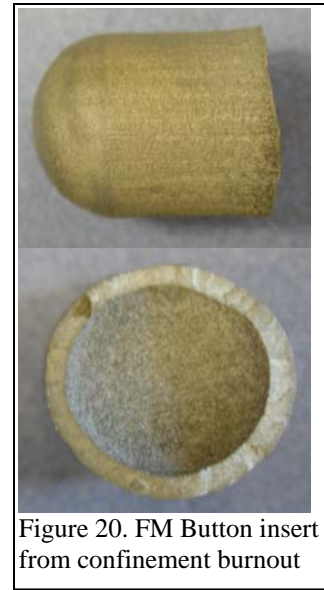
Figure 20. FM Button insert from confinement burnout

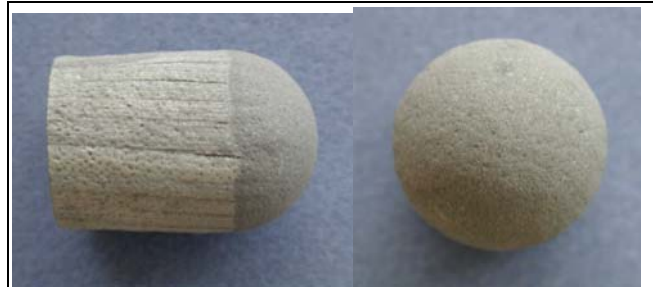
Figure 30. FM Insert after binder burnout and sintering in sand confinement

Three green FM inserts were tested. The three inserts were produced by cutting and machining a FM green rod which was made by ACR through a three pass extrusion. The first insert was embedded in a clay crucible filled with silica sand. The confinement came from the weight of sand on top of the insert. The heating rate was 0.5°C/min from room temperature to 500°C, followed by a sintering to 1100°C for two hours. Figure 30 shows the appearance of the insert after burn-out and sintering. Bloating is observed

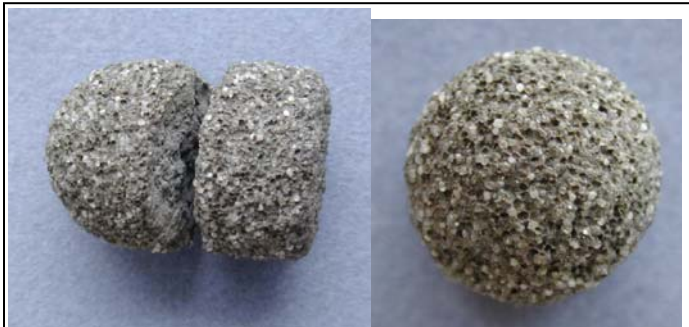
Figure 31. . FM Insert after binder burnout and sintering in container confinement with coarse sand

The second insert was embedded in a metal container completely filled with silica sand and covered by a metal lid. The confinement was introduced by the metal container's resistance to expansion. The burn-out rate was also 0.5°C/min from room temperature to 500°C, followed by sintering to 1100°C for two hours. Figure 31 shows the appearance of the insert after burn-out and sintering. From these figures, we can see that FM material penetrated into the surrounding sand and there are many large internal pores. We think that it is due to coarse surrounding sand (20-28 mesh) giving little resistance to the penetration of FM material into the sand interspaces.

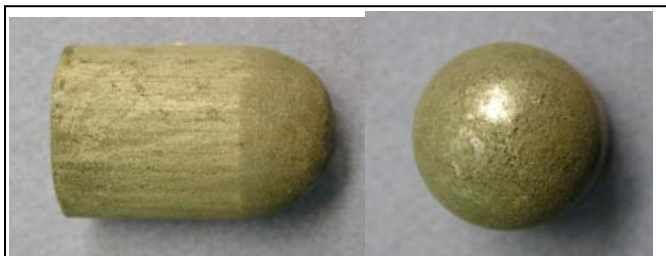
Figure 32. . FM Insert after binder burnout and sintering in container confinement with finer sand

The third insert burn-out and sintering process was the same as the second one except a much finer (100-150 mesh) graphite sand was used as the surrounding material. Figure 32 shows the resulting insert. There are no cracks or bloating. A density measurement revealed that the insert was not fully dense. The insert absorbed water. The insert was then sintered to 1200°C for one hour and the density checked after cooling. The insert still absorbed water. The insert was sintered to higher temperatures in 50°C increments, up to 1350°C for one hour. Then, the insert absorbed no water, assuming over 95% relative density. The insert was then sent to ACR for 1300°C and 30 ksi container-less HIPping.

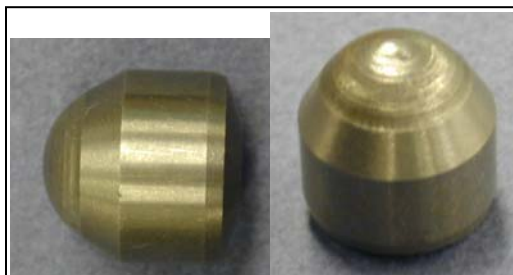
Figure 38. Two Views of the Round Top Drill Bit Insert. The insert is typical of the cutting tools placed on rotary drill bits. (Orientation of the fibrous monolith was right to left, from the round top to the flat base.)

Four HIPped inserts were sent to The Robbins Group and they arranged the grinding to specified dimensions (0.905" in height and 0.6895" in diameter, with a 60 degree tapered point). The grinding was done by a ceramic machining company in the Seattle area. One of the inserts had minor surface cracks. This insert was produced by free standing burnout and sintering, followed by container HIPping. The HIPping does not close all surface cracks generated during the free standing burnout. Figure 38 shows the machined insert.

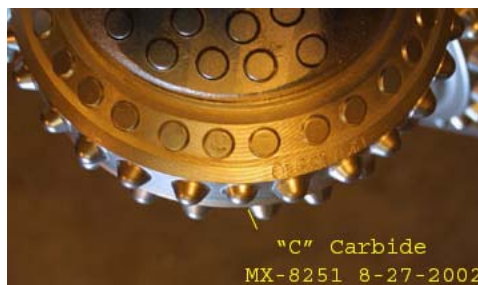
Figure 40. Drill Bit Used in Field Tests. The Superior Rock Bit test bit was 16.5 inches in diameter. The "C" carbide was the new art test insert.

The field tests were assisted by Superior Rock Drill Bit Company. Three inserts were placed on three 16 ½ inch diameter rotary tri-cone drill bits (Figure 40) manufacture by Superior Rock Drill Bit. The inserts were on the outermost row of the bit (i.e. the gauge row, also called the heel). The drills drilled taconite rock until the bits were completely worn out. For example, the rotary cone bearing in one bit lost all of the bearing rollers. Additionally, all three drill bits had their heel rows completely worn away, and nothing was left of the inserts, either new or current art on those rows.

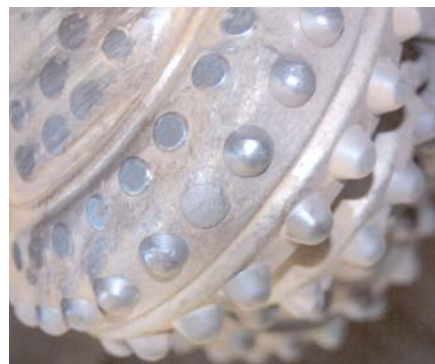
Figure 41. Current Art and Fibrous Monolith Inserts on a Worn Superior Rock Bit. The FM insert in the center has worn more than the current art inserts, although no brittle failures have occurred like the small chip on the insert to the left of the test insert.

The FM carbide-cobalt inserts wore away faster than current art inserts, although the wear rate was not significantly much higher (Figure 41). The relatively soft boundary seems to cause the wear. The boundary layer is composed of cobalt, which is significantly softer than the very hard tungsten carbide core.

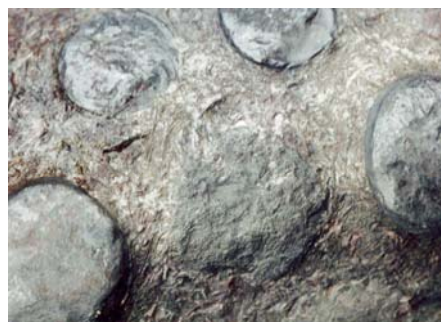
Figure 42. Highly Worn FM Insert on a Worn Superior Rock Bit Drill Bit. Compare the worn insert (center) to the surrounding current art inserts. The two current art inserts at the top exhibit brittle failures.

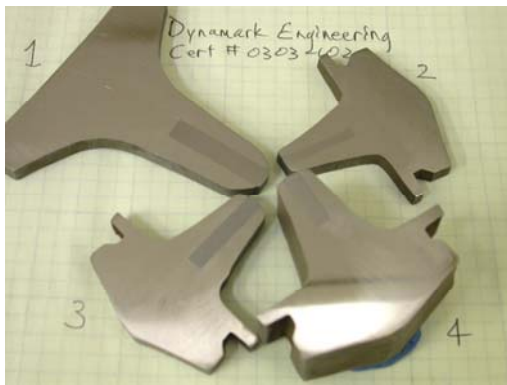
Figure 49. Disc cutter section pieces, the 17" section with the conventional WC insert is labeled **1**, a 6.5" section with a "green" FM WC insert **2**, a 6.5" section with hot pressed FM WC insert **3**, and a 6.5" section with sintered conventional WC insert **4**

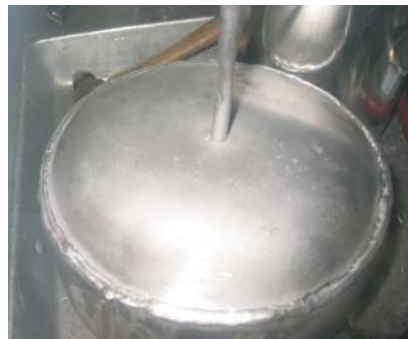
Figure 53. Blown HIP can

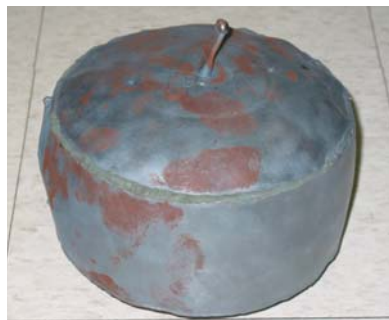
Figure 56. Blown HIP can with oxidation scaling

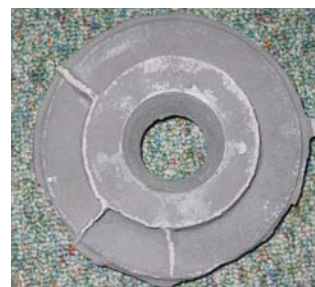
Figure 57. Rib defects on disc cutter

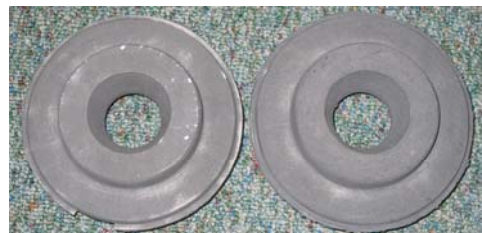
Figure 58. Disc cutters from Trial 3

Two 6.5" disc cutters were made, one from H13 powder only and the other from H13 powder with WC inserts. The cans did not expand during binder burn-out and off-gassing. There were no leaks during HIPping. The discs after removal from the cans looked good as seen in Figure 58. The disc with WC inserts was sent to The Robbins Group for final machining. The disc was difficult to machine because the material is very hard. During the machining, two

problems were found. First, the disc hub was still not thick enough for machining to final specification. Second, micro cracks were present along the radial directions. The thickness problem can be solved by modifying the disc pattern in the future. We believed that the micro cracks were caused by the low temperature binder burn-out and off-gassing. From our past experience, the H13 powder surfaces could be contaminated if the off-gassing temperature is not high enough.
