Municipal Solid Waste Open Dump Site Juba, South Sudan

Preliminary Environmental Assessment

April 2013

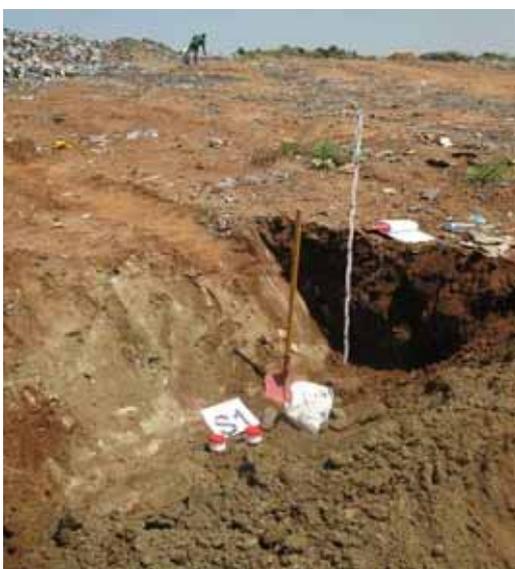
Photo 1: Excavation pit, Sample No. 1

A pit was excavated at the site up to a depth of 1 m. The lateritic soil taken from that pit consists of gravely and stony sand with little clay components. A soil sample from the pit was taken for analysis (Sample No. 1).

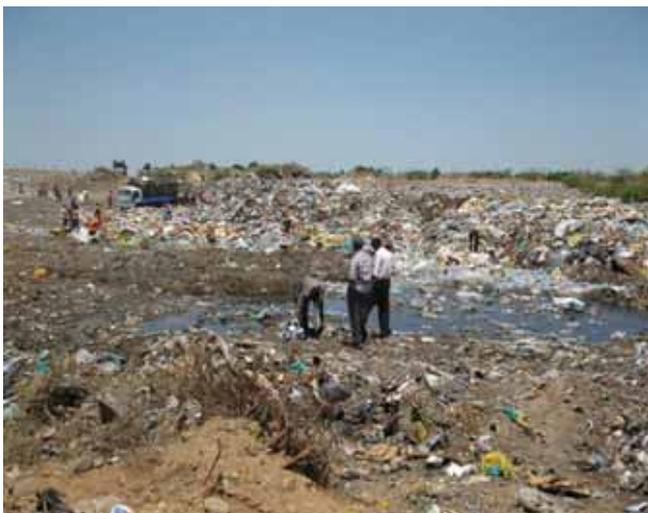
logged pool within the dump site area. The sample does not show the actual impact on the underlying soil, but provides an indication of the waste characteristics, and the potential risks to the health of waste-pickers of standing water. Similarly it gives an indication of the potential risks to the surrounding environment if contaminants are leached and transported as a consequence of rainfall. The leachate samples were dispensed into appropriate plastic and glass containers.

Photo 2: Ponding, collecting a leachate sample

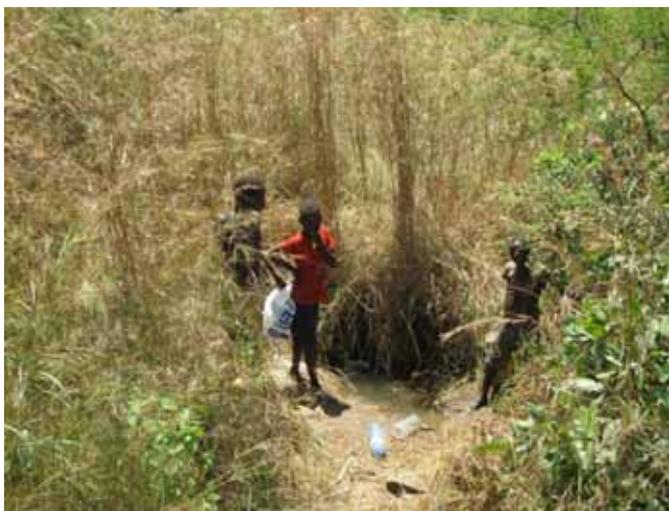
the waste-pickers fetch their drinking water. Sample No. 2 was drawn from this place and dispensed into appropriate plastic and glass containers. Physico-chemical parameters were measured in-situ by the water quality specialists from the Ministry of Water Resources and Irrigation. As the tested water is used for drinking water purposes, the analysis focused on testing WHO guideline parameters.

Photo 3: Children collecting water from a pond

The chemical analysis results of the surface water pool used for drinking water purposes were compared to the WHO Guidelines for drinking water. That analysis did not reveal any toxic components and therefore there is no chemical hazard. That is not to suggest that the water in the pool is fit to drink. It certainly is not: the hygienic condition of the pool is atrocious.

The contaminant migration from surface runoff and sub-surface flows during the wet season poses a significant health risk to waste-pickers, either from direct contact or through drinking water. A small ephemeral water body on the north side of the hill is used for drinking water purposes by some waster pickers and hygiene conditions are appalling. Although the preliminary analyses of industrial contamination levels showed no cause for concern, the ubiquitous and unregulated presence of faecal and decomposing animal matter in the refuse is an unacceptable health risk. Sanitary waste should be separated immediately from any other material.

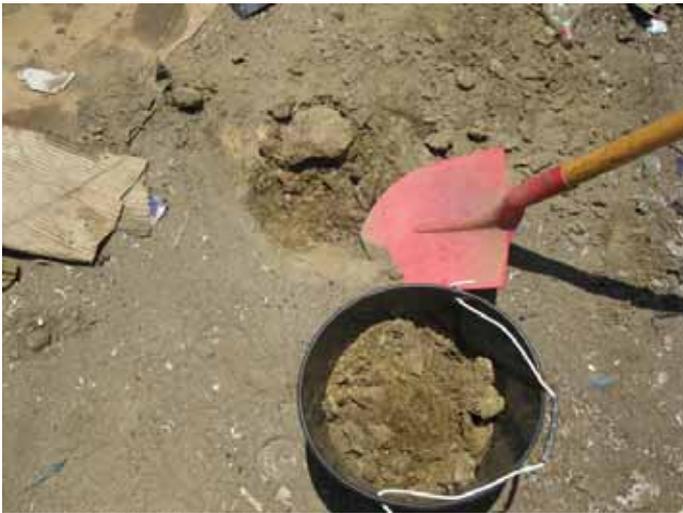
Photo 4: Sampling the dump site surface, Sample No. 4

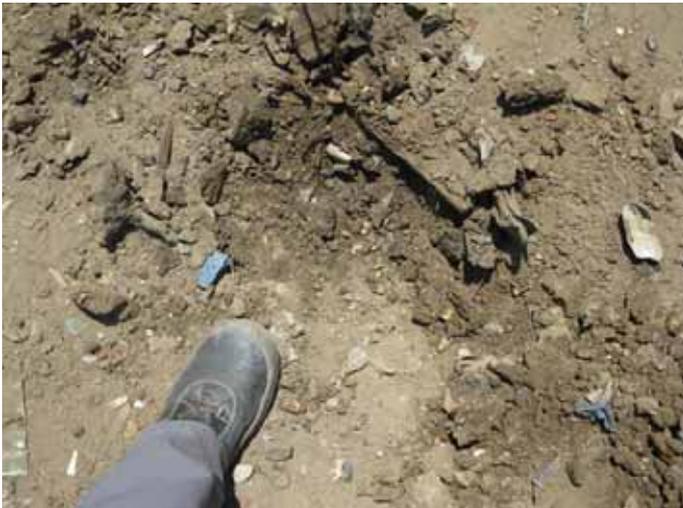
Photo 5: Sampling the dump site surface, Sample No. 4

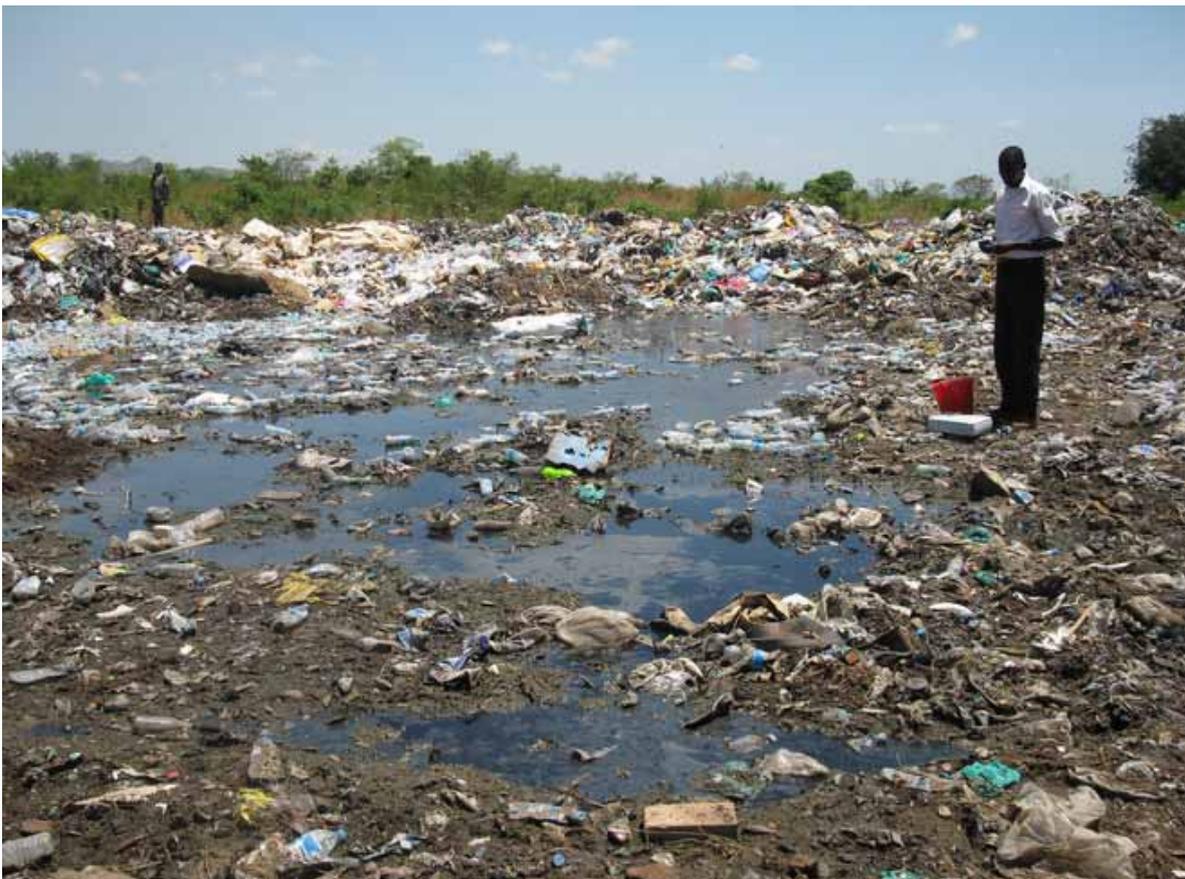
The unfiltered leachate shows elevated values of various parameters (e.g. Manganese, TOC) which are characteristic of the wastes involved. The comparison of the results (chemical analysis) for the filtered leachate sample gives no indication of an environmental hazard.

Photo 6: Collecting a leachate sample from a logged pool, Sample No. 3

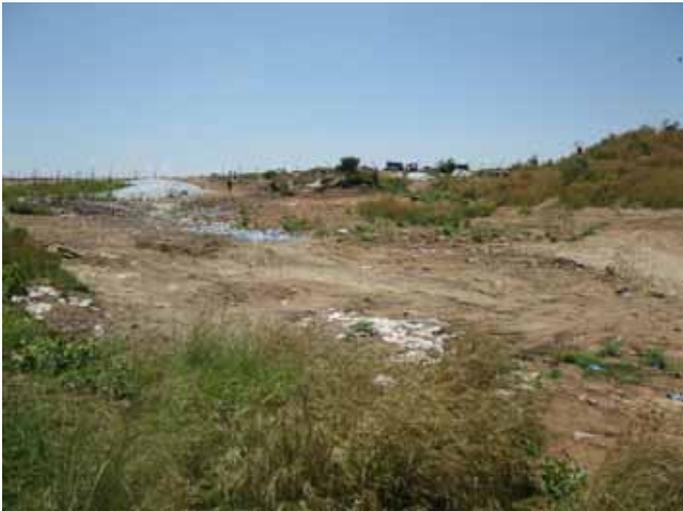
Erosion from surface run-off can be observed on the northern slope of the dump site. The flow of surface run-off is increased by the terrain and very shallow bedrock. Approximately 500 m down the north hillslope there is a small pool within an ephemeral stream where

Photo 7: Hill slope north of dump site

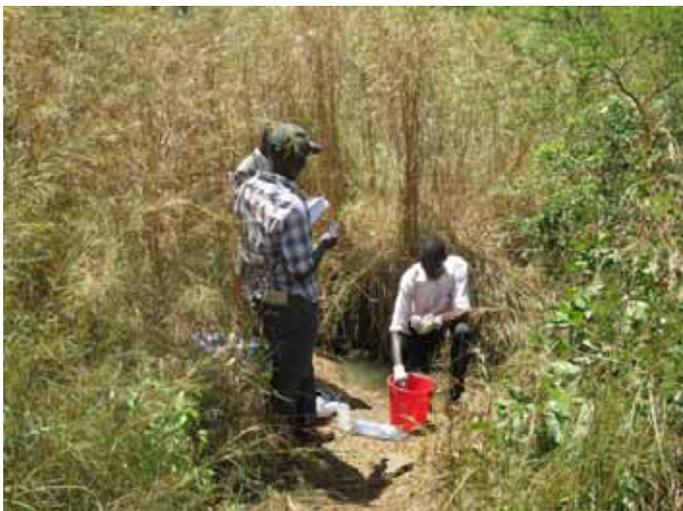
Photo 8: Sampling the water pond, Sample No. 2

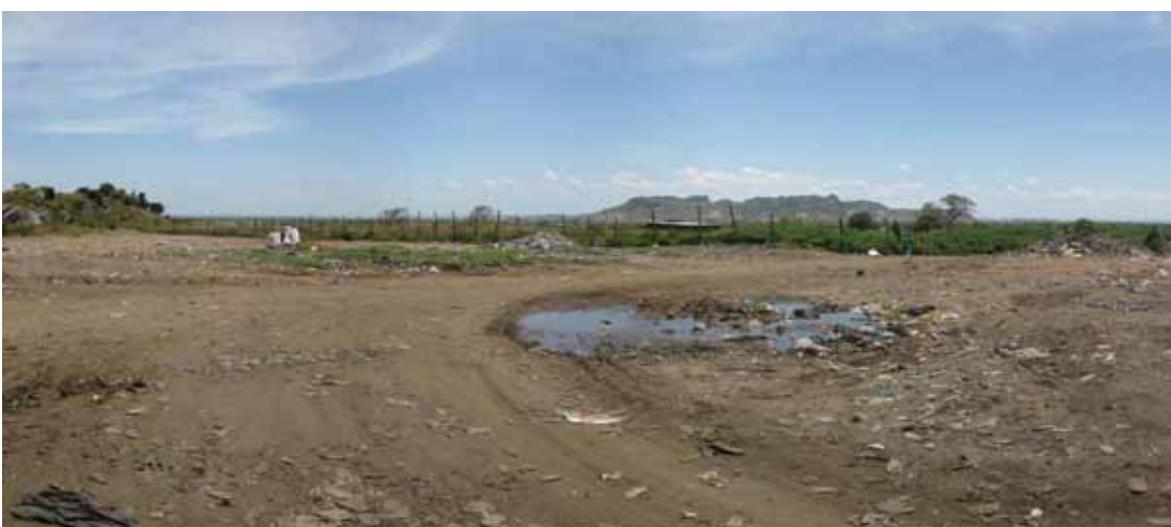
Photo 9: Highest section of the dump site area, facing West, background: Jebel Kujur

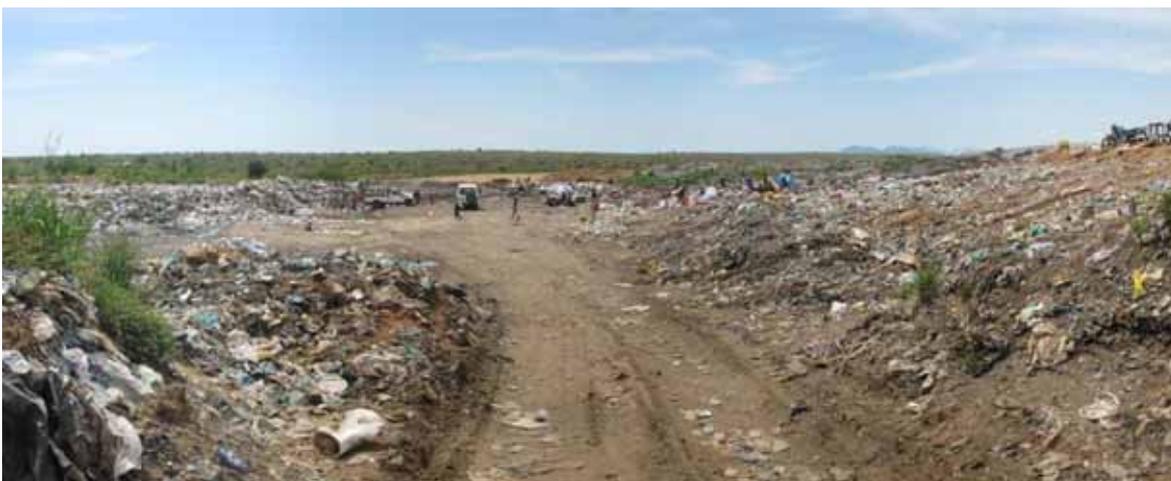
Photo 10: Initial dumping area, facing SE

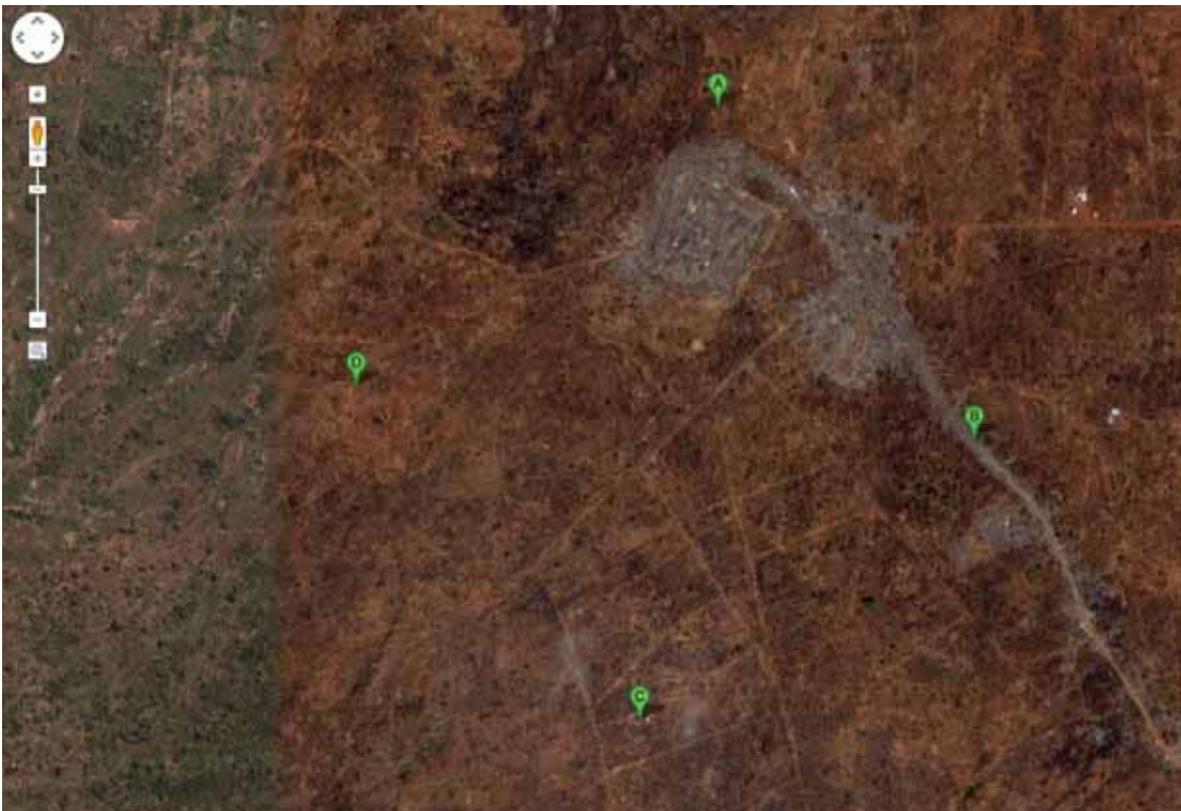
Dump site area, A-B-C-D indicate Coordinates of total projected site area (Source: google maps)

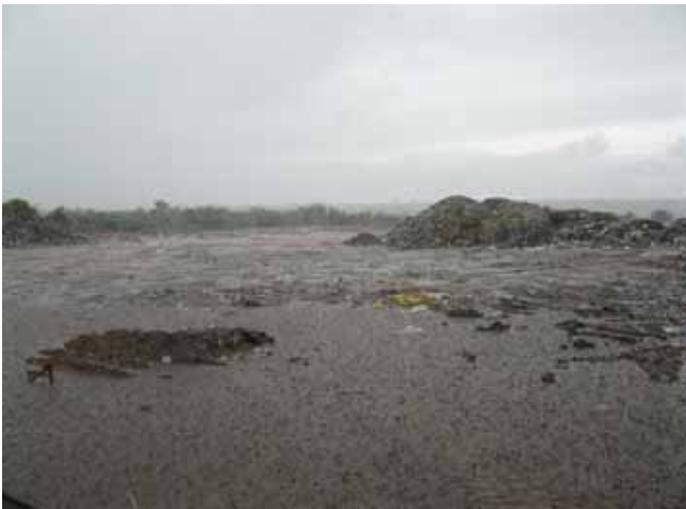
Photo 14: Dump Site during heavy rainfall, 12.10.2012

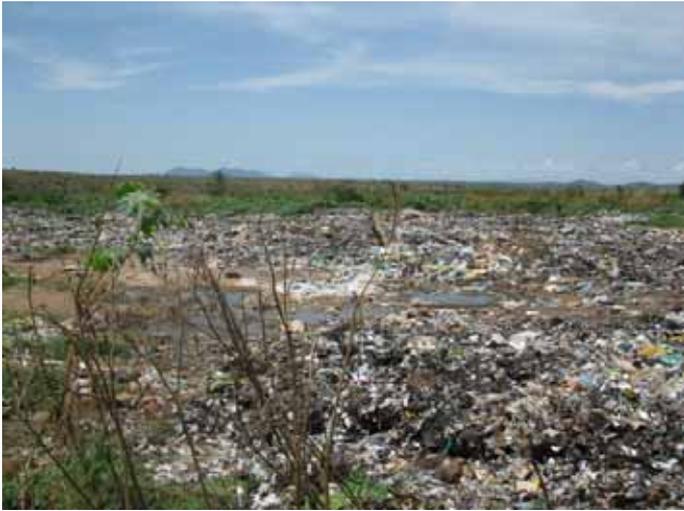
Photo 17: Dumping along the access road

- Discourage illegal dumping activities.
- Plan for handling waste picking activities. Waste-pickers provide an important economic and environmental service in recycling material. There are examples in other countries where innovative recycling enterprises can provide both economic and social benefits, rather than exploitation due to negligence and indifference.
- Plan for alternative or separated dumping of prohibited waste (e.g. hazardous industrial wastes, hospital refuse, munitions).
- Set up a monitoring plan, especially for water resources and flows.
- Establish an onsite Health and Safety Plan

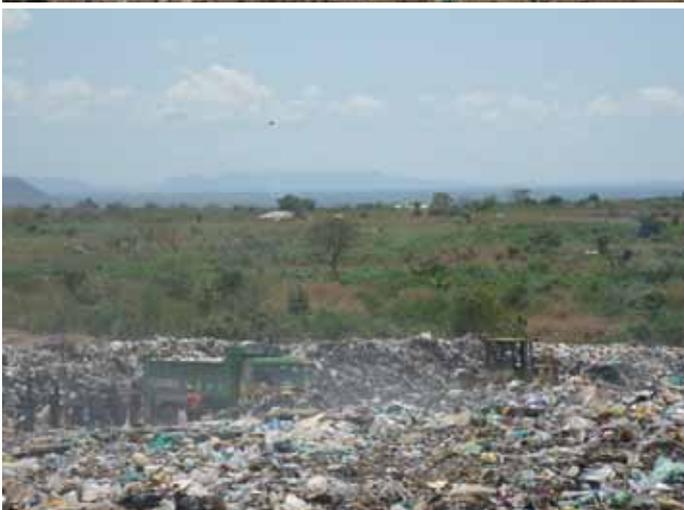
Photo 22: Dumping activities

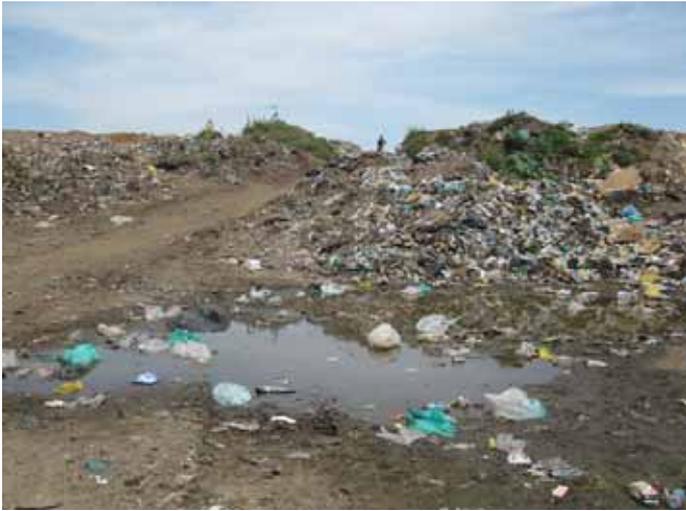
Photo 23: Water ponding

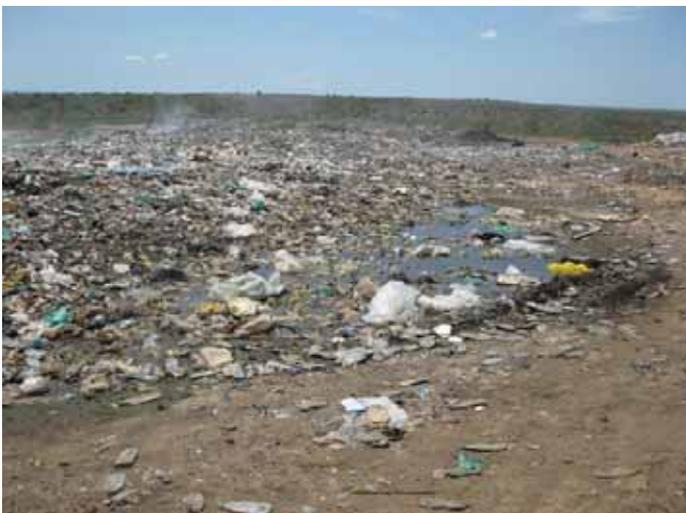
It was obvious from visiting the site that the burning of waste is a routine occurrence. The practice is used not only to reduce the volume of waste but also to expose sought after metals that might otherwise remain concealed (UNEP 2012). The toxic fumes generated by the practice of burning hazardous materials are a serious threat to the health of the waste-pickers. It is noteworthy that the technique of covering waste has led to a reduction in waste burning activities.

Photo 24: The wastes have not been covered with soil and occasional burning can be seen

Stability of slopes	The stability of slopes is sufficient.
Soil covering	Currently, the soil for covering activities is taken within the site. Soil cover is applied in accordance to the availability of heavy machinery.
Heavy machines on site	Wheel loader or bulldozer (depending on availability)
Leachate seepage and ponding	Due to the coarse soil characteristics of the dump site bed, seepage is considered to be moderate to high in areas with no direct underlying bedrock. In areas of underlying bedrock seepage is low and occurs mostly in fractures or weathered zones. Ponding can be seen on several areas of the dump site.
Run-off and erosion	During heavy rains the run-off is high due to the convex topography leading to erosion on the site and of the access road.
Burning of wastes	Burning is still very common. Since the management of operations by JICA, waste burning is discouraged and has lessened.

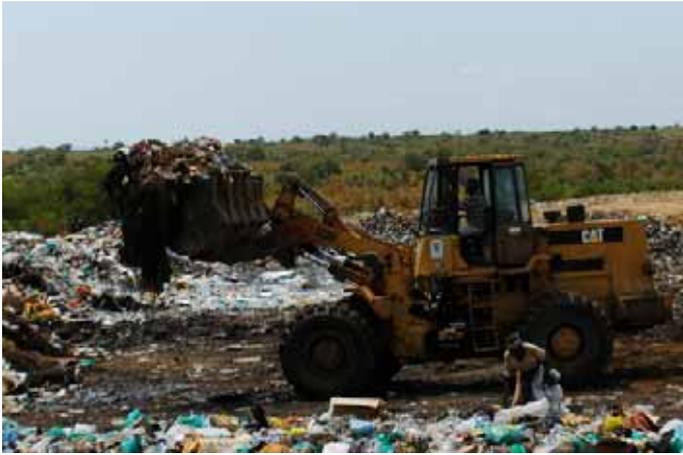
At the time of writing the waste-pickers use absolutely no protection when they collect recyclable materials. When the waste trucks arrive, the pickers simply stand next to or behind the vehicles so as to get a good chance of finding anything useful.

It was very clear from visiting the site that there are a wide variety of severe health risks facing the picker community. Waste-pickers that were interviewed offered as an example of those risks, the recent death of a child who was killed by a reversing waste truck.

Photo 26: Safety risk of waste-pickers (see woman with child) from nearby heavy machinery (Photo: Jada Albert)

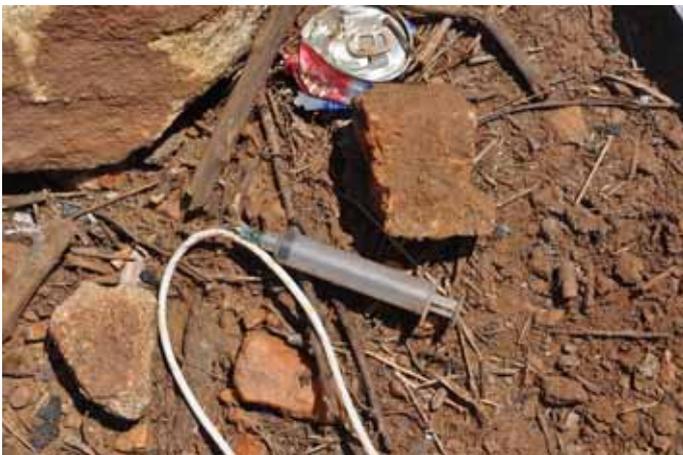
Furthermore there are no practical methods or mechanisms available at the site for the safe disposal or treatment of hazardous wastes like industrial waste, oil sludge, or surgical waste. There is a high probability there will be uncontrolled dumping of hazardous waste materials at the dump site near Jebel Kujur.

Photo 27: Hospital waste (Syringe with needle) posing a health risk

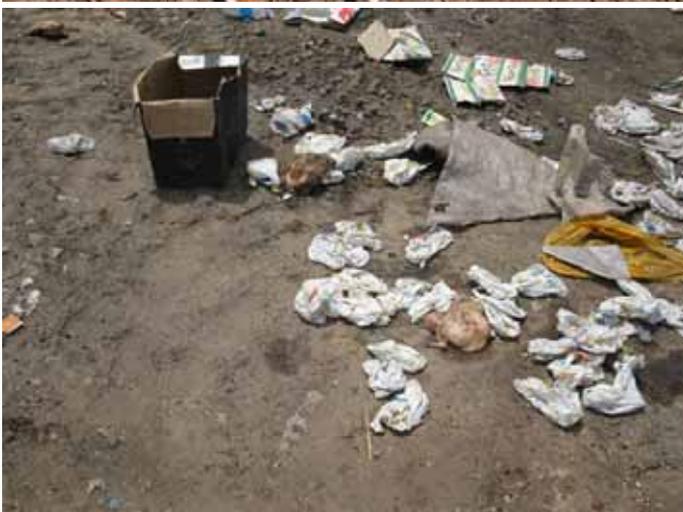
Waste-pickers prepare and eat food amid the waste at the dump site. In doing so, they risk ingesting hazardous substances. Frequently they eat foodstuff that they find at the site regardless of its condition or the threat it poses to their health.

Photo 28: Dumped expired food
