Post-event field observations in the İzmir–Sığacık village for the tsunami of the 30 October 2020 Samos (Greece) M_w 6.9 earthquake

M. Ersen Aksoy¹

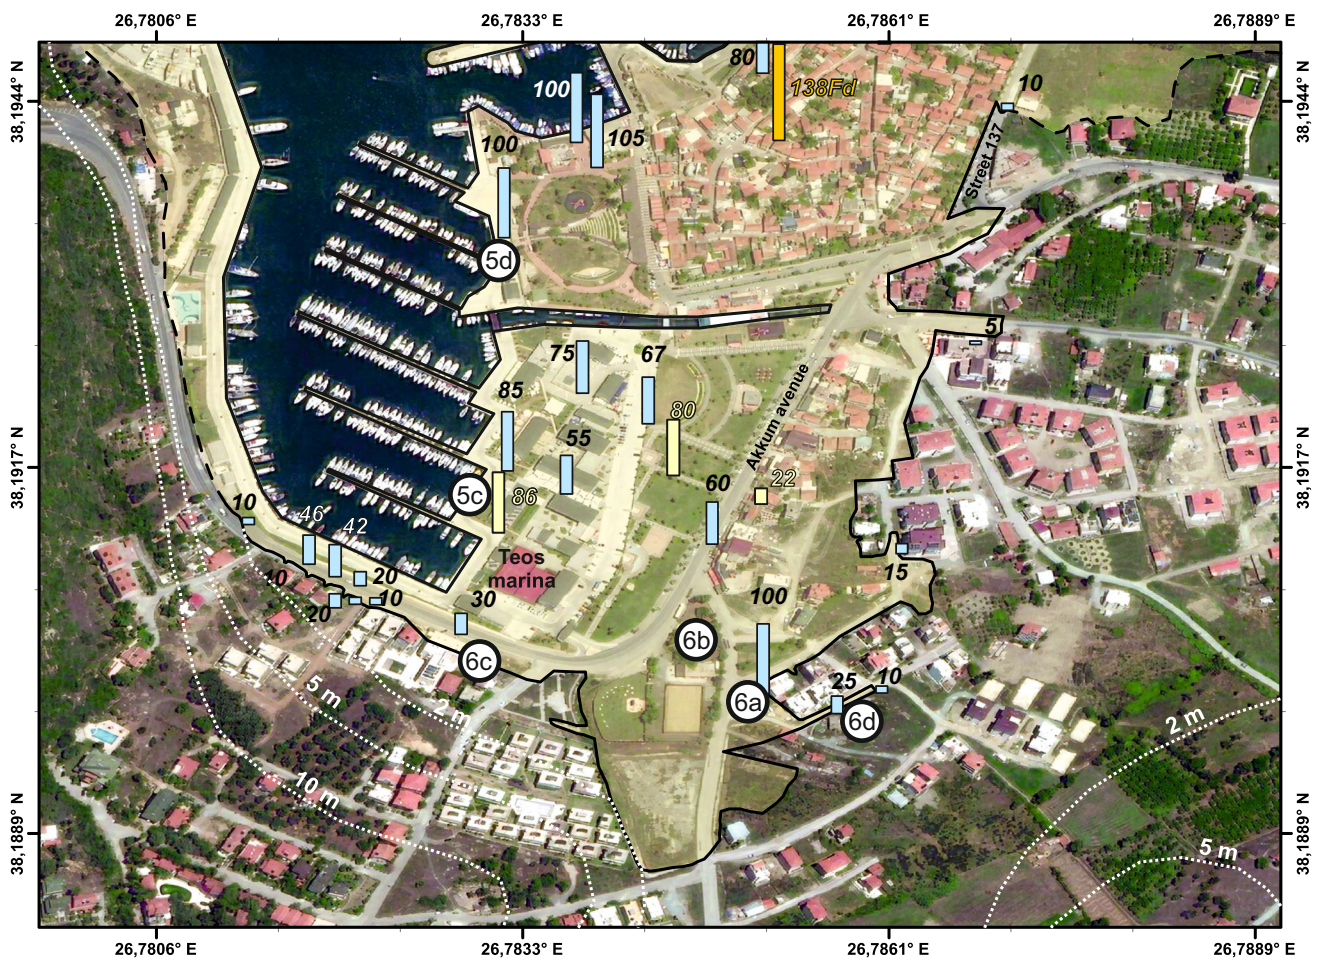
Fig. 3 The columns represent the flow depth measurements. Yellow, orange, grey and blue columns are from Yalçiner et al. (2020a, b), Doğan et al. (2020) and this study, respectively. The yellow shading corresponds to the inundated area. White circles indicate figure

locations. White dotted lines are elevation contours. The inundation is controlled by the high topography at the south; therefore, the west of the marina was inundated for 30–40 m, while in the east the sea water reached nearly a distances of 300 ± 1 m

In the south, near the Teos marina, the topography is moderately steep and the marina is enclosed with 50–200-cm-high walls (Fig. 3). Here, the waves overtopped the marina walls and penetrated 30 to 40 ± 1 m inland. The maximum flow depth was limited to 46 ± 1 cm along the main road outside the marina. Here, the flow drifted the boats, debris and garbage containers (Figs. 4, 5c). Additional photographs of inundation traces in this area are available in Supplementary file (Figs. s1–s6). Towards SE, the topography flattens, here the tsunami travelled 277 ± 2 m inland and occupied a large area (Fig. 3). The shops along the Akkum avenue (which runs parallel to the coast), the village clinic, and a park were inundated (Figs. 3, 5a, b). A shop owner claimed 100 ± 10 cm flow depth in this area (Fig. s7). Little fishes have been observed in the remaining ponds of the park and surrounding terrain (Fig. 5a, s8).

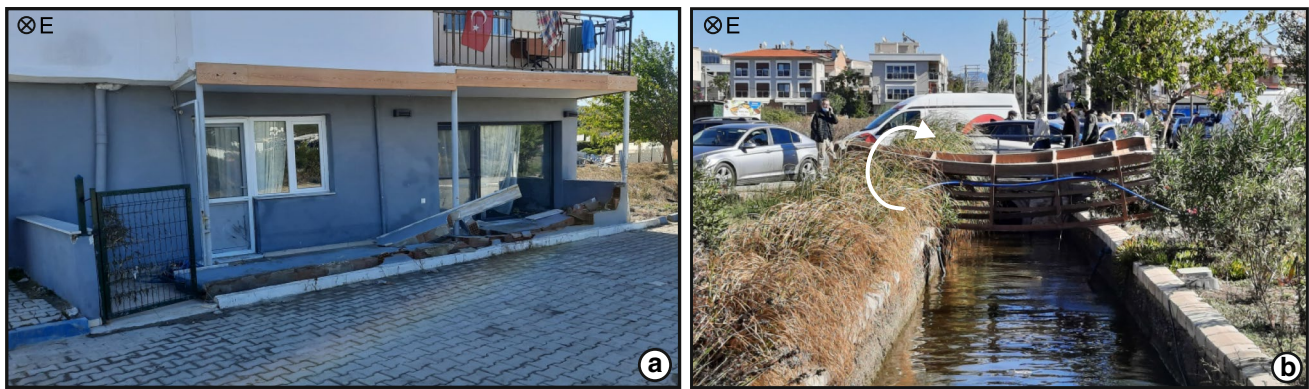
Fig. 7 **a** A 80-cm-high N–S-oriented wall facing the shore did not resist the tsunami destroyed walls. **b** A bridge on the E–W was drifted and toppled by the waves

20–30-cm-thick) received directly the tsunami and collapsed (Figs. 7, 8).
