CIVIL & ENVIRONMENTAL ENGINEERING | RESEARCH ARTICLE

Durability study of reinforced polyester composite used as pipe lining under artificial aging conditions

Parastou Kharazmi^{1*} and Folke Björk¹

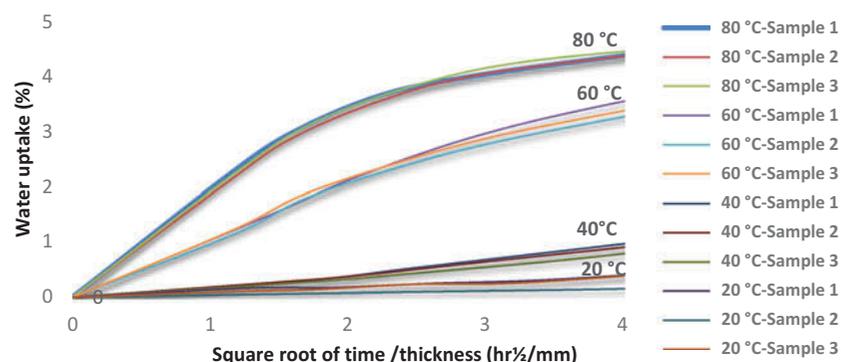
Figure 1. Water uptake (Weight change (%)) for samples immersed in deionized water during the initial 2 weeks of exposure time.

Water sorption measurements were carried out by immersing coupons of material in water at different temperatures (20°C, 40°C, 60°C and 80°C). Comparison of the initial water uptake of samples at different temperatures demonstrates that the amount and rate of water uptake increases as the exposure temperature increases; see Figure 1. One reason for the degradation of the material is the hydrolysis of the resin, which causes a reduction in the density of cross-linking and consequently more water permeability (Boinard et al., 2000). Another reason is that debonding between the resin and glass-flake particles occurs at higher temperatures, which permits more water uptake. Higher temperatures (60°C and above) can cause consistent degradation in a polymeric system based on polyester resin (Carra & Carvelli, 2015).

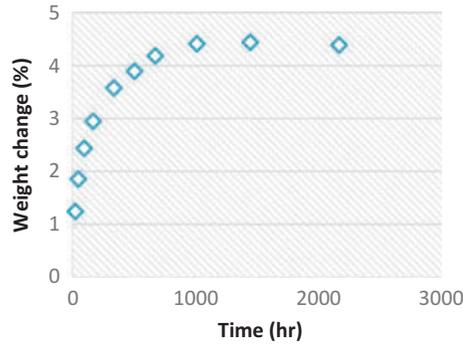
Figure 2. Water absorption plotted as weight gain ratio against time for a coupon exposed at 60°C for 2 months.

The material showed increases in weight of up to 4.44% during 2 months of immersion before eventually reaching equilibrium, as seen in Figure 2. Continued measurement up to 14 months showed a far reduced water uptake, as seen in Figure 3. Reduction of water absorption after reaching equilibrium is a sign of the material's degradation. Relatively low and slow water uptake during water immersion is a sign of the strong inner bond in the composite in general, as well as the material's increased stability against degrading factors.

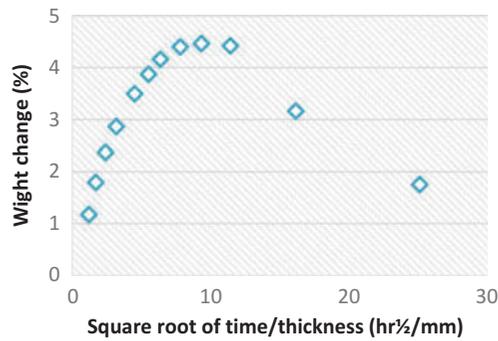
Figure 3. Water absorption curve for a coupon exposed at 60°C for 14 months.

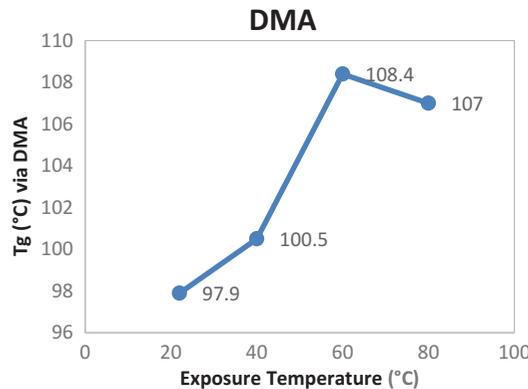
Figure 4. T_g measurements via DMA for samples after water aging for 2 months at room temperature (20 –22°C), 40°C, 60°C and 80°C and drying.

T_g measured via DMA increased as the exposure temperature increased from 20°C to 60°C, but then decreased at 80°C, as can be seen in Figure 4. Considering that the mechanism of the T_g

measurement used in DMA is a mechanical shock, a decrease in T_g at 80°C was expected, as it was observed that the material's properties generally change due to degradation at this temperature. Analysis of the DSC measurements revealed similar behavior on part of the material as was identified through the DMA measurements, with an increase in T_g (from the second heating phase in DSC) from room temperature (20°C–22°C) up to 60°C and then a decrease at 80°C, as seen in Figure 5. The different T_g values observed from the DSC and DMA measurements arose because the measurement mechanisms differ between these two instruments. It must also be noted that T_g may not be an exact point, but rather a range at which a material undergoes softening (Jotun, 2016). Since T_g highlights the temperature at which the material is stable, a decrease in T_g at 80°C observed using DSC and DMA can be a sign of deterioration of the material; this assumption is also indicated in other analyses in this study.

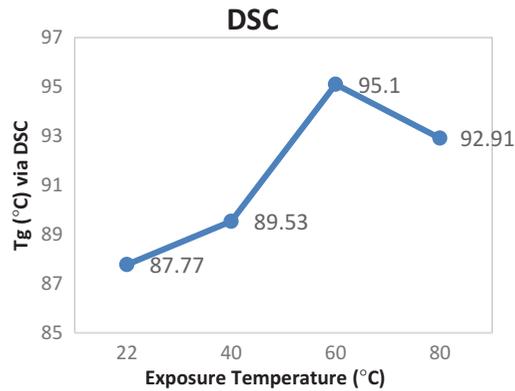
Figure 5. Tg measurements via DSC for samples after water aging at room temperature (20 –22°C), 40°C, 60°C and 80°C and drying.

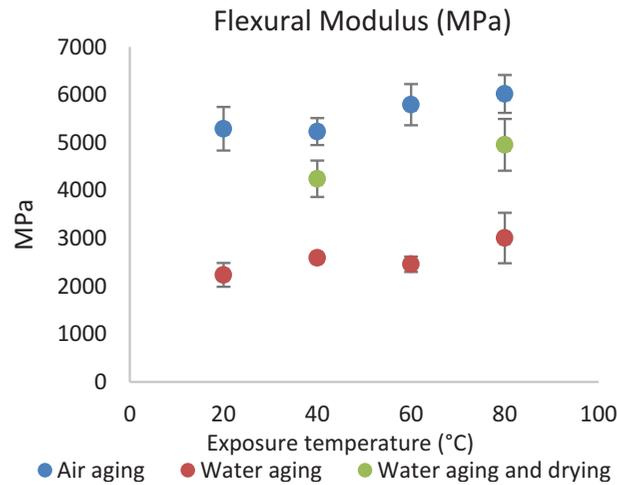
Figure 6. Flexural modulus for samples after air aging, water aging for 2 months and drying after water aging after the same exposure time.

The specimens immersed in water demonstrated a continued reduction in mechanical performance compared to materials that underwent air aging, as can be seen in Table 1–4. Mechanical testing further showed that flexural modulus and strength decreased up to 57% and 58% (Table 1–2), respectively, for material immersed in water for 2 months when compared to the material exposed to similar temperatures in air aging; however, these mechanical properties also improved significantly after the aged samples were dried as shown in Figure 6–7 . Results for elongation did not differ significantly between different conditions. Moreover, the differences between the flexural modulus and strength of the materials exposed to wet and dry conditions were higher under longer exposure times and exposure to higher temperatures. It was observed that the reduction in the flexural modulus and strength after 6 months of water aging was more significant at 80°C, where the decreases were 77% and 72%, respectively, compared with the material subjected to air aging (Table 3–4). Weakness in mechanical properties can result in failures, including cracks and other damage, in the liner film. Moreover, the observed delaminations at the interface of the applied layers (Table 5) for samples that underwent water aging at 80°C demonstrated that the material would be more brittle during mechanical testing. Debonding of the interface between the glass-flake and polymer matrix can also decrease the expected reinforcement effects of the reinforcing particles (Sterling et al., 2009). Water diffusion diminishes the majority of inner-polymer bonds, while high temperatures can cause the degradation of the polyester matrix (Carra & Carvelli, 2015); both of these leads to a reduction in mechanical properties. The service life and performance of the materials in operation are highly related to the mechanical properties. When comparing the effects of aging between artificial aging and operational conditions, it should be noted that the lining material is exposed to water only from one side during operation that the average temperature inside the sewerage systems in residential buildings is known to be 40°C, and that the average day flows in water lines are highest during a few hours in the morning and evenings and very low in the late evening (Mazraeh & Abdullahi, 2018; US Environmental Protection Agency, 2002; Wallin, 2015); this underscores the fact that the lining material will not be constantly exposed to water or high temperature outside of the lab. A less significant changes in the material’s properties after

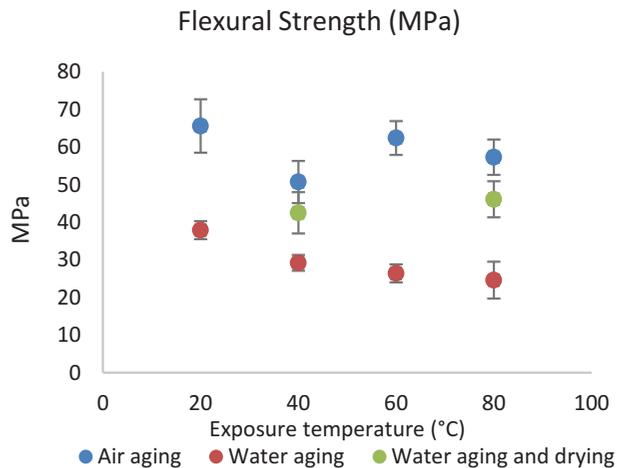
Figure 7. Flexural strength for samples after air aging, water aging for 2 months and drying after water aging after the same exposure time.

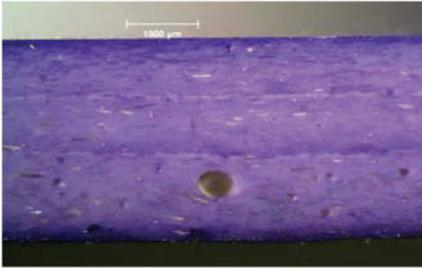
Image 1: Interface of a sample after water aging for 2 months at 20°C.

Images 1, 2 and 3 in Table 5 show the three applied layers of the lining without any major defects after aging during 2 months at 20°C, 40°C and 60°C (the air bubbles were created due to aspects of the preparation in the lab, and are not expected to occur when applied by airless spray in the field). Microdelamination and delamination, as seen in Images 4 (a) and (b) (taken from samples immersed in water at 80°C) show the defects caused by degradation-related changes to the material at the highest temperatures used in this study after 8 weeks of combined exposure.

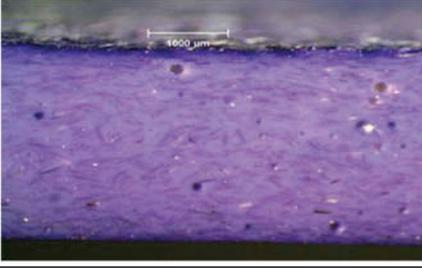
Image 2: Interface of a sample after water aging for 2 months at 40°C.

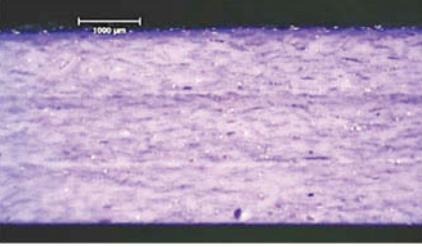
Image 3: Interface of a sample after water aging for 2 months at 60°C.

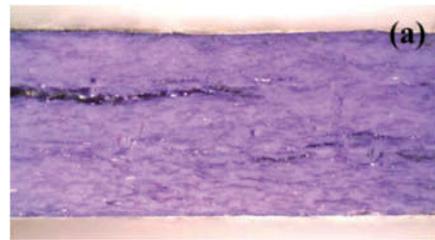
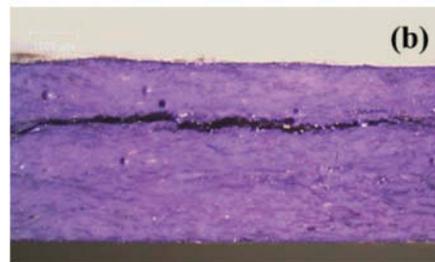
Image 4 (a) and (b): Interface of a sample after water aging for 2 months at 80°C.

However, the sample that underwent air aging at 80°C over a similar aging time did not exhibit any major defect or delamination between the lining's layers, as seen in Images 5(a) and (b). A comparison between Images 5 (a)/(b) and 6 (a)/(b) reveals that the material is more affected by water than high temperature: while delamination and deterioration were observed for the material that underwent water aging at 80°C, the material showed more stability under air-aging conditions at a similar temperature and exposure time.

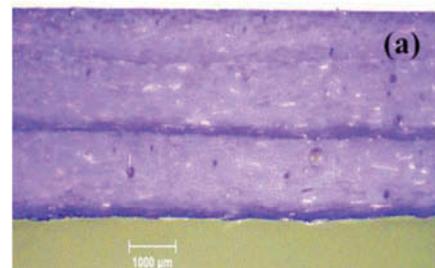
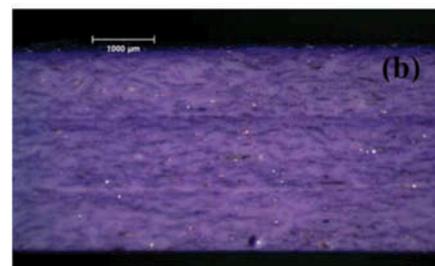
Image 5 (a) and (b): Interface of a sample after air aging for 2 months at 80°C.
