DIAGNOSTIC AND CHARACTERIZATION OF MATERIAL STATE FROM THE FIRST JEWS' ADOBE RANCH IN ALGARROBOS, CARLOS CASARES, BUENOS AIRES, ARGENTINA

LEMIT (Laboratorio de Entrenamiento Multidisciplinario para la Investigación Tecnológica) Calle 52 e/ 121 y 122 (1900), La Plata, Argentina
*Corresponding Author E-mail: paulaalfieri@gmail.com

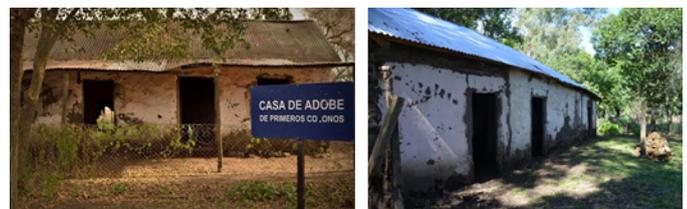
Figure 2: Adobe Ranch which was study

In the visit the first ranch build was built in Algarrobos was found. It is located in the old Colonia Mauricio, Carlos Casares, province of Buenos Aires, Argentina, Figure 2. This build is an important due to that it is a reflex of an important historical event: the Jews establishment in Argentina. This historical event was linked to the massive Jewish immigration to our country, mainly from the Russian Empire, at the end of the 19th century. Nowadays, it is inside of the Buenos Aires tourist circuit [1-11].

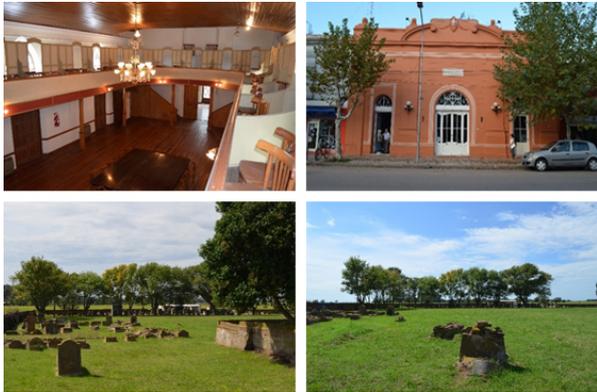
Figure 3: Synagogue and Italian Theatre, buildings of 1920 and Jewish Cemetery: views from and to the access

Nowadays the Colony became in four rural towns: Smith, Moctezuma, Mauricio Hirsch, and Algarrobos. In addition, there also is the cemetery, declared a Provincial Historic Site in 1991 for being the first Jewish cemetery in the province of Buenos Aires and the second in the country (Fig. 3).

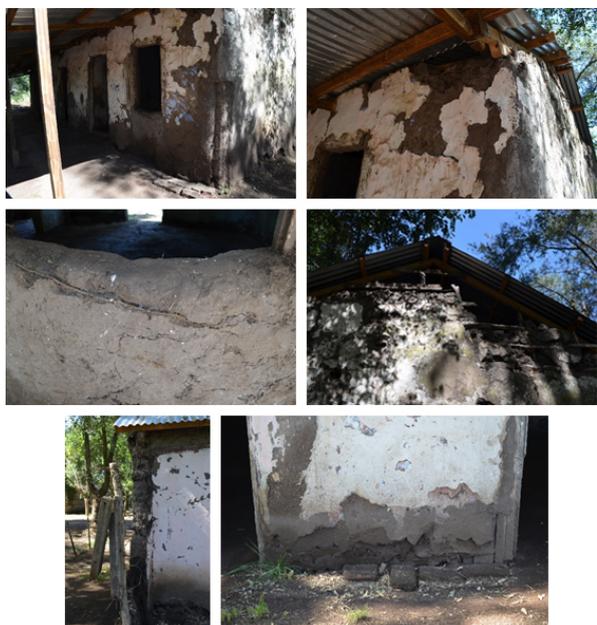
Figure 4: Construction details and materials of the Ranch

In the first instance, a visual analysis of the ranch's materials were made. It was observed that it was done on adobe, a framework of wood and structurally reinforced with rod and wire mesh on the sides. The roof is sheet metal put in the restoration made in 2014 (Fig. 4). Minimum samples of the mentioned materials were taken (adobe, wire, and nails, wood and coatings).

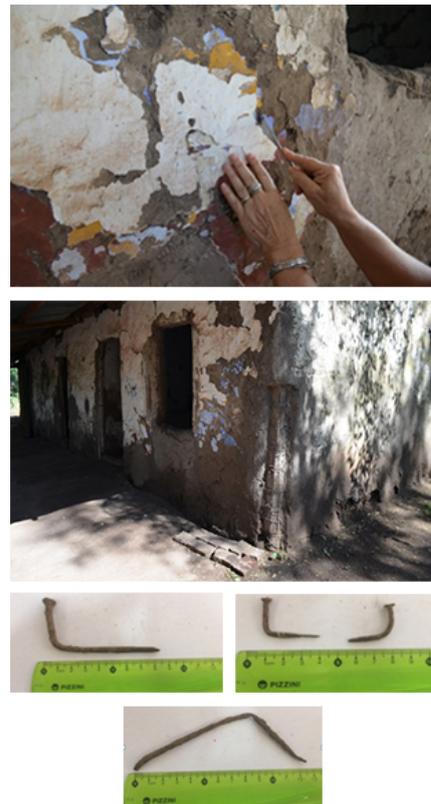
Figure 5: Wood, painting in the murals and metal elements found

Regarding the coating, minimum samples of the different layers were extracted by a superficial scraping with a spoonbill (Fig. 5). Samples were chemically analyzed by FT-IR (MATTSON Mod. GENESIS II spectrophotometer) with Attenuated Total Reflectance (ATR). The spectrograms were compared with spectrograms of Atlas "An Infrared Spectroscopy Atlas for the Coatings Industry" [33].

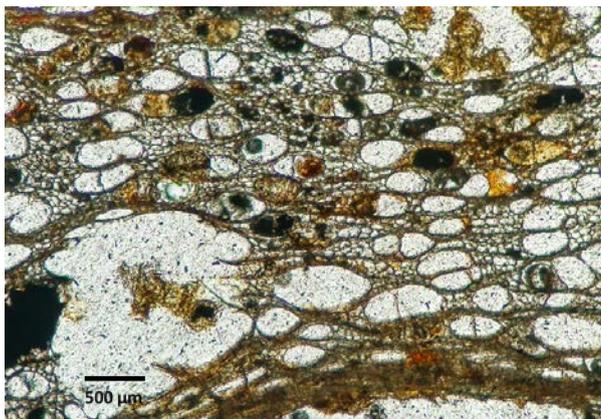
Figure 6: Biodeteriorated wood under microscope

On the other hand, wood microscopy observations were carried out. It indicated that the wood species was Quebracho Blanco (*Aspidosperma Quebracho Blanco*). This species was characteristic of the north of Argentina and it was much utilized on that period by vapour railways [30-32]. On the other hand, active biodeterioration was found, majority a patron corresponding to soft rot, Figure 6.

This allows concluding that the ranch has original materials from the time was built, as many primary materials (adobe, nail, wire, and wood) as protection (coating) in an acceptable deteriorate state. But it needs a conservation process as soon as possible due to a biodeterioration active process found.

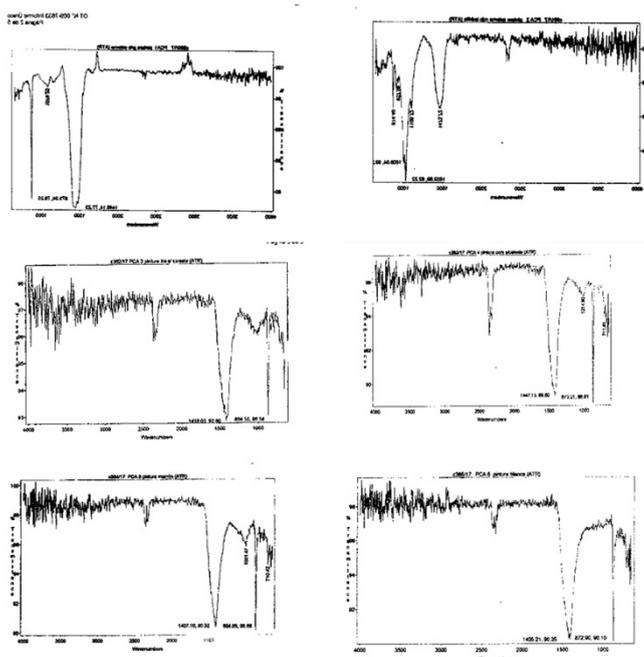
Figure 7: FTIR of coating layers

Regarding the coating layers (Fig. 7), it was observed that the compound utilized as a binder was $\text{Ca}(\text{OH})_2$ in all the layers ("lime" coatings group). CaCO_3 is designated by bands: 1426 cm^{-1} ; 875 cm^{-1} and 712 cm^{-1} [33]. This was an interesting fact meanwhile the first coating layer was based on lime, so the others continue with this binder because it wouldn't be compatible with other subsequent coatings.

Concerning coating pigments, it was observed that the most external coating (grey) had a mixture of pigments: one of black colour (BONE BLACK: $\text{Ca}(\text{PO}_4)_2/\text{CARBON}$, Spectrogram No. 839), and another one of white colour (CO_3Ca , Spectrogram N° 796) in equal proportions. With respect to the red one, it had an inorganic pigment, formed by a mixture of Iron Oxides (Fe_2O_3) and Silicates, commercially known as RAW SIENNA designated by 1620 cm^{-1} ; 1113 cm^{-1} ; 1032 cm^{-1} ; 915 cm^{-1} and 793 cm^{-1} bands, spectrogram 921 [33]. It indicated that it was a more recent coating matching with layer location.

On the other hand, the pale-blue layer linked to an inorganic pigment Sulfo Aluminum Silicate known commercially as Ultramarine Blue. The bands were 1634 cm^{-1} and 1026 cm^{-1} , spectrogram 854 [33].

The brown pigmentation of the other layer corresponded to an inorganic pigment formed by a mixture of oxides of Iron, Chrome and Zinc, commercially known as Ferro Light Brown, that was designated by 1633

cm^{-1} ; 1030 cm^{-1} ; 911 cm^{-1} ; 792 cm^{-1} and 655 cm^{-1} bands, spectrogram 864 [33].

Finally, the white layer corresponds to pure lime pigment (Calcium Carbonate, spectrogram 796 [33]).

All pigments had dated of the period of the ranch was build. So, both restoration records observed, and this FT-IR analysis allowed concluding that coating belongs to the colonist's age and not of the contemporary restoration [29].

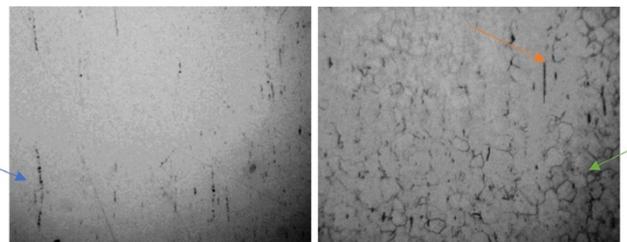
Figure 8: Metal analysis. Blue arrow indicated alumina inclusion; orange arrow, sulphur inclusion (ASTM E 45) and green arrow indicated perlite structure

Concerning to metallography study, it was carried about by metal microscopy without and with NITAL (Nitric acid between 2% in ethylic alcohol) attack, Figure 8. In figure without attack, it was observed non-metallic inclusions aligned by plastic deformation due to the manufacturing process (longitudinal view). These inclusions were determined by ASTM E45 obtained that they were if alumina.

In Figure 8 with the attack, it was also observed low perlite structure (ferrite and cementite in laminated aggregates) and sulphur non-metallic inclusions (ASTM E45). In addition, the metal microstructure observed denote that the metal found had low steel content ($< 0.10\%$).

The metal inclusions were relevant because it marks indirectly the metal age. It was due to the Siemens-Martin process (the open-hearth furnace) developed by German engineer (Carl Wilhelm Siemens) in 1865. This steel development process included an "open-hearth" furnace, which allowed to obtain elevated fusion temperature. This last allowed that the oxygen in iron oxide and other impurities were decarburized the pig iron by burning excess carbon away, forming clean steel. So, if metal was clean of inclusions it was the development from after 1865 [34].

For the aforementioned, it concluded that the wire and nails were of the late nineteenth or early twentieth-century steel, due to the degree of cleanliness of the steel, contemporary with the colonization of the area.
