# GEOENGINEERING INVESTIGATION OF AN EROSION INDUCED HIGHWAY STRUCTURAL FAILURE ALONG IFON – BENIN HIGHWAY, SOUTHWESTERN NIGERIA

Olumuyiwa Olusola Falowo\*, Adekunle Aliu

Department of Civil Engineering Technology, Faculty of Engineering Technology, Rufus Giwa Polytechnic, P.M.B 1019, Owo, Ondo State, Nigeria

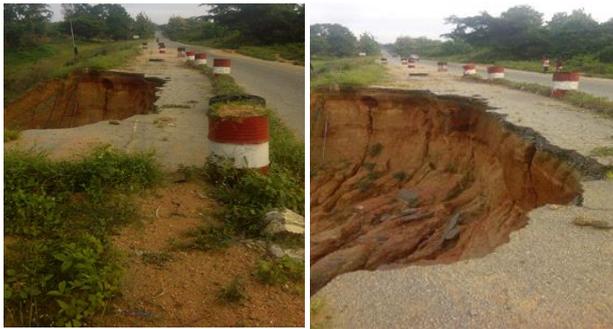
**Figure 2:** Failed Segment 1 at Ifon in Ondo State, showing (a) collapse pavement structure (b) eroded foundation soil and destroyed buried cables and utilities by erosion

The studied highway cut across two States of Nigeria, namely Ondo State and Edo State in southwestern and south-south regions respectively (Fig. 1). Two major segments of the highway had failed sometimes in year 2016 (Figs. 2 and 3) without due rehabilitation/reconstruction. The first segment is located in Ifon (Ose Local Government) while the second segment is in Owan area of Edo State (Fig. 3). The pavement failures at both failed segments manifested as local subsidence, potholes, depressions of diverse dimensions, disintegration, blow-up, sub-grade intrusion, surface stripping, cracking and sliding. The study area is underlain by sedimentary Benin and Ewekoro Formation which has been described severally in Akujieze (2004), Akujieze and Oteze (2006). Drifts and soil-cover characterized the formation over lateritic reddish brown clayey sand capping highly porous friable white sands, pebbly sands and clay stringers with basal indurated ferruginous pebbly - coarse grained sandstone. The Benin Formation is poorly bedded and occasionally cross-bedded at greater depths (Ntom, 2001; Omatsola and Adegoke, 1981). However the local geology of the studied sites are shale/mudstone. Sedimentary rocks differ according to their sedimentary environments. The mechanical properties of the sedimentary strata depend on the sediment facies characteristics. Shale and mudstone are soft rock whose strength in terms of cohesion are usually reduced due to high (pore) water pressure, occasion by erosion/flooding.

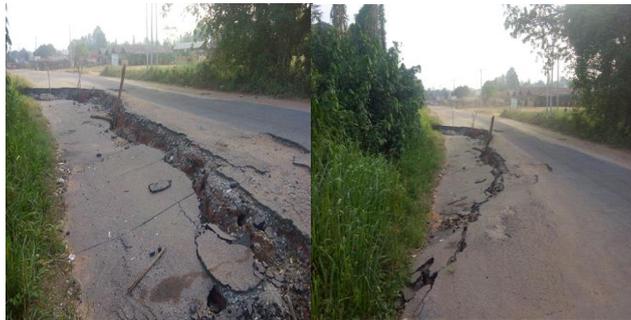
**Figure 3:** Collapsed Pavement Structure along Owan – Uyere Highway, representing Failed Segment 2
