# Comparative Evaluation of Dentinal Microcrack Incidence After Root Canal Preparation by BioRaCe and Edge Taper Platinum

**J Res Dent Maxillofac Sci 2020;5(4):7-12 DOI: 10.29252/jrdms.5.4.7**

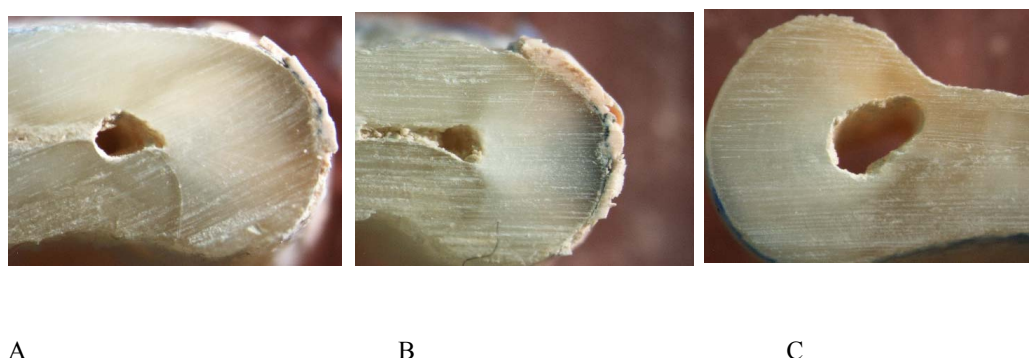
**Figure 1.** Samples instrumented with rotary systems under a stereomicroscope at  $\times 20$  magnification; A) Presence of a complete crack; B) Presence of an incomplete crack; C) Absence of crack

Irrigation was performed using 2.5% NaOCl (Kimia Tehran Acid, Tehran, Iran). Apical patency was confirmed using a #10 K-file after each file use. All roots were cut horizontally at three levels (3, 6, and 9 mm) from the apex with a diamond disc (D&Z, Wellington, New Zealand) under constant water cooling. The sections were viewed under a stereomicroscope (SZX9, Olympus, Tokyo, Japan) at  $\times 20$  magnification (Figure 1). Digital images were captured with a digital camera (Nikon, SMZ1000, Japan) attached to the stereomicroscope. Each sample was inspected by two experienced operators for the presence of dentinal microcracks.

In this study, cracks were divided into complete and incomplete types, similar to the study by Bürklein et al.<sup>(25)</sup>
