An experimental study of acoustic emission methodology for in service condition monitoring of wind turbine blades

A laboratory study is reported regarding fatigue damage growth monitoring in a complete 45.7 m long wind turbine blade typically designed for a 2 MW generator. The main purpose of this study was to investigate the feasibility of in-service monitoring of the structural health of blades by acoustic emission (AE). Cyclic loading by compact resonant masses was performed to accurately simulate in-service load conditions and 187 kcs of fatigue were performed over periods which totalled 21 days, during which AE monitoring was performed with a 4 sensor array. Before the final 8 days of fatigue testing a simulated rectangular defect of dimensions 1 m × 0.05 m × 0.01 m was introduced into the blade material. The growth of fatigue damage from this source defect was successfully detected from AE monitoring. The AE signals were correlated with the growth of delamination up to 0.3 m in length and channel cracking in the final two days of fatigue testing. A high detection threshold of 40 dB was employed to suppress AE noise generated by the fatigue loading, which was a realistic simu

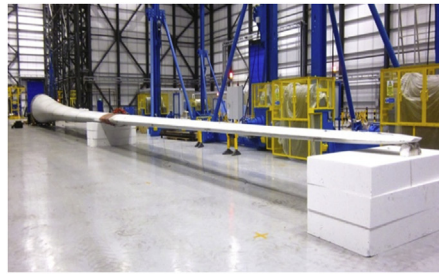
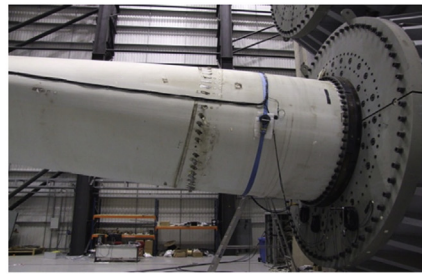
Fig. 1. Wind turbine blade under test.

(a) Full length view of the blade prior to installation

(b) Close up view of the blade root on the test stand

The blade being tested was a glass-reinforced plastic composite blade, measuring circa 45.7 m in length, with 2 internal supporting webs running the entire length of the blade. An external view of the entire blade length is shown in Fig. 1, prior to the tests. The blade was installed on the test stand with the suction side of the blade facing the test lab floor as shown in Fig. 1 (b).

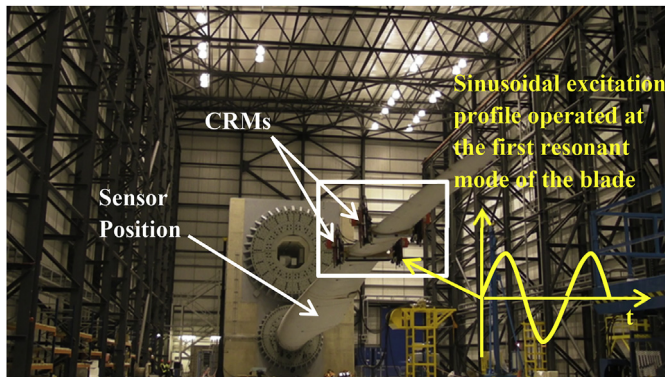
Fig. 2. Compact resonant masses installed on the wind turbine blade.

Multiple pairs of Compact Resonant Masses (CRMs) were used to excite vibrations in the blade, which served both to produce the conditions under which crack defects generate AE and to simulate the natural vibrations that the blade would experience when in service. These masses were supported on steel saddles at initial distances of 30 m and 35 m measured from the root of the blade, as shown in Fig. 2. The saddles clamp the blade using wooden profiles cut to the shape of the blade using CAD data. The stroke and frequency of the moving mass of the CRMs could be adjusted during the course of the experiment to suit specific root bending moments. A MOOG Hydraulic Test Controller and bespoke software was used to apply a sinusoidal excitation profile which was operated at the first resonant mode of the blade, such that the hydraulic power consumed by the actuators is almost entirely coupled into the blade. A combination of actuator position and mass, and strain ranges were used in the control of the test.

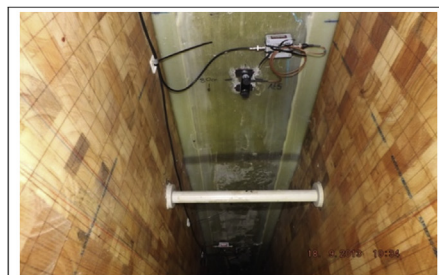
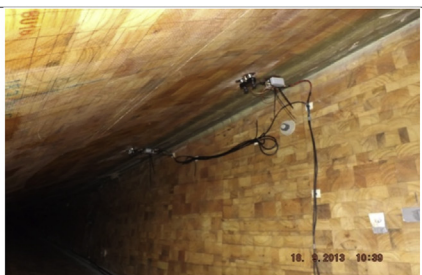
Fig. 3. AE sensors mounted internally on the blade.

(a) AE sensors mounted between the two webs

(b) AE sensors mounted the trailing edge side

The wind turbine blade under test is large in size and wind turbine designers often employ an increased thickness section of GRP to increase strength. This creates challenges for AE monitoring in wave propagation because of wave attenuation. Attenuation will reduce the measured signal amplitude and this can cause lack of damage observability. By analysing the two primary wave modes which exist in the wind turbine blade, the extensional and flexural wave modes, Van Dam et al. [23] determined the dispersion curves, their results showing that the sensor spacing should be limited to a maximum value of 1 m. In this study an attenuation test using pencil lead break was performed initially on the surface of the blade, in order to determine the required number and spacing of the sensors. Four sensors were used and the locations of the sensors are shown in Fig. 3 and Table 1.

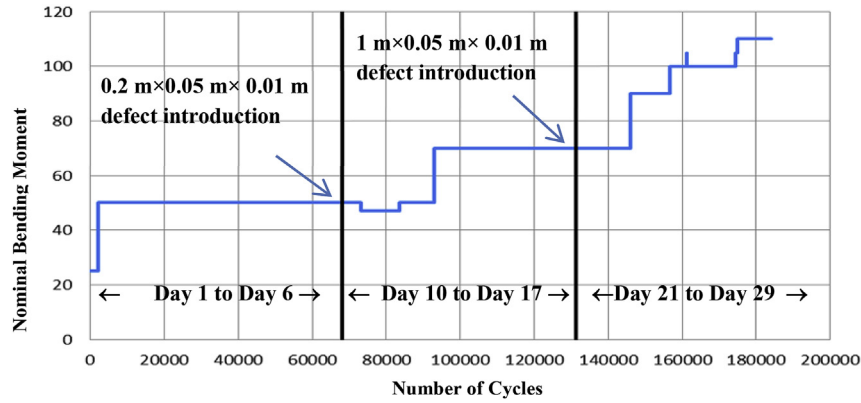
Fig. 4. Nominal root bending moment of loading used versus number of cycles.

The effective loads applied to the blade were increased in stages during the fatigue test in order to promote the crack propagation. The cyclic loading test was performed in three stages over 6 weeks and details are presented in Table 2 and Fig. 4. A nominal root bending moment for fatigue loading was selected based on prior experience blades with blades of similar length.

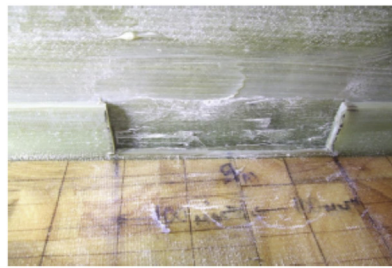
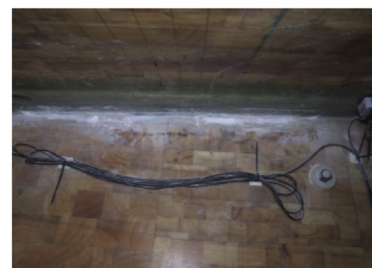
Fig. 5. Induced defect.

(a) Day 7- Day 9: Defect induced into the internal surface of the blade at a blade-web boundary

(b) Day 18- Day 20: Defect extended to 1 m x 0.05 m x 0.01 m

After roughly 67,000 fatigue cycles (Day 1–Day 6) at 50% nominal load, a 0.2 m (along the boundary) \times 0.05 m (perpendicular to the boundary) \times 0.01 m (blade thickness direction) crack was made in one of the shear webs at 30 m from the blade tip (Fig. 5(a)). The AE sensors were located in this region internally. Testing continued for a further 65,000 cycles (Day 10–Day 17) at 50% and 70% load without any noticeable changes in the blade structure. It was then decided to increase the size of length of the induced defect to 1 m \times 0.05 m \times 0.01 m (Fig. 5(b)) in order to increase the likelihood of further damage propagation for the purpose of evaluating the proposed AE damage monitoring technique. However, further testing at 70% load and then 80% yielded no noticeable change in the blade structure. So a decision was made to further increase the test load to 100% and subsequently this was increased further to 115% on the final day of testing.

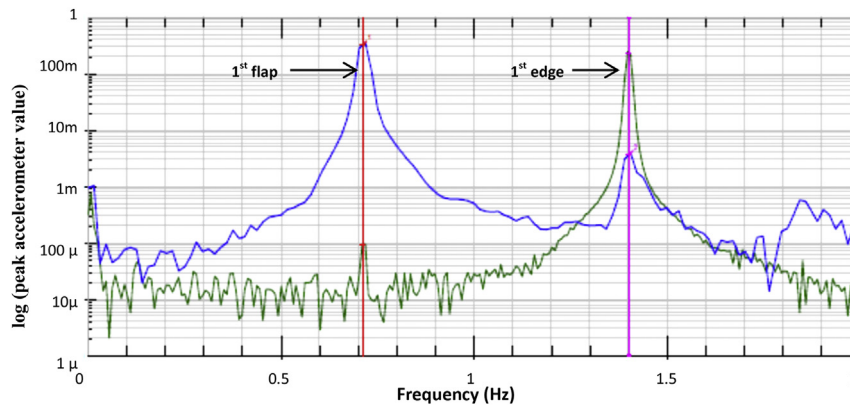
Fig. 6. Frequency spectrum of the blade without any added mass from the fatigue equipment.

Fig. 6 shows the frequency spectrum associated with the first flap and edge vibration frequency modes obtained with no added mass from fatigue loading equipment. As explained in Section 2 the spectra had been obtained by the detection with accelerometers of manually excited vibrations. Fig. 7 clearly show the decrease in the first modal frequencies in both flap and edge directions with the addition of the static mass of the fatigue equipment. The first flap frequency decreases from 0.72 Hz to 0.56 Hz. Similarly the first edge frequency drops from 1.4 Hz to 1.08 Hz. Although this does not identify a change in blade structural integrity, the addition of mass for testing could be argued to be similar to the addition of mass in

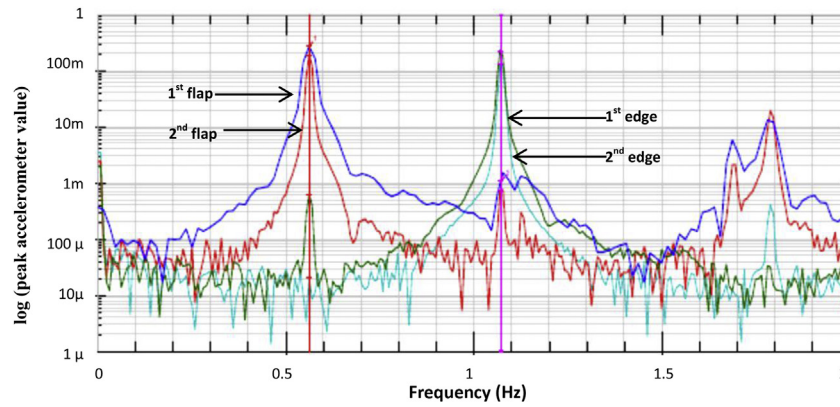
Fig. 7. Frequency spectrum shifts caused by added static mass.

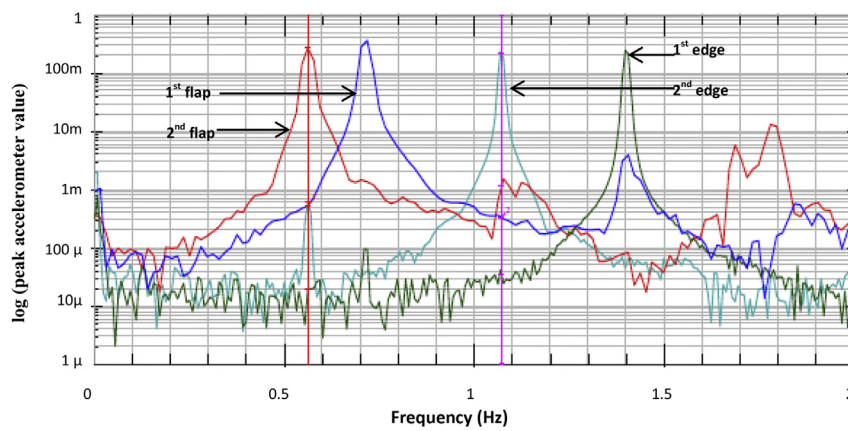
Fig. 8. Frequency spectrums after introduction of a $0.2 \text{ m} \times 0.05 \text{ m} \times 0.01 \text{ m}$ on the blade.

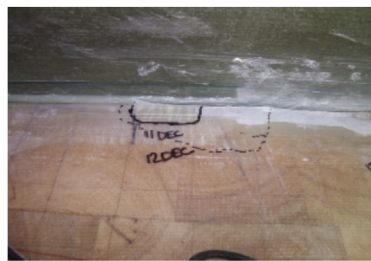
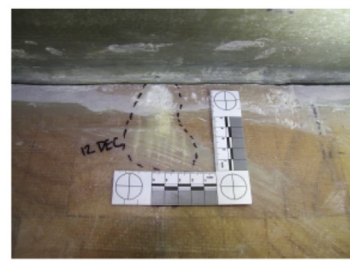
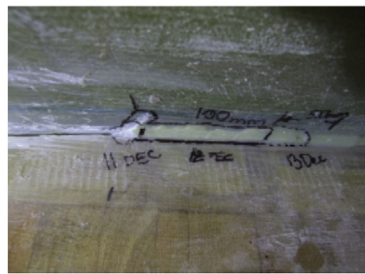
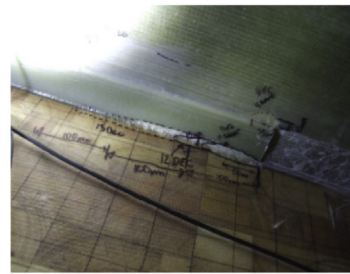
Fig. 9. Induced defect and defect growth.

(a) Day 27: The start of damage propagation

(b) Day 28: Further channel cracking arising on

(c) Day 29: Delamination reached 0.15 m

(d) Further growth in the delamination to 0.3 m

Typical defect photographs taken during visual inspection are shown in Fig. 9. The testing focussed on the induced internal cracks, which was considered to have a great effect on the blade structural integrity. No significant damage growth occurred until the final three days (Day 27–Day 29) of testing when delamination and channel cracking initiation and growth were observed on the last day of testing. Fig. 9 (a–d) shows some of the typical damage initiation and growths in the blade structure that arose in this period. This damage was mostly delamination and channel cracking, but also slight crack propagation which was noticed at the edge of the manually induced cut in the shear web. It will be shown Sections 4 and 5 that these damage growths correlated well with AE events arising in the same period.

The results of the visual inspection for damage presented in Fig. 9 (a–d) will be used to interpret the AE results in Fig. 12 (Section 4.3). The following argument quantifies the advantage of time correlating burst signals from a number of sensors: It is possible that burst signals above thresholds can arise from large deviations (i.e. amounting to several standard deviations) above the threshold in the AE noise continuum, thus carrying the danger of a false signal. Noise is the unwanted energy that may enter the sensor through the antenna or it can be generated within the sensor. Depending on the noise analysis approach in Section 4.3.1, the threshold of 45 dB results in a probability of false alarm 7.9%. The probability that the signal will be detected is defined as probability of detection (POD),

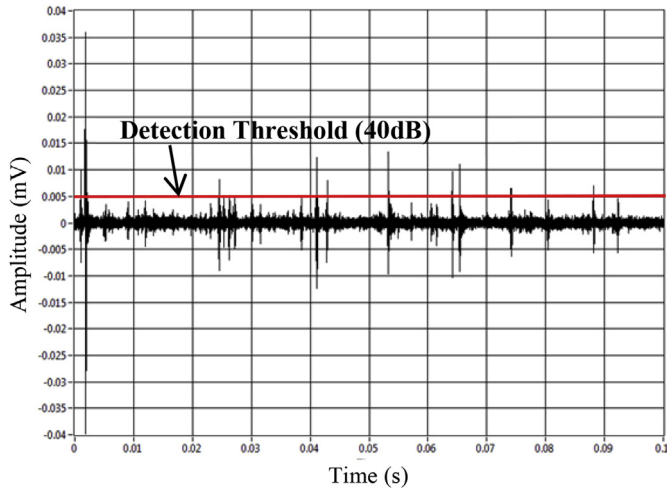
Fig. 10. A typical AE signal acquired during fatigue tests with the threshold detection level set at 40 dB.

AE monitoring was carried out throughout all fatigue tests. Variations and vibrations in the drive chain from the gear teeth and tower caused by wind impact can couple into the blades because of the long wavelengths involved. The steady wind impact will generate standing waves which will be largely time coherent but variable with the wind speeds; particularly gusts will generate time random components in the standing waves. These sources thus constitute noise which can be both random and coherent, sometimes exceeding by far the crack signals. From the viewpoint of monitoring the progress of damaged mechanisms in blades all of these sources increase the complexity of robust detection. The detection threshold for the recorded events was set at 40 dB to largely eliminate unwanted noise signals; this value was obtained through the pencil lead break testing and was used in similar experiments [27]. In this experiment, the signals were saved for 0.1 s once triggered, an example of which is shown in Fig. 10.

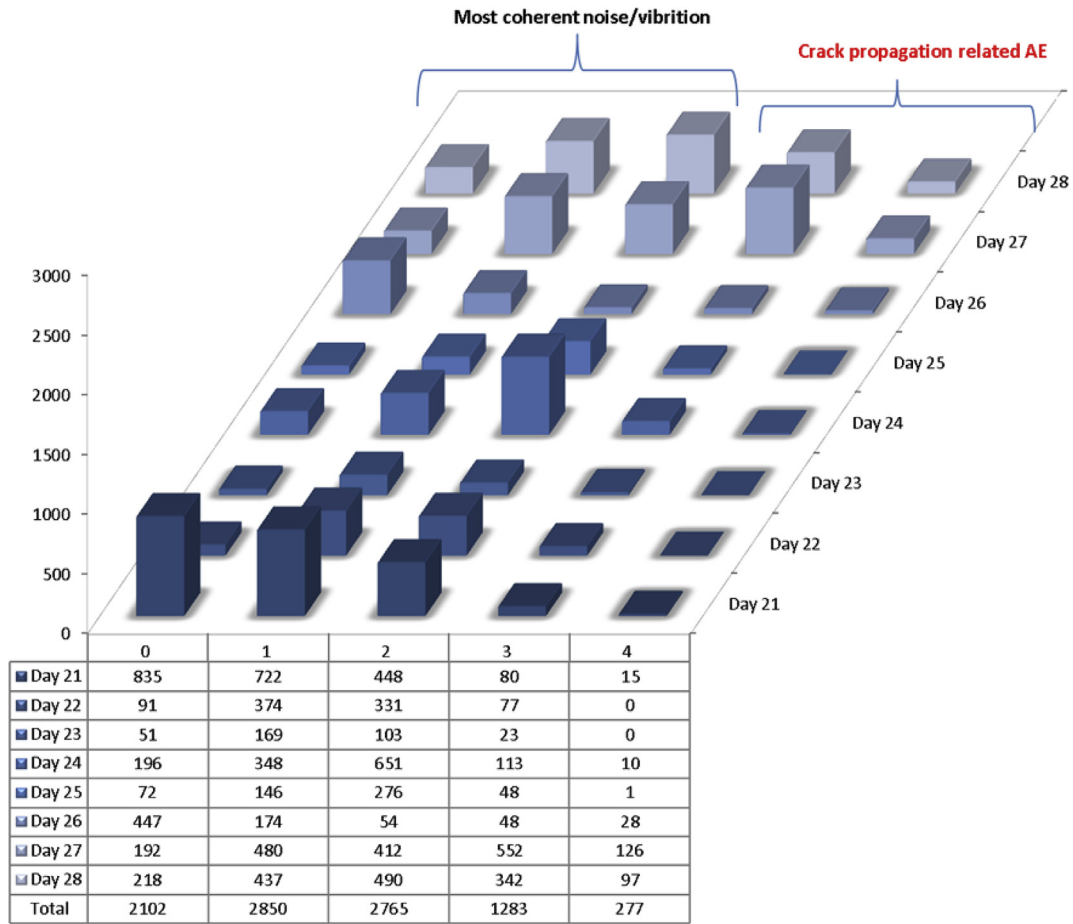
Fig. 11. Number of files in which bursts occurred in none, one, two, three or four sensors.

An analysis was conducted to identify the number of files that occurred in each situation and the results are shown in the convenient form of a 3 dimensional histogram (Fig. 11).

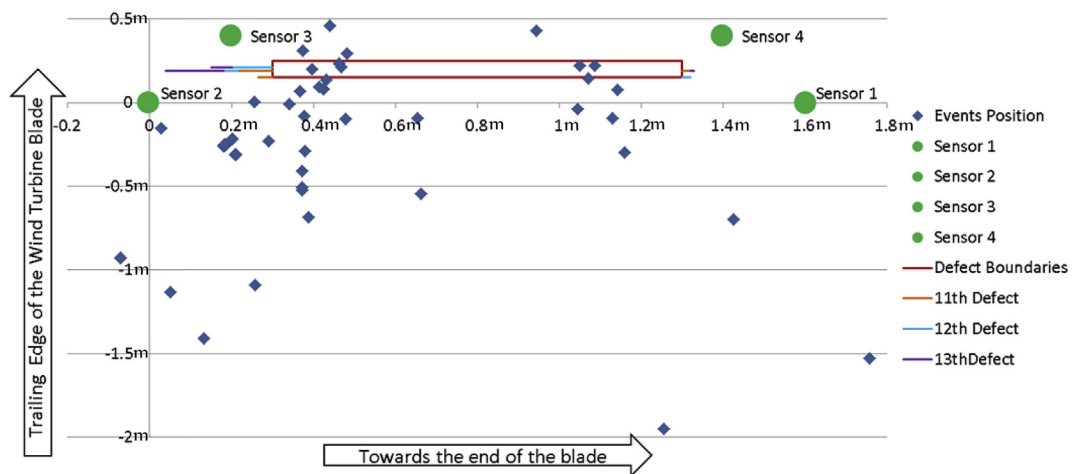
Fig. 12. Locations of AE event sources obtained by triangulation of data from four sensors situated as indicated.

From inspection of Fig. 12 (Section 4.3.2) it can be seen that the

AE event locations computed by triangulation are clustered round $1 \text{ m} \times 0.05 \text{ m} \times 0.01 \text{ m}$ void defect providing evidence of the growth of damage originating from this source. Quantitatively the 29 AE events locations have an average perpendicular distance from the defect axis of $0.6 \text{ m} \pm 0.45 \text{ m}$. 18 of 29 AE events (62%) have an average distance of 0.24 m from this axis. In taking an AE pulse arrival time at any sensor as the first threshold crossing the most

Therefore it can be said that, within the experimental error in the AE threshold detection system, the $1\text{ m} \times 0.05\text{ m} \times 0.01\text{ m}$ defect has been identified by AE monitoring as the source of growing fatigue damage.
