Interior Duct System Design, Construction, and Performance

Field Study of Interior Duct System Design, Construction and Performance

Duct Chases and Air Handler Closets

Final Report
FSEC-CR-1256-01

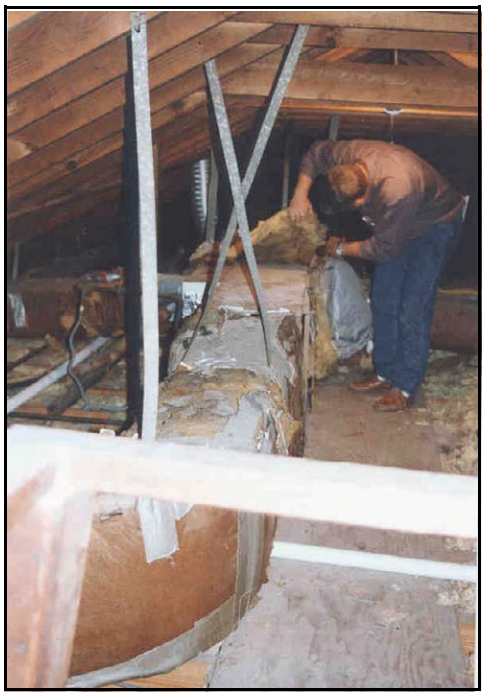
Figure 3 *Ducts and air handlers in unconditioned spaces where supply leakage can create conditions ideal for condensation, mold growth, and building decay.*

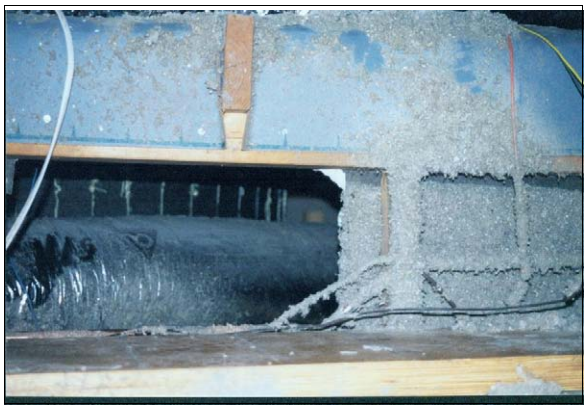
Figure 11 *Bentwood Custom Homes*

Typical fur up in the attic
Left: Compromise of both the thermal barrier and the air barrier. Insulation has blown or fallen away from sides and top. Part the chase side was removed for plumbing installation.
Right: Well sealed air barrier and continuous thermal barrier. Spray foam provides both despite wiring penetrations into the chase.
