RDI Development: Wisdom Way Solar Village, Greenfield, Massachusetts Field Test Report

X. Fang
National Renewable Energy Laboratory

E. Hancock
Mountain Energy Partnership

Technical Report
NREL/TP-550-45865
May 2009

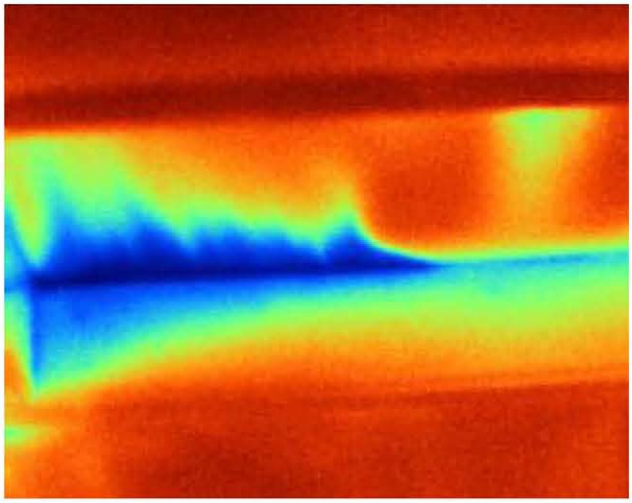
Figure 12. Attic access door during blower door test

Figure 12 through Figure 16 are the IR pictures taken during the walkthrough during the blower door test to help detect major leakage areas. Leakages were detected at the attic access door, the first-floor door leading to the basement, and the bathroom exhaust fans. There was also some leakage through walls and window cracks and electrical outlets (see Figure 13 and Figure 16).

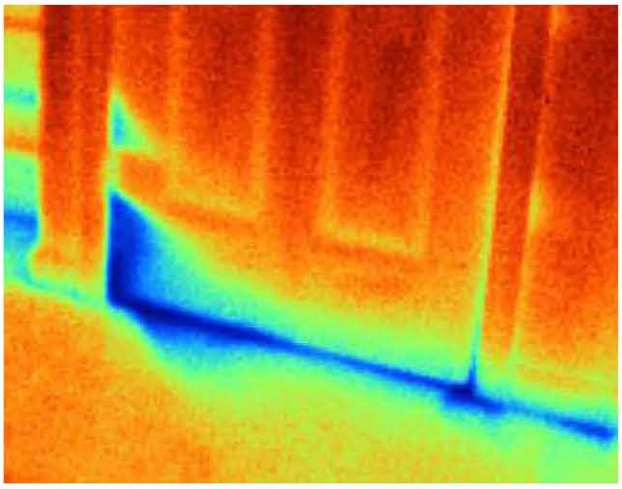
Figure 15. Basement door during blower door test

The basement was not dosed or heated during the tracer gas tests. The first-floor door to the basement was closed but not taped. The door is designed with a spring-latch mechanism that minimizes the door undercut gap when the door closed. Figure 15 shows some leakage through the basement door gap during the blower door test. This may introduce some error into our analysis. For now, this is not counted.

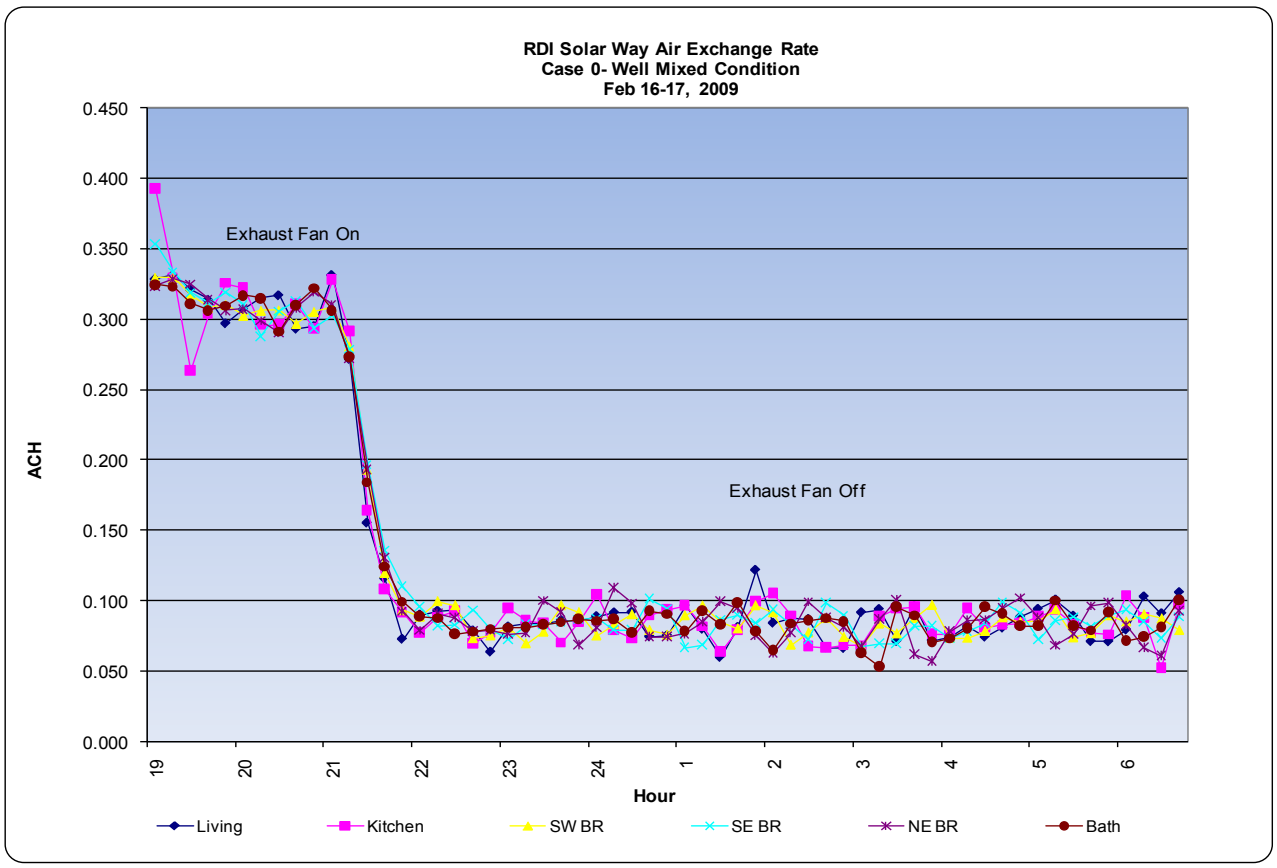
Figure 21. Air exchange rate (case 0)

The six sampling points (Figure 21) showed very close air exchange rates with and without the exhaust fan running. The combined ventilation rate with the exhaust fan running averages 0.32 ACH (64 cfm). The natural infiltration rate averages 0.075 ACH (14 cfm) without the central exhaust fan running. This natural infiltration ACH matches very well with the blower door test results of 0.07 ACH year average Estimated Natural Infiltration Rate (ENIR). This is probably due to the mild wind conditions throughout the Case 0 test period.

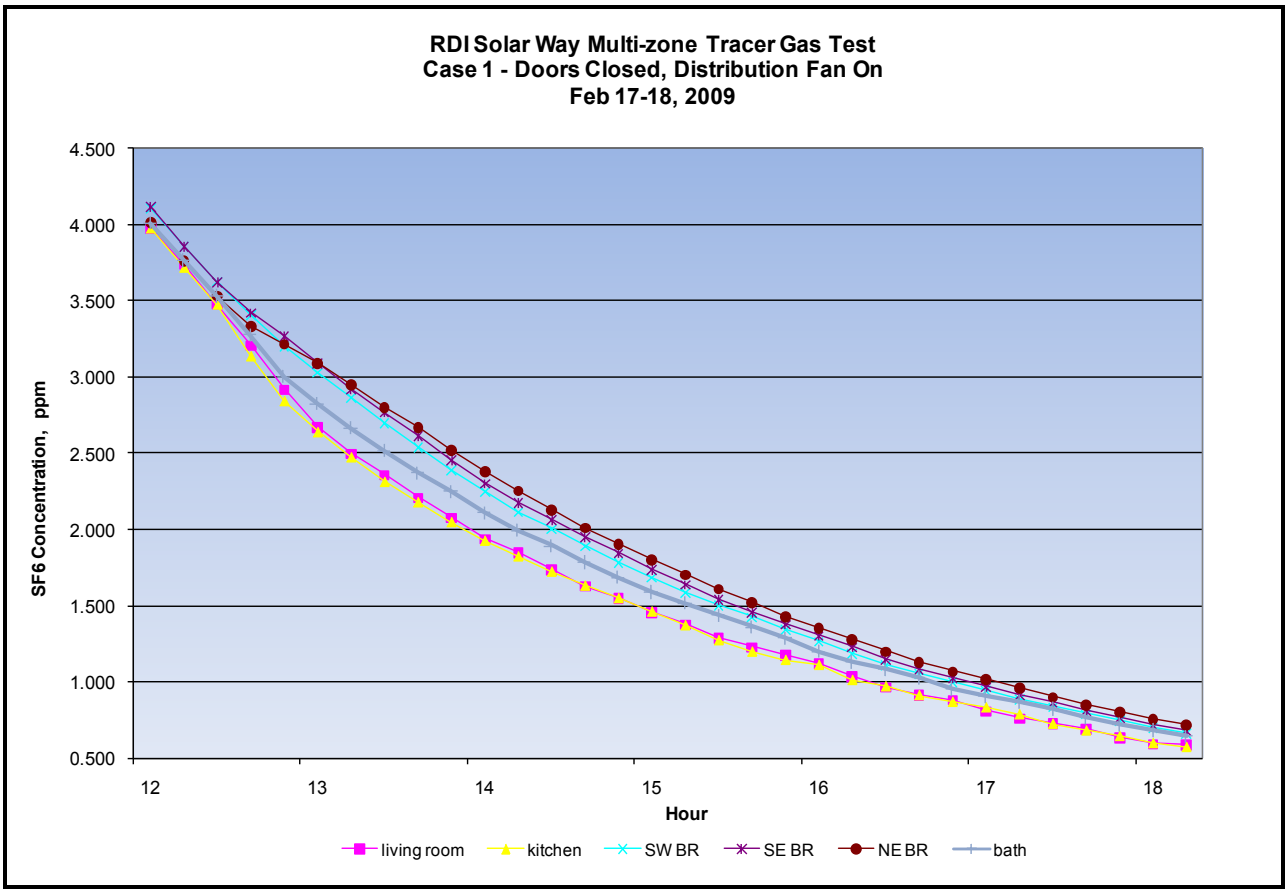
Figure 22. Concentration decay plot (case 1)

Figure 22 is an example of an enlarged plot of concentration decay of tracer gas for the first six hours of the test period. In all cases, test conditions were sufficiently steady to use the age-of-air method. The first-floor tracer gas concentration decayed faster than that of the second-floor rooms. In the second-floor main bathroom, where the outside air escaped last, the concentration decay rate stayed in the middle range because the exhaust fan kept the air flow rate in the room high.

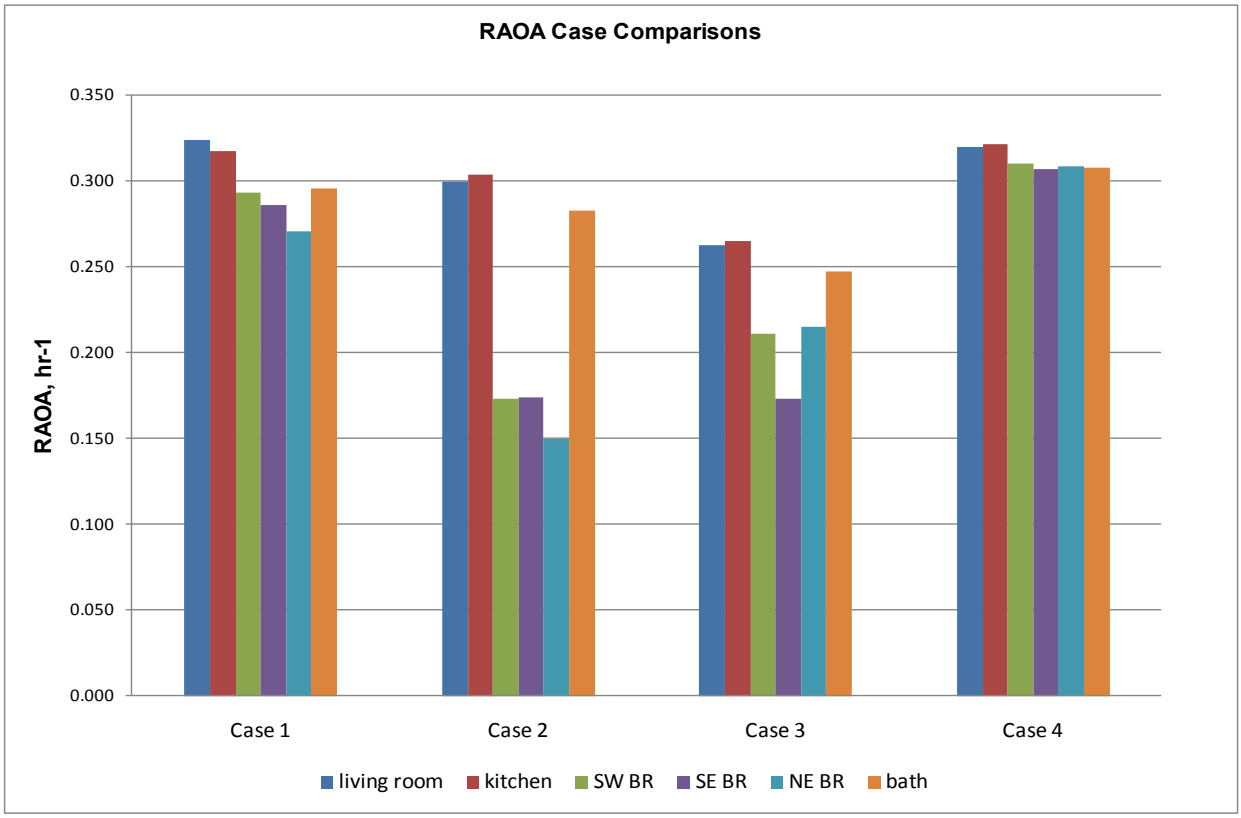
Figure 23. Tracer gas test summary (RAoA)

- A distribution/transfer fan effectively distributes outdoor air into second-floor bedrooms. Without this fan, the second-floor bedroom sampling points showed much lower RAoA (the air stays longer in the bedrooms). With the fan, the sampling points RAoA stayed close.
- Occupants will be encouraged to leave unoccupied second-floor bedroom doors open to help distribute outside air by natural stack buoyancy effect.
- One square-inch openings through the window cracks (Figure 20) in each bedroom increased outside air distribution in second-floor bedrooms. But the openings brought in unwanted natural ventilation that suppressed the outside air flow from the first floor to upstairs. This decreased the first-floor RAoA (first-floor outside air took longer to escape). The overall effect is undesirable, so this practice is not recommended.

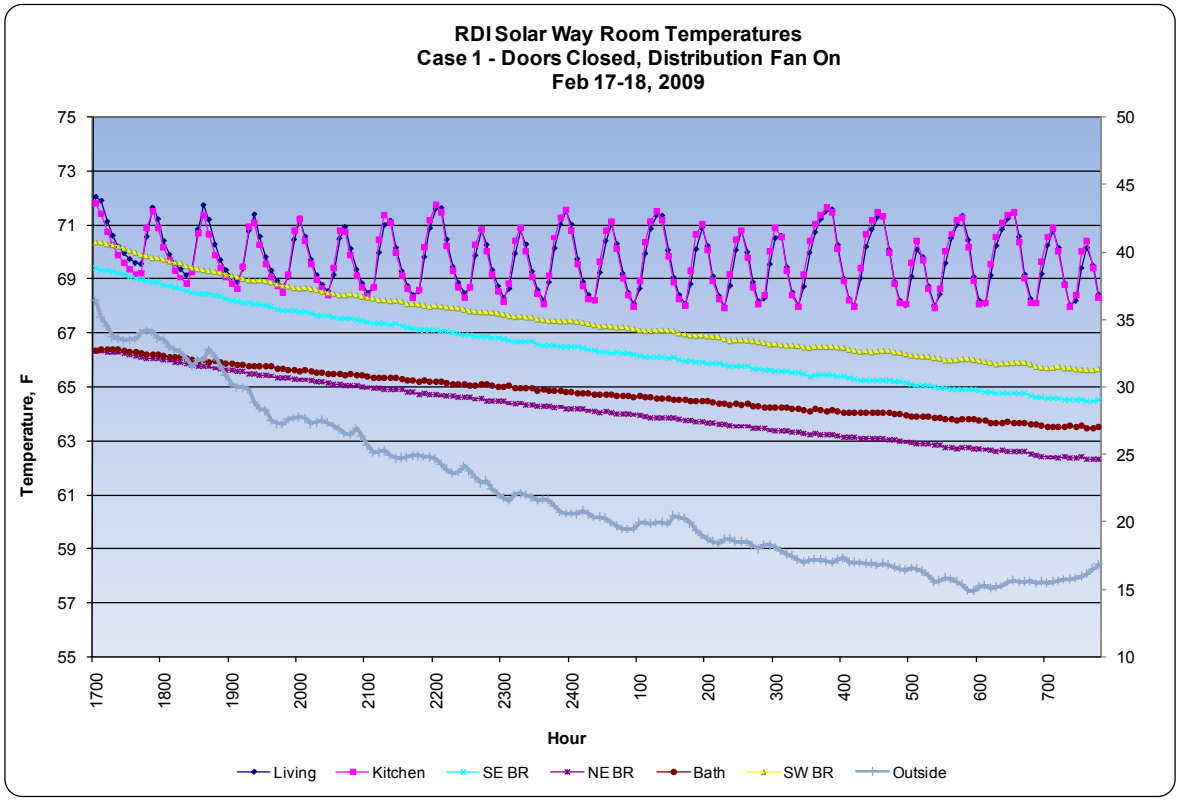
Figure 25. Temperature distribution overnight plot (Case 1)

- Leaving the bedroom doors open (Case 4) helps to reduce the room-to-room temperature difference.
- Operating the distribution/transfer fan (Cases 1 and 4 [Figure 27 and Figure 28]) helps to reduce room-to-room temperature difference. When Case 1 experienced the coldest outside air conditions, the upstairs bedrooms remained near 60°F.

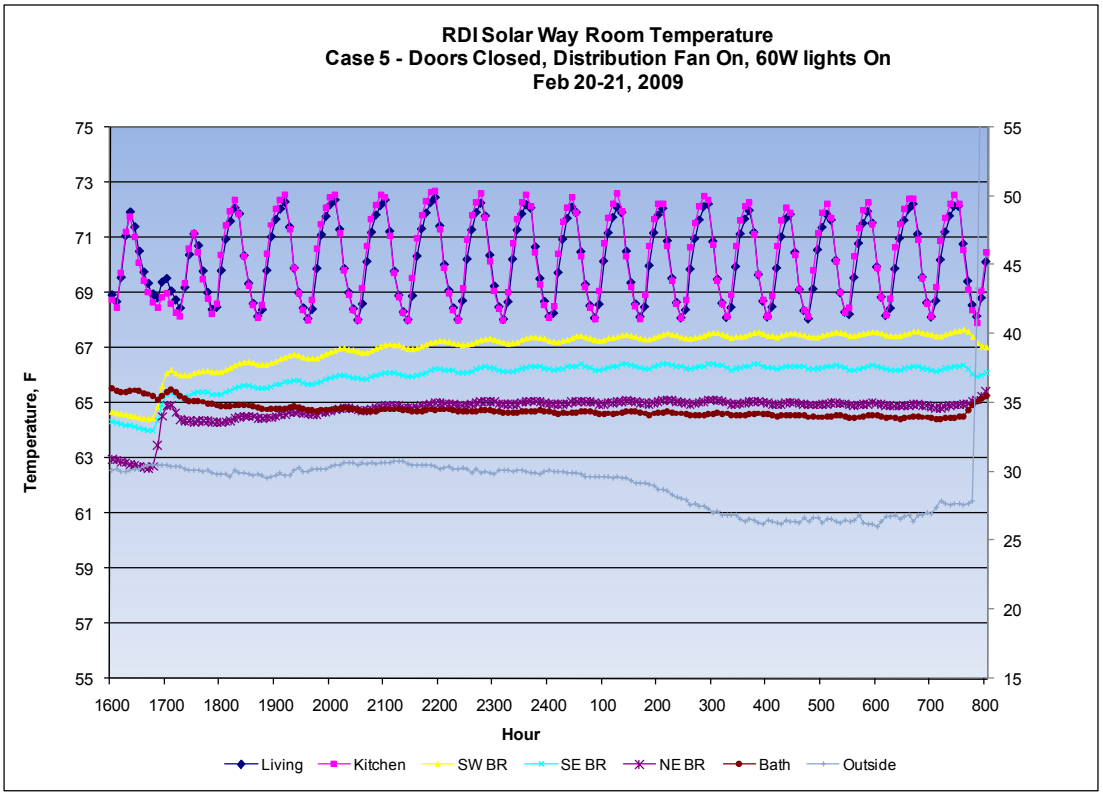
Figure 28. Temperature distribution overnight plot (Case 5)

Case 5 was created as the last test metric for temperature distribution. Case 5 is the same as Case 1, except a 60-W (205 Btu·h, which corresponds to about 0.85 Met) light was installed in each bedroom to simulate heat gains from a human body. This number is slightly higher than the sleeping metabolic rate (0.7 Met), so the room temperature could be slightly lower.

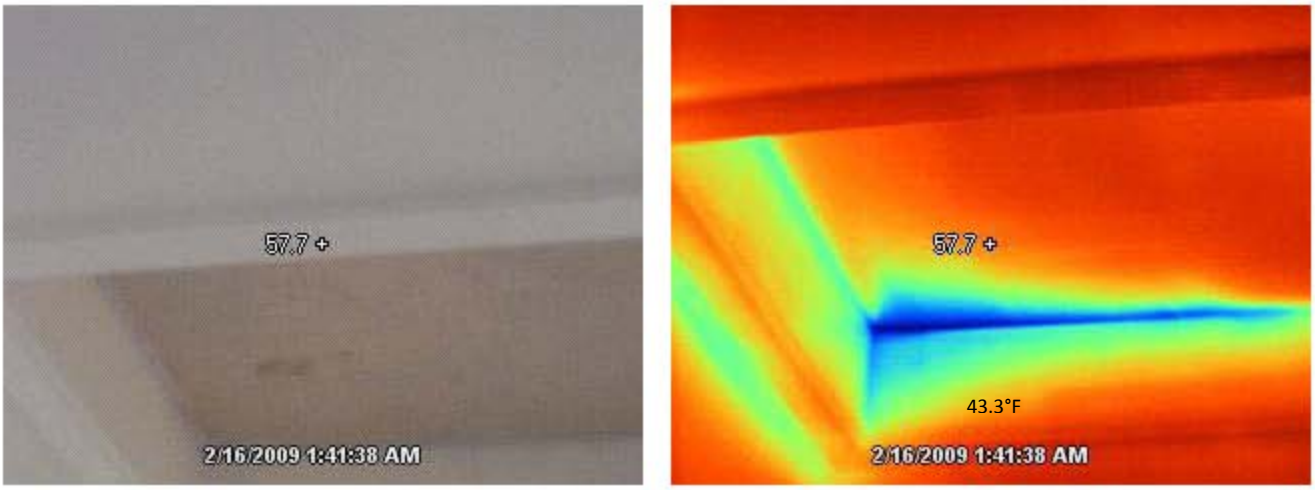
Figure 33. Attic access door thermal imaging

Figure 29 through Figure 36 show thermal imaging for various places in the building. Figure 33 shows cold spots at the attic access door edge under normal operating conditions when warm air escaped. A better air seal gasket is recommended for the attic access door.

We also recommend a better air seal gasket on the attic access door; more hot water draw tests when solar water heating systems are brought online, and long-term diagnostic monitoring of the solar water heating systems.

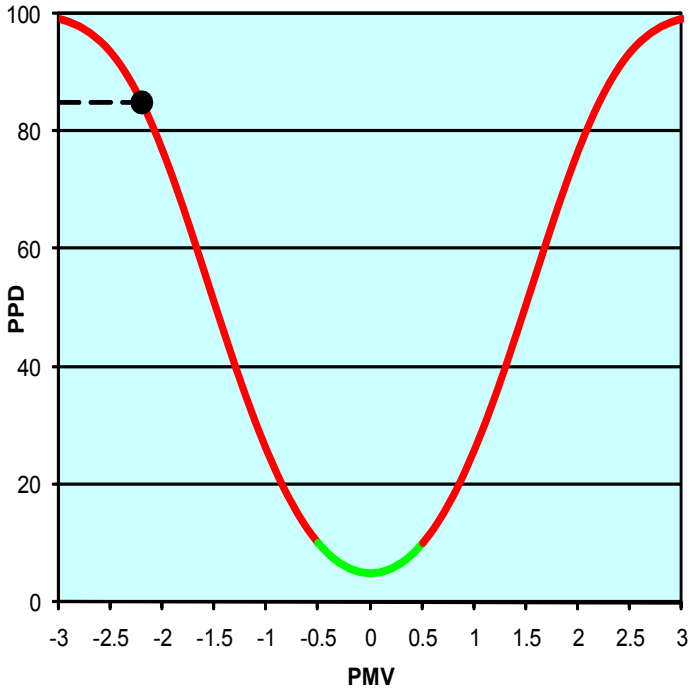
Figure 37. Northeast bedroom comfort estimate (occupant sleeping)

The northeast bedroom was selected for calculation. The outdoor air temperature used is 16°F with indoor air temperature at 62°F, derived from test conditions. A relatively simple room mean radiant temperature calculation was performed counting all wall, ceiling, floor, and window surfaces. On cold winter nights, the room occupant will feel cool (PMV –2.2) with a clothing level of 2 when the room temperature is kept at 62°F, estimating mean radiant temperature of 61.5°F. For a highly insulated envelope, the room's mean radiant temperature is much closer to room temperature than a conventional house envelope (see Figure 37 and Figure 38).

According to ASHRAE standard 55, upstairs bedrooms, particularly the northeast bedroom, will feel cool during chilly winter days or nights.

Under extreme winter conditions, homeowners are likely to increase the space temperature set point to 72°–73°F to heat the upstairs. We also recommend that homeowners leave the room doors open during the daytime when the unit is not occupied.
