# **DESTRUCTIVE EXAMINATION OF SHIPPING PACKAGE 9975- 02101**

SRNL-STI-2016-00209, Revision 0

## **DESTRUCTIVE EXAMINATION OF SHIPPING PACKAGE 9975-02101**

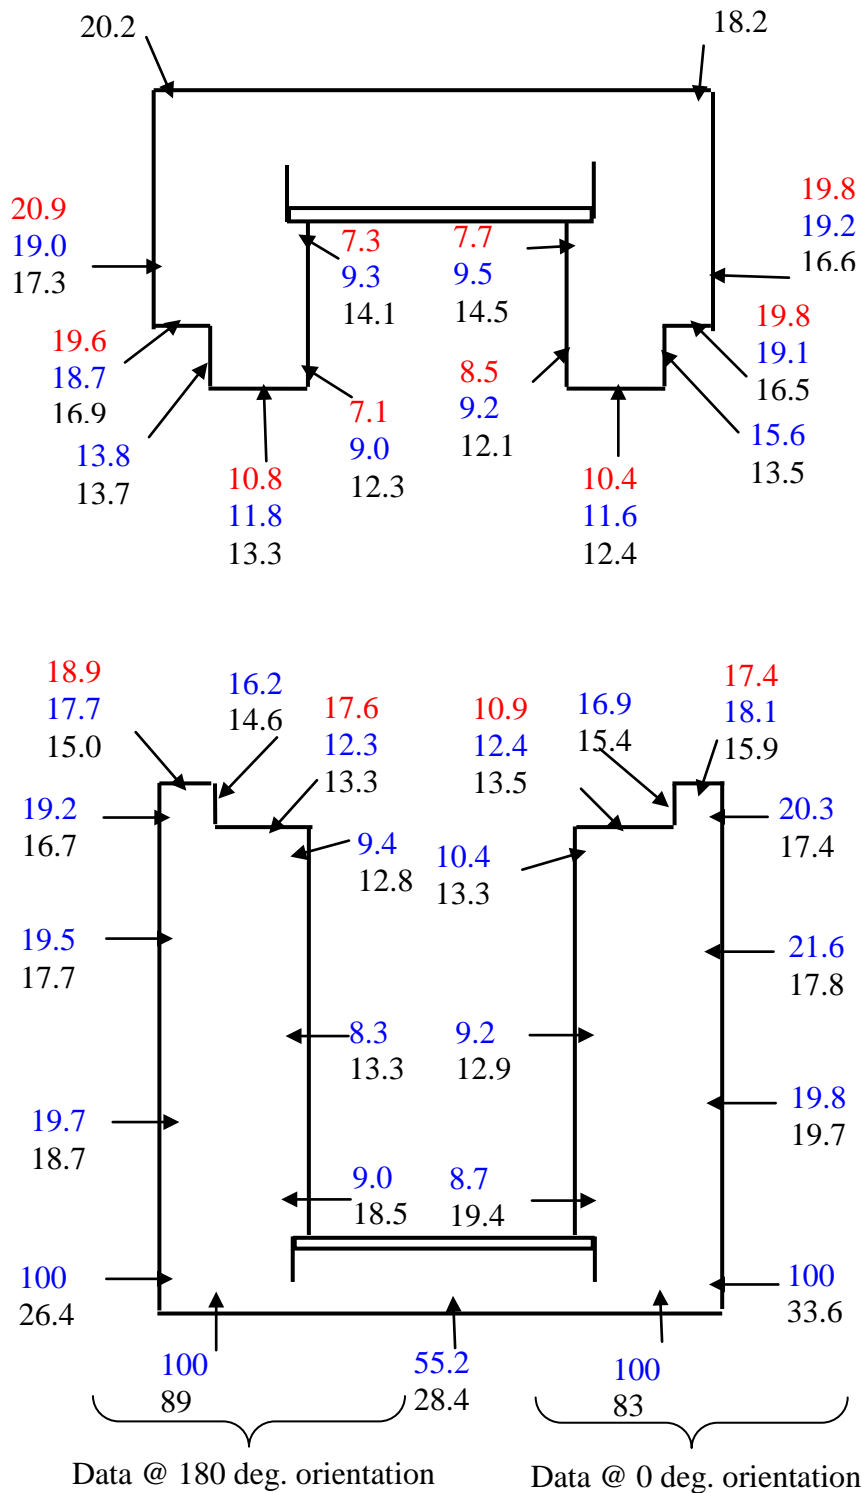
A GE Protimeter Surveymaster moisture probe was used to measure the moisture content of the top and bottom fiberboard subassemblies. This probe identifies the wood moisture equivalent (WME), or the weight % of moisture that would produce the same electrical conductivity in wood. Moisture content data from each examination are presented in Figure 5.

Figure 5. Fiberboard moisture content data. The values in red were measured during field surveillance. The values in blue were measured 3 days later, while the values in black were measured 168 days after field surveillance. All values are % wood moisture equivalent.

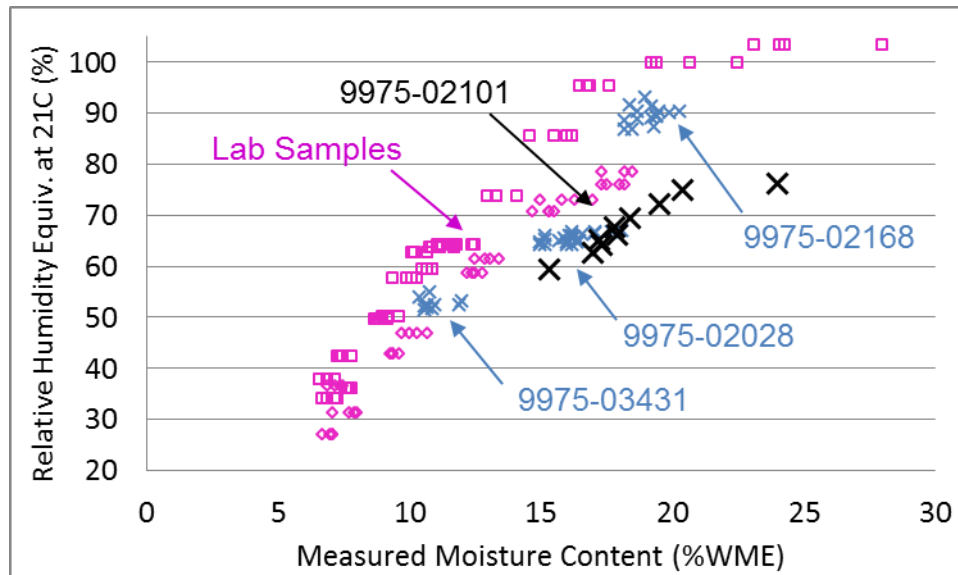
Consistent with recent efforts to correlate moisture content of fiberboard with humidity in the surrounding air, data were taken to correlate these two parameters. The fiberboard was placed back in the drum with a narrow channel cut down the side. A humidity probe was placed in this channel such that it could be raised and lowered with the drum closed. The edge of the drum lid was taped to seal around the gap created by the humidity probe cable. After allowing time for the humidity levels in the drum to approach equilibrium, humidity readings were taken at several elevations along the fiberboard, and the fiberboard was then removed to measure the moisture content at those same locations. The humidity data were then converted to the relative humidity that would result from a constant temperature of 21 °C, since relative humidity is temperature dependent. These data are summarized in Figure 6, and compared to similar data from several previous DE packages and laboratory samples with cane fiberboard. The data from 9975-02101 are consistent with that from the other DE packages, and slightly lower than the laboratory data, suggesting the data from full packages was not quite at equilibrium.

Figure 6. Correlation between fiberboard moisture content and relative humidity of the adjacent air. Data from 9975-02101 are shown with comparable data from prior cane fiberboard DE packages and laboratory samples. Measurements were taken along the fiberboard OD surface. Since relative humidity is temperature dependent, all the data in this graph have been converted to a consistent equivalent relative humidity at 21 °C.

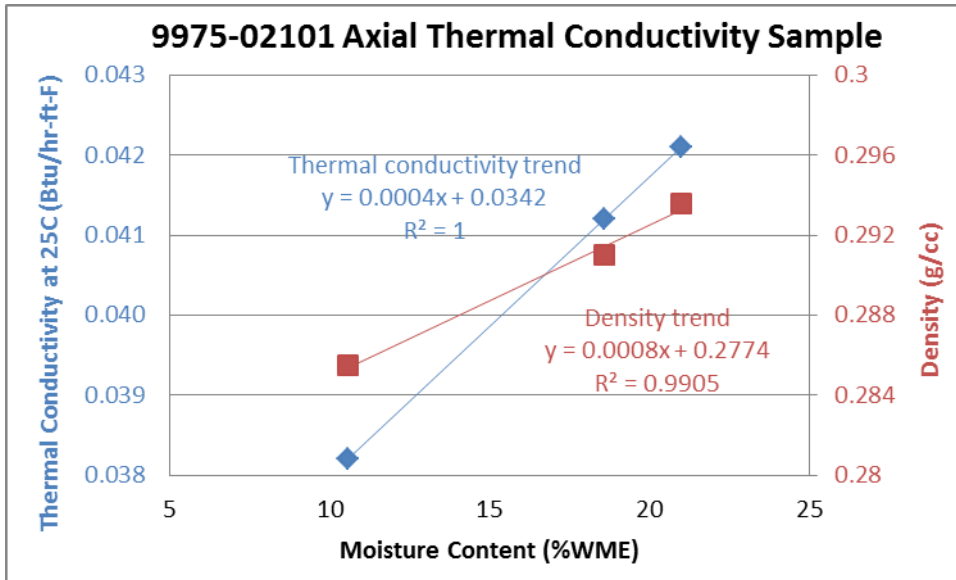
conductivity was above the identified acceptance range. It is seen from these tests that the fiberboard density and thermal conductivity vary linearly with moisture content (Figure 8). For the sample with radial heat flow (parallel to the fiberboard layers), the measured thermal conductivity is 0.1152 W/m-K (0.0666 Btu/hr-ft-°F), with a typical moisture content of 9.8 %WME. This thermal conductivity value falls within the identified range [5], and is also slightly higher than typical baseline laboratory data [10].

Figure 8. Variation in thermal conductivity and density as a function of fiberboard moisture.

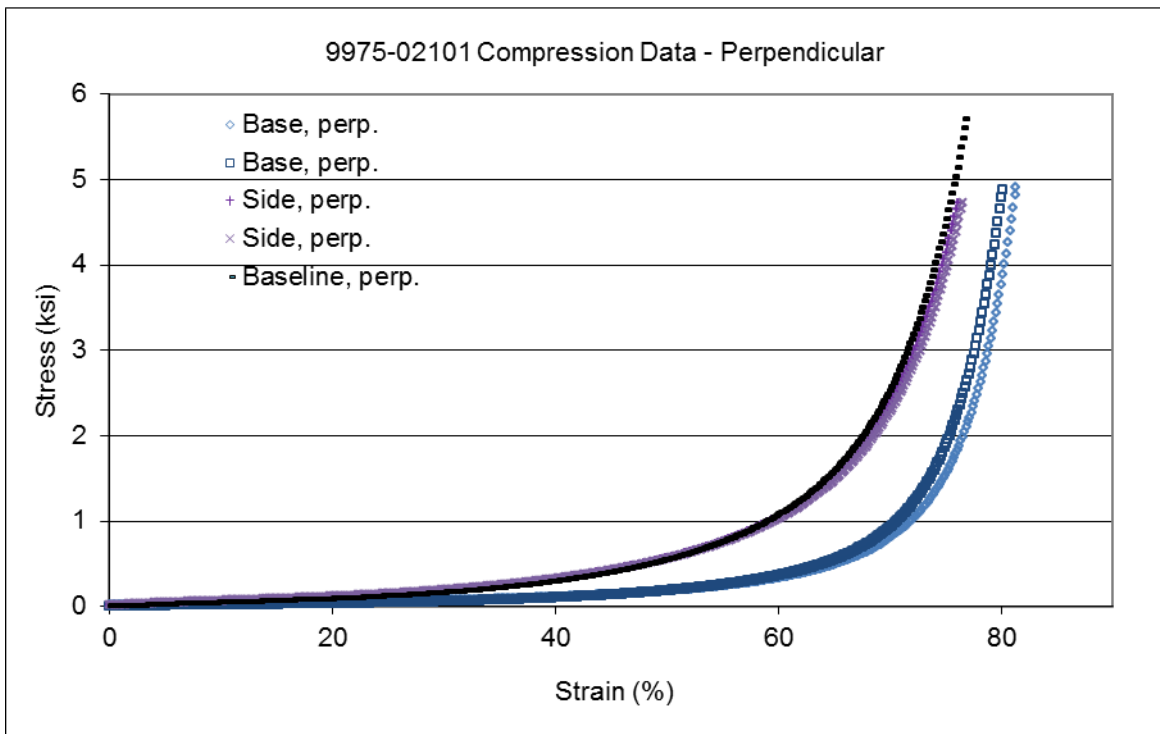
Figure 9. Fiberboard compression test data, compared with typical baseline data from an unaged assembly, in the perpendicular orientation (i.e. load applied perpendicular to the fiberboard layers).

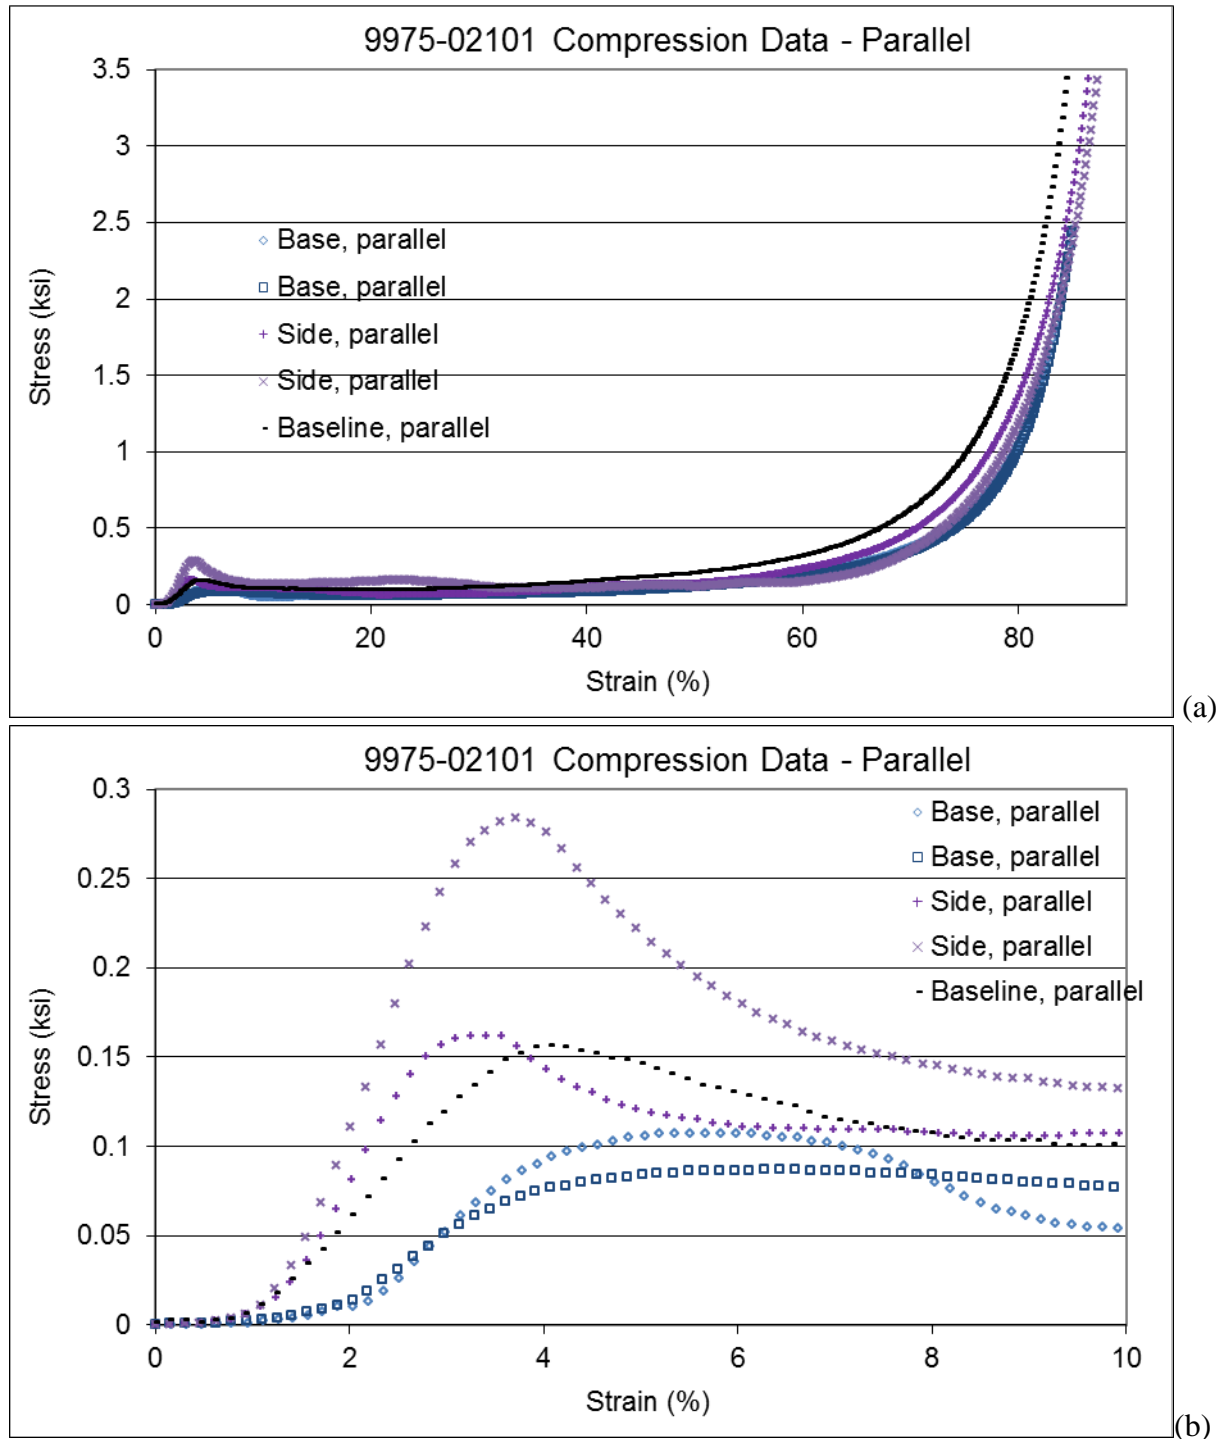
Figure 10. Fiberboard compression test data, compared with typical baseline data from an unaged assembly, in the parallel orientation (i.e. load applied parallel to the fiberboard layers). The full curves are shown in (a), while the initial buckling region is expanded in (b).

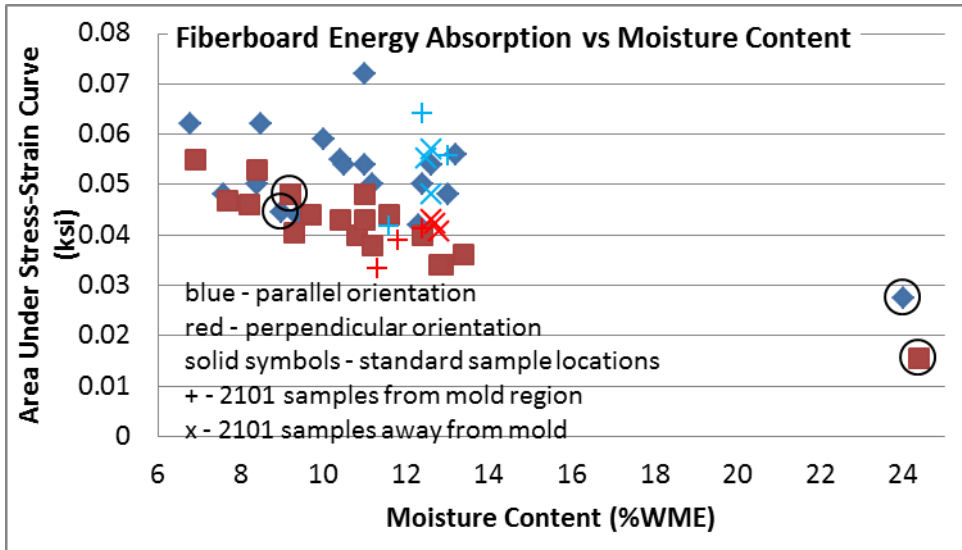
The compression test data are shown in Figures 9 and 10, along with baseline data for a different fiberboard assembly. A series of photographs showing typical compression behavior under parallel loading is shown in Figure 11. The area under the stress-strain curve up to 40% strain is used as a relative indication of the energy absorption capacity of the fiberboard. This metric is shown in Figure 12 for all destructively examined packages as a function of fiberboard moisture content. In general, the energy absorption capacity decreases as the moisture content increases. The results from 9975-02101 are circled in Figure 12. Based on the comparison in Figures 8 and 10, the 9975-02101 fiberboard has slightly less energy absorption capacity than the baseline samples. However, the Figure 12 data collectively show a trend consistent with the other DE packages.

Figure 12. Fiberboard energy absorption, represented by the area under the stress-strain curve up to 40% strain, from tensile test samples from all destructively examined packages. The results from the standard locations in 9975-02101 are circled. The +, x symbols indicate additional samples from 9975-02101 base representing either the mold region (+) or away from the mold (x).

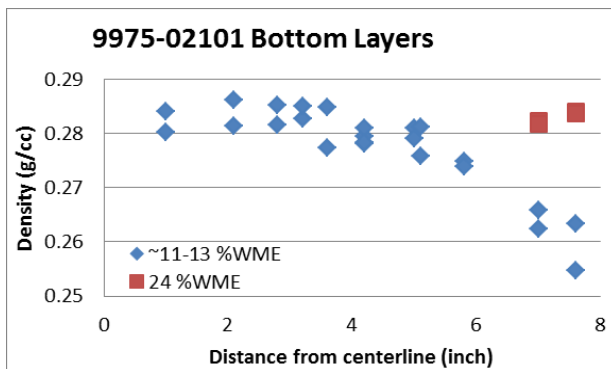
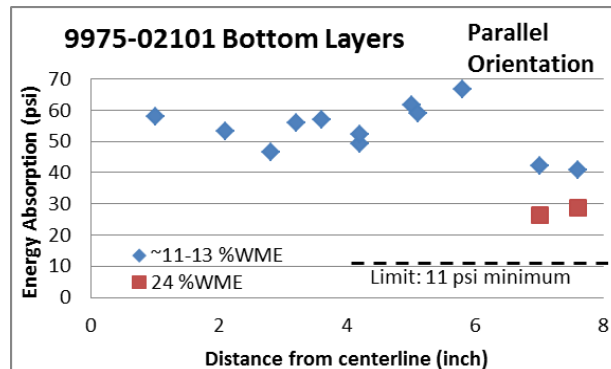
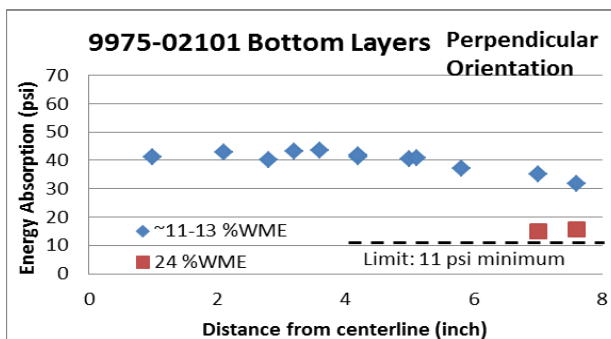
Due to the high moisture levels and heavy mold around the outside bottom of the lower fiberboard subassembly, which are significantly reduced toward the package centerline, the axial thermal conductivity sample was intentionally made larger than usual. This allowed it to be further sectioned into additional compression samples after thermal conductivity testing was completed. The relative position of each of these samples was tracked to identify the distance from it to the package centerline. After allowing these samples to dry to a uniform moisture content (~11 – 13 %WME), these samples were tested to identify whether the elevated moisture and/or mold had created a permanent decrease in density or strength. By performing this exercise on samples that were removed from the same fiberboard layers with a similar moisture content, much of the potential for sample-to-sample variation is eliminated. Results are summarized in Figures 12 and 13. A pronounced decrease in density (up to 10%) is seen for samples more than ~5 inches from the centerline. Energy absorption (represented by the area under the stress-strain curve up to 40% strain) also shows a decrease in this region up to ~25%. While there is variation in these data, some of the samples from the outer molded region (more than ~5 inches from the centerline), are seen in Figure 12 to fall slightly below the envelope of other DE packages. This indicates that the fiberboard was degraded locally in its properties from the elevated moisture and/or mold.

Data from the primary compression samples removed from the base layers (and tested at 24 %WME) are also shown in Figure 13 for comparison. The higher moisture content increases the density, and decreases the energy absorption. For perpendicular orientation samples, the energy absorption is barely above the 11 psi limit based on the forklift impact scenario. While this heavily degraded condition exists only in a small region of the lower fiberboard assembly, it illustrates that moisture and mold have the potential to produce significant degradation in properties. Note, however, that the fiberboard properties away from this limited region are consistent with that typically seen in other non-degraded packages.

Figure 13. Additional density and mechanical data from bottom fiberboard layers. Samples taken further from the package centerline had higher moisture content and more mold. These samples were dried to a more consistent 11 – 13 %WME moisture content before testing. Results for the compression samples taken from the bottom layers and tested at 24 %WME are shown for comparison.
