# **Idaho National Laboratory Quarterly Performance Analysis FY 2013 Third Quarter**

August 2013

## INL/INT-13-29860

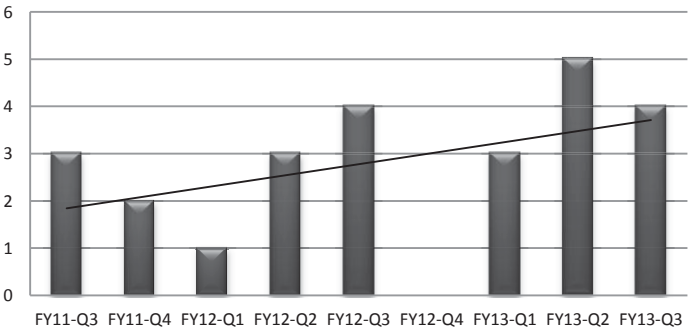
**Group 3 - Nuclear Safety Basis**

*Through an extent of conditions review associated with an unreviewed safety question (USQ) reported via NE-ID--BEA-ATR-2012-0027 in November 2012, a problem was discovered associated with an electrical pull box located on the ATR reactor main floor.*
