Title: Canless HIP Development for Aluminum Cladding of LEU Fuel Foils using Electron Beam Welding

# **Canless HIP Development for Aluminum Cladding of LEU Fuel Foils using Electron Beam Welding**

## **Summary Report for FY12**

MST-6  
Los Alamos National Laboratory  
March 13, 2013

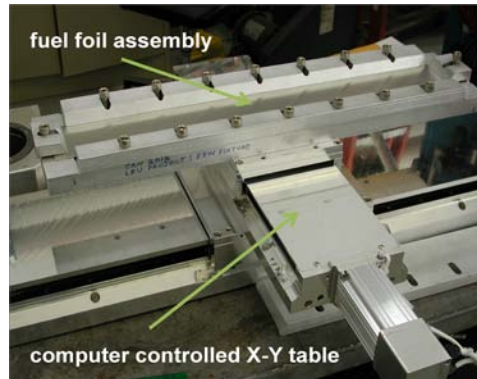
Figure 2: Photograph of EBW fuel foil welding fixture mounted to Aerotech X-Y linear motion table.

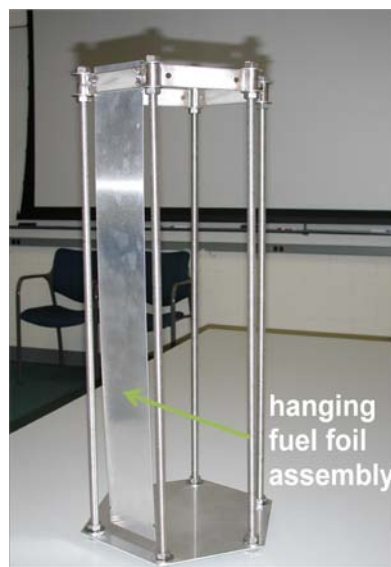
Figure 6: New HIP fixture made specifically for canless HIP processing of 24-inch long foils. Foils are clamped at the top of the fixture and hang freely.

After HIPing, the fuel foils (with divots) were examined and found to be intact with little difference in appearance or flatness from before HIPing. Also, there was no indication of problems with creep. When foils were evaluated using scanning ultrasonic (UT) inspection, however, it became apparent that there was no bonding and that the welds had leaked during HIPing. In particular, water was found to leak into and out of the HIPed plates during UT testing, where water is used as the transducer couplant. The UT technique uses a pulse-echo method whereby a strong reflectance signal represents an unbonded interface. Where there is bonding (or water), more of the signal gets transmitted through the foil as opposed to being reflected, thus resulting in a weaker reflection signal. The strong reflectance signal in Figure 7, as represented by the light yellow color in the middle of the foil, suggests a condition of non-bonding. The darker color around the perimeter is likely due to the presence of water.

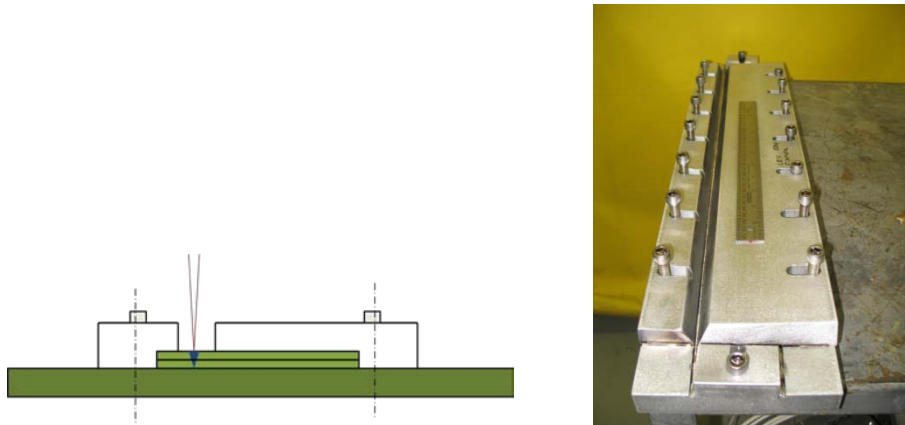
Figure 10: Modified EBW fixture providing clamping on both sides of the beam path.

Welds made on two surrogate fuel foil assemblies using the above modified weld parameters and fixture again resulted in divot defects. It was decided at this point to attempt weld repair, knowing that divots previously resulted in failed HIP runs. This was accomplished by welding directly over the divots using the same established weld parameters (Table 2). A 2-inch (run and stop) weld length was employed. The good bead appearance of the repair welds suggested that this approach may serve to seal the joint. Although it is known from general experience that welding over defects does not always eliminate them.

Weld fixture modifications were made to provide clamping on both sides of the beam path as depicted in Figure 10. In essence, a bar extending over the center of the foil assembly provided hold-down pressure on the inner side of the beam path. The amount of force exerted, however, was limited due to the associated moment arm. By the nature of this new configuration, fuel foil assemblies now require two separate pump-down and weld cycles, where the foil assembly must be rotated 180° in the fixture between cycles.
