# **Reinforcement studies and renewal of installations for the contemporary use of the Bursa Inebey (Egne Beg) Madrasah**

**O. Koprulu Bagbanci\* and M. B. Bagbanci**

Engineering and Architecture Faculty, Uludağ University, Bursa, Turkey.

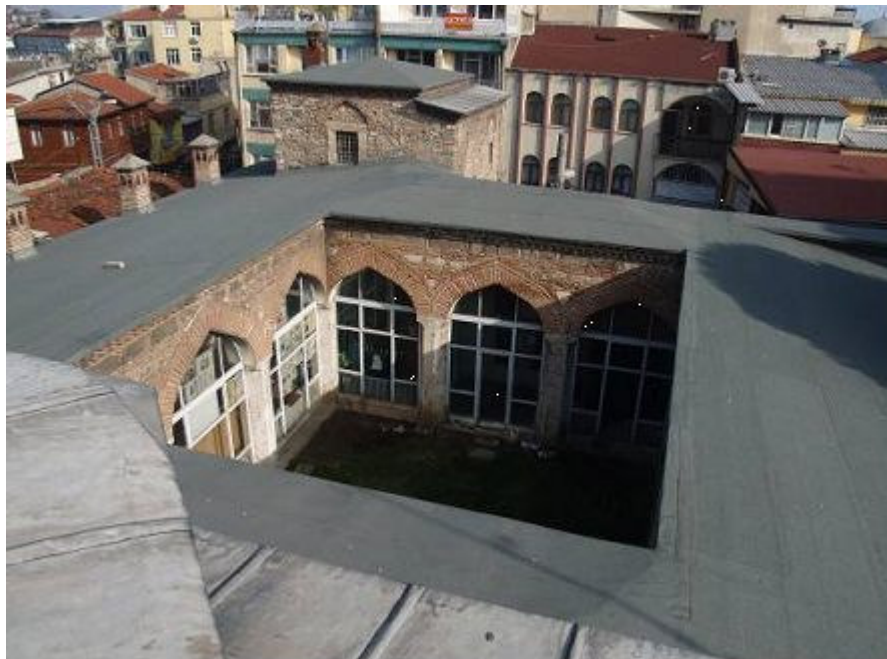
**Figure 2.** The general view of the Inebey Madrasah.

decorating the walls of the courtyard. The walls are finished by five rows of saw-tooth eaves. The building's masonry system is composed of rubble stone, limestone, mortar, brick and timber (Figure 2 and 3). The outer walls are 116 cm thick. Brick was used in the arches, vaults and dome and in the transition elements to the domes. Khorasan mortar was used as the binder material. It was a lime mortar manufactured in Turkey using crushed or finely ground bricks as aggregate (Akman et al., 1986). The crushed bricks were mixed with the lime and left to harden in the presence of water. Khorasan mortar has high mechanical strength (Lea, 1940). The facades of the building were not plastered, but the inside of the building was plastered with Khorasan mortar.

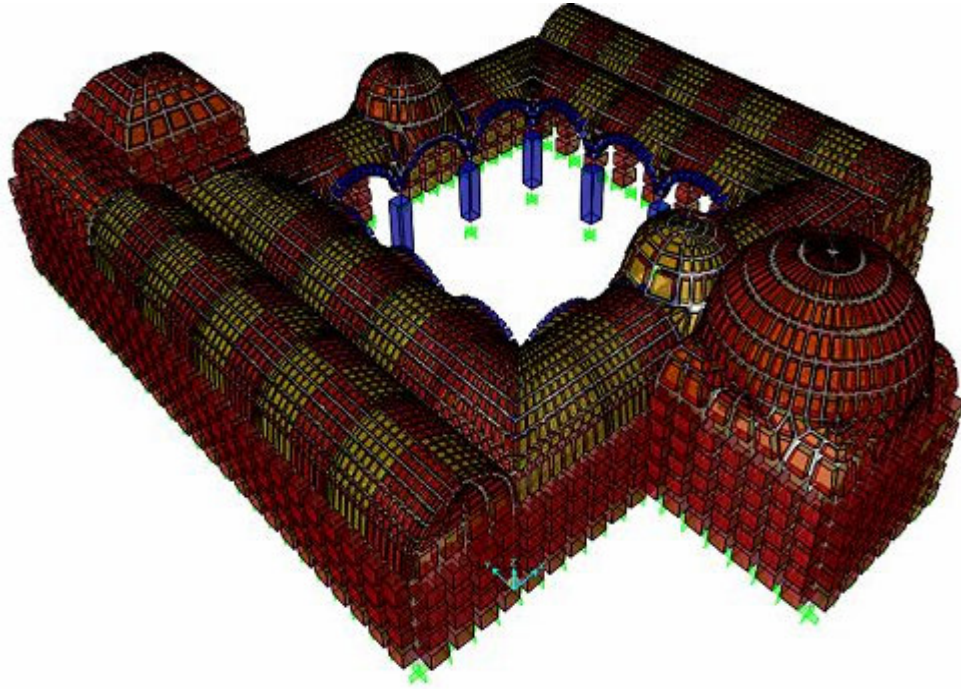
**Figure 6.** Finite element model of Madrasah.

The structural analyses were conducted by using the SAP2000 finite element programme (Computers and Structures, Inc., 1998). A roof load of 1.75 ton/m<sup>2</sup> was applied to the model to find out what effect the filling material was having on the structure. The model of the Madrasah consisted of 6777 shell elements and 28 frame elements (Figure 6). In the self-weight analyses, the highest level of tensile stress, measured at around 0.4 - 0.5 MPa, was found under the vaults. *In situ* observation revealed that there were continuous cracks in these areas (Figure 7 - 9). It was clear that the load on the vaults was making the structure hazardous. The structural analyses were continued, this time by analysing the effect of removing the load from the roof. The results showed that the tensile stress under the vaults dropped to around 0.1 ~ 0.2 MPa, 3 times less than
