EMERGENCY REPAIRS TO THE MAIN BREAKWATER OF CALSHOT HARBOUR ON TRISTAN DA CUNHA ISLAND

Paul Bouton¹, Frans van Eeden¹, Marthinus Retief¹, Francois De Roubaix¹ and Johan Kieviet²

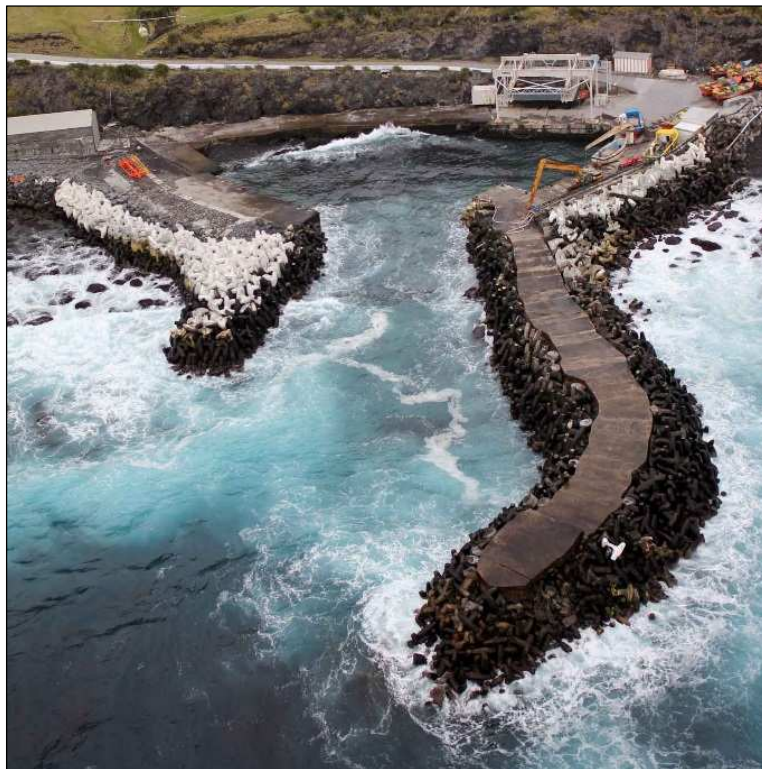
Figure 1. Aerial view of Calshot Harbour taken towards the South from helicopter during transfer of the survey team to land from SA Agulhas on arrival at Tristan da Cunha, 9 September 2010 (WSP, 2011).

The first quarter of 2009 saw repairs to the dolos slope (by external contractor) on both breakwaters but no extension of breakwaters or layout changes. All new dolosse placed were 3.5 t mainly on the eastern breakwater and in the most vulnerable section of the western breakwater (white dolosse seen in Figure 1). However, damage to the breakwaters was once again reported by the local Public Works Department in their ongoing maintenance survey between April 2009 and January 2010. This already showed six new dolosse missing from the western breakwater and reported severe vulnerability of the western breakwater in that "any future storm may lead to failure of the breakwater". It is clear that damage at the vulnerable section on the seaward side of the outer western breakwater was progressing rapidly despite the repairs done less than 9 months previously.

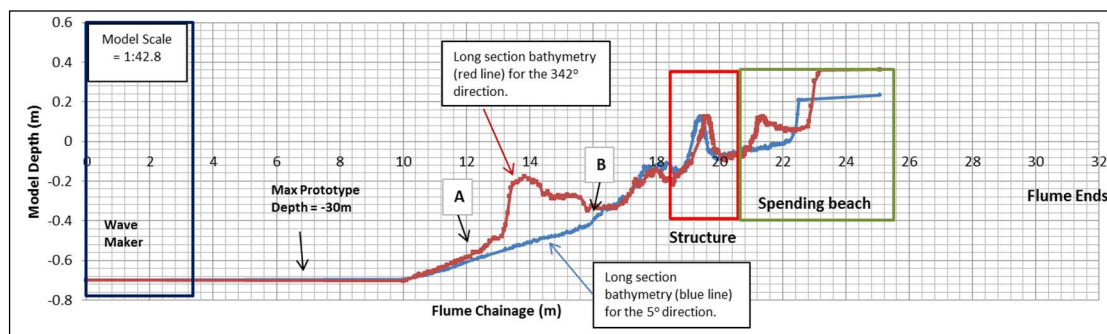
Figure 3. Long sections of the idealized flume bathymetry for the 342° and 4° incident wave directions . The red line represents the 342° while the 4° direction is represented by the blue line.

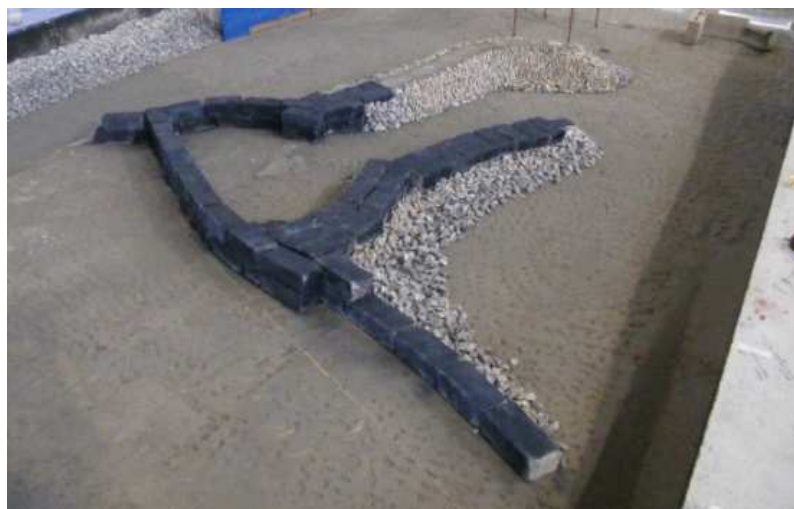
Figure 4. Calshot harbour during model construction phase.

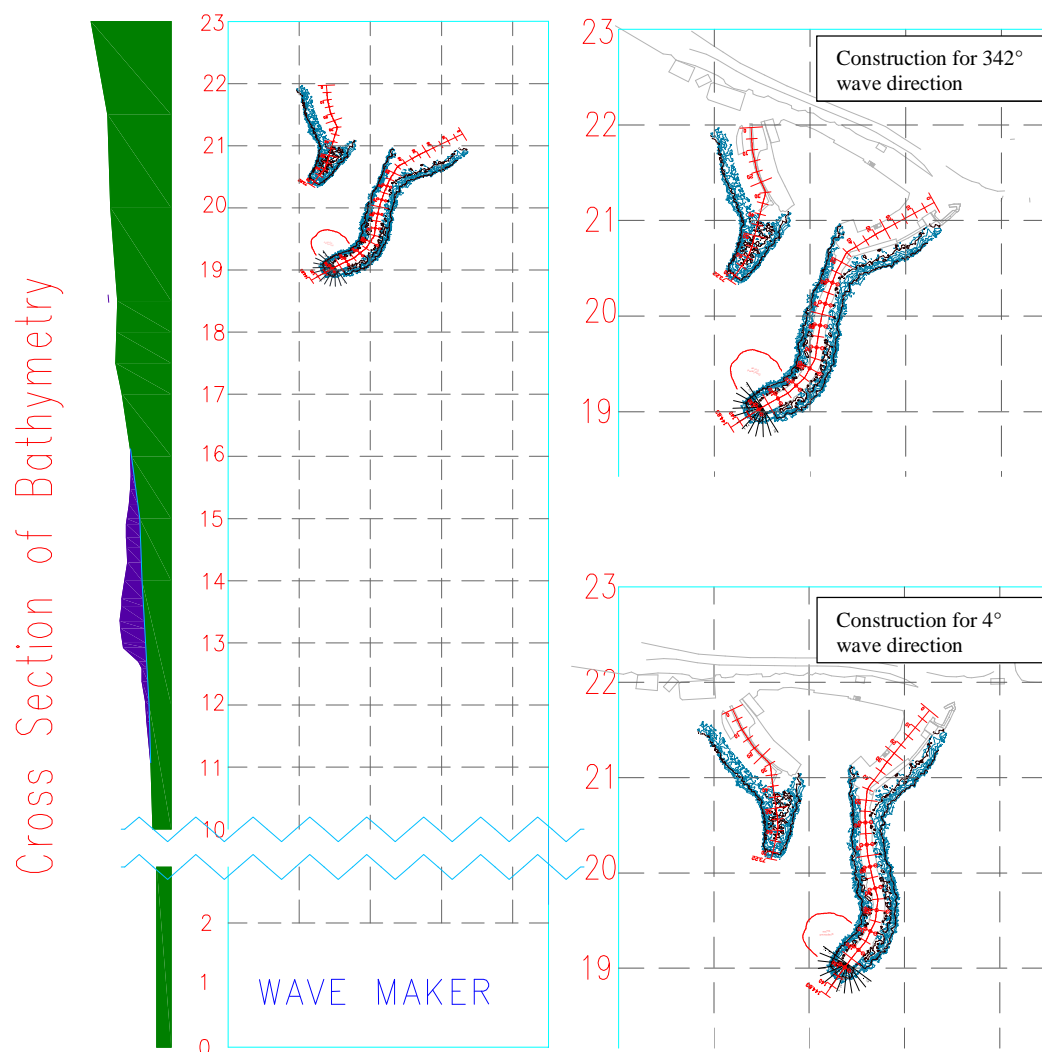
Figure 5. Model layout for 342° wave direction and 4° wave direction (CSIR, 2010).

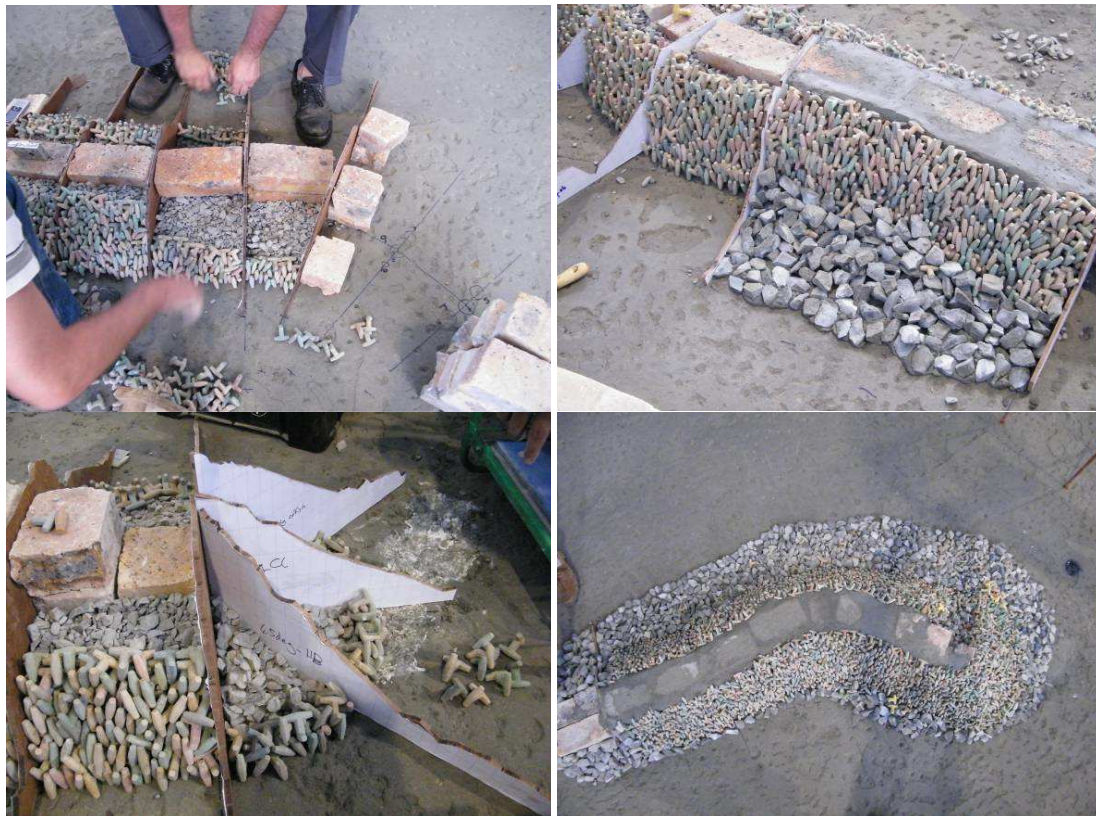
Together with WSP Africa, the assumption was made that the core was impermeable and solid, therefore to ensure the centre of the core remained stable during testing; the capping of the breakwater was constructed with bricks that were screed to the correct level. The images in Figure 6 gives an indication of how the construction was done. Testing of the core for the breakwater was not part of the scope, however to pack the 3.5 t dolosse realistically, core material was placed between the bricks and dolosse (to simulate the original prototype packing of the breakwater).

Figure 6. Breakwater Construction Images.

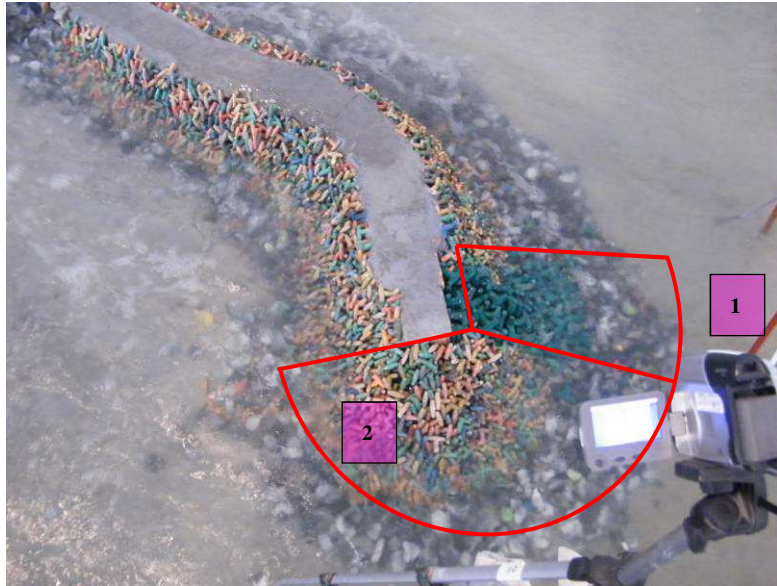
Figure 7. Camera Stations (CSIR, 2010).

Camera station one covered the section of armour where the core material had become severely exposed and threatened the survival of the structure. Stability results for the 3.5 t dolosse on the roundhead (camera station 2) were also taken but only for observation purposes.

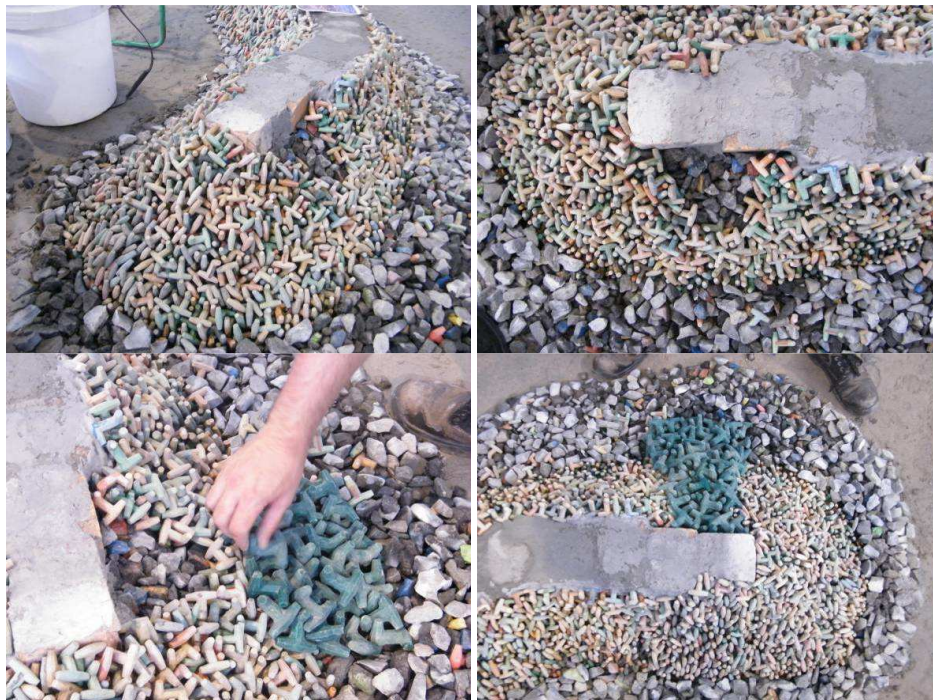
Figure 8. Breakwater Construction Images for Test 004.

Each repair consisted of placing 10 t dolosse over the section to be repaired. The dolosse were then stitched (joined) into the 3.5 t armour layer. The dolos placement for each repair is described in detail in Table 3. Due to the remoteness and logistical aspects of getting material to Tristan da Cunha, a limited number of 10 t dolosse (75 in total) were available for each repair option to be tested. Figure 8 shows how one of the repair options was constructed.

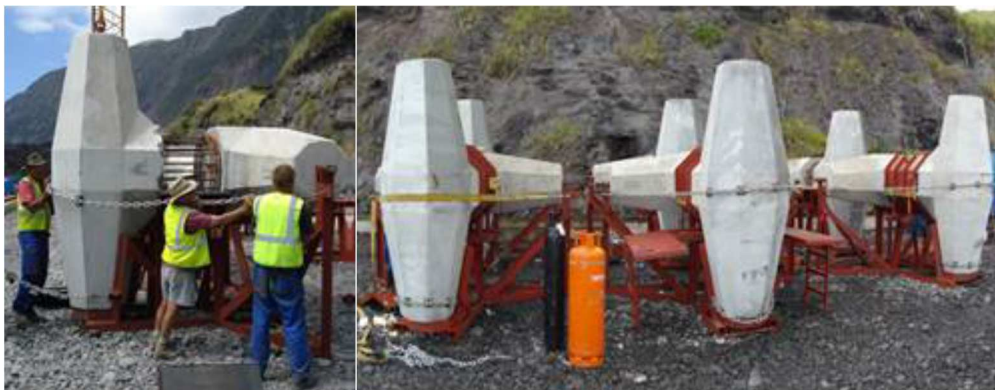
Figure 10. Stitch casting yard at Tristan da Cunha

The dolosse were cast as halves in Hermanus, South Africa, and stitch cast to whole units on site at Tristan da Cunha, see Figure 10.
