**Pacific Northwest  
National Laboratory**

**Ultrasonic Examination of  
Double-Shell Tank 241-AN-105  
Examination Completed  
September 2002**

AF Pardini  
GJ Posakony

January 2003

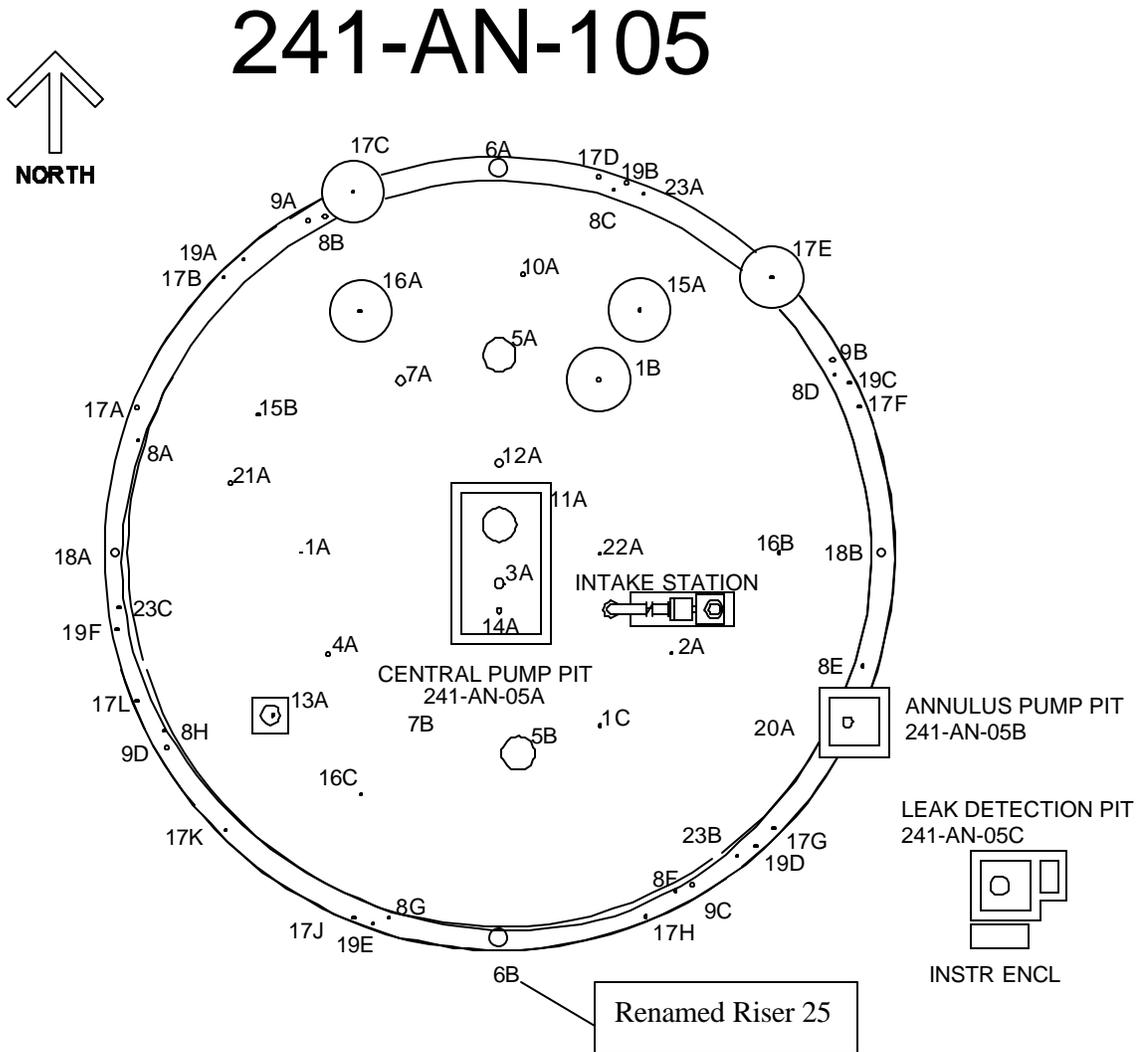
**Figure 4.1.** UT of 241-AN-105 Riser 25

Tank 241-AN-105 is located in the Hanford 200 East area in AN Tank Farm. The crawler and associated scanner were lowered into the 24-in. riser located on the south side of 241-AN-105 and designated as Riser 25. In the previous examination of 241-AN-105 in 1999, the examination took place in Riser 6B. Riser 6B has been renamed Riser 25. Figure 4.1 provides a graphic of the location of this riser.
