**Pacific Northwest
National Laboratory**

Ultrasonic Examination of Double-Shell Tank 241-AN-105 Examination Completed September 2002

AF Pardini
GJ Posakony

January 2003

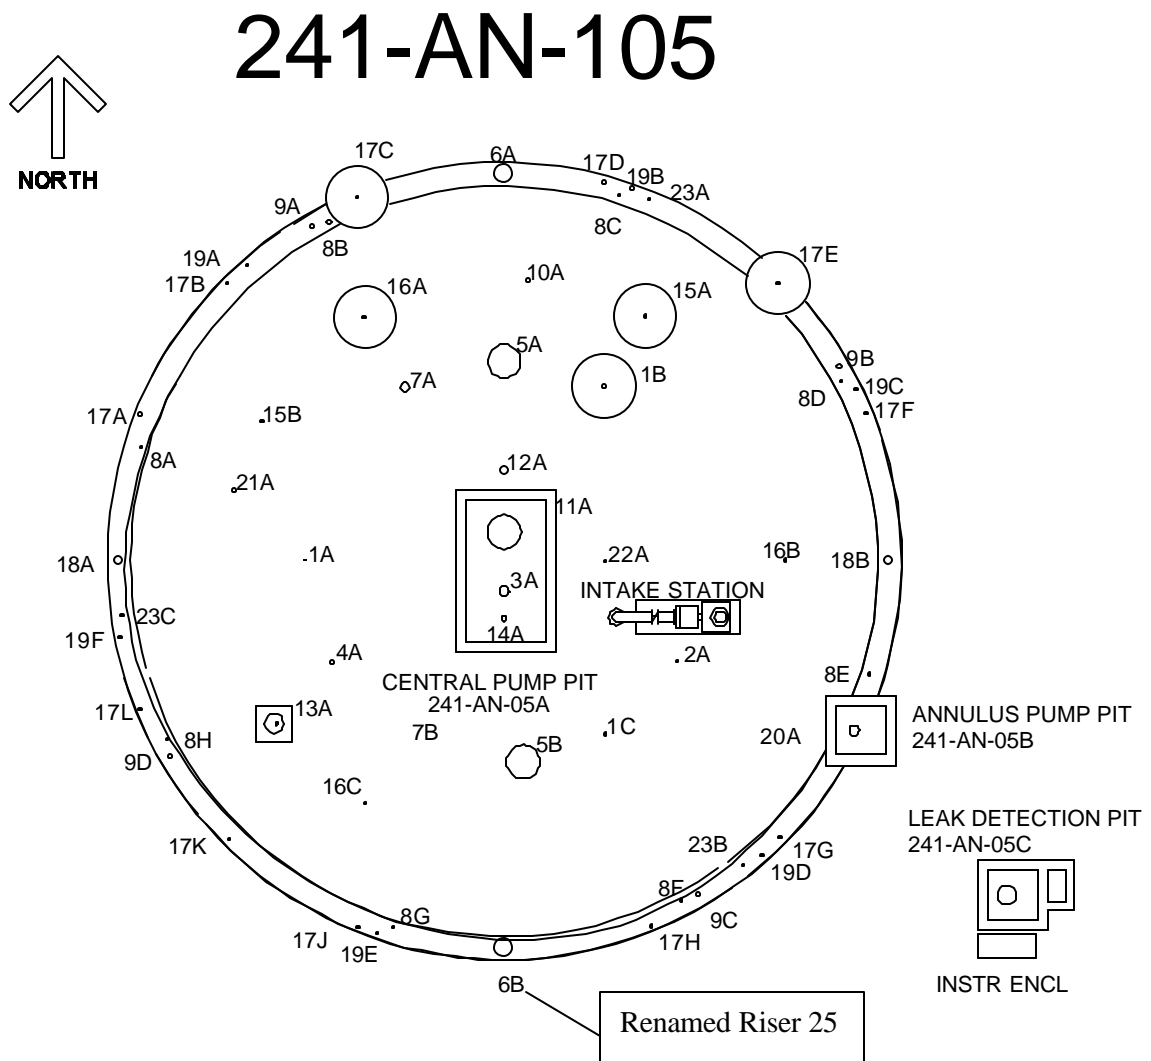
Figure 4.1. UT of 241-AN-105 Riser 25

Tank 241-AN-105 is located in the Hanford 200 East area in AN Tank Farm. The crawler and associated scanner were lowered into the 24-in. riser located on the south side of 241-AN-105 and designated as Riser 25. In the previous examination of 241-AN-105 in 1999, the examination took place in Riser 6B. Riser 6B has been renamed Riser 25. Figure 4.1 provides a graphic of the location of this riser.
