Washington Phase II Fish Diversion Screen Evaluations in the Yakima River Basin

Annual Report 2000

March 2001

DOE/BP-00000652-3

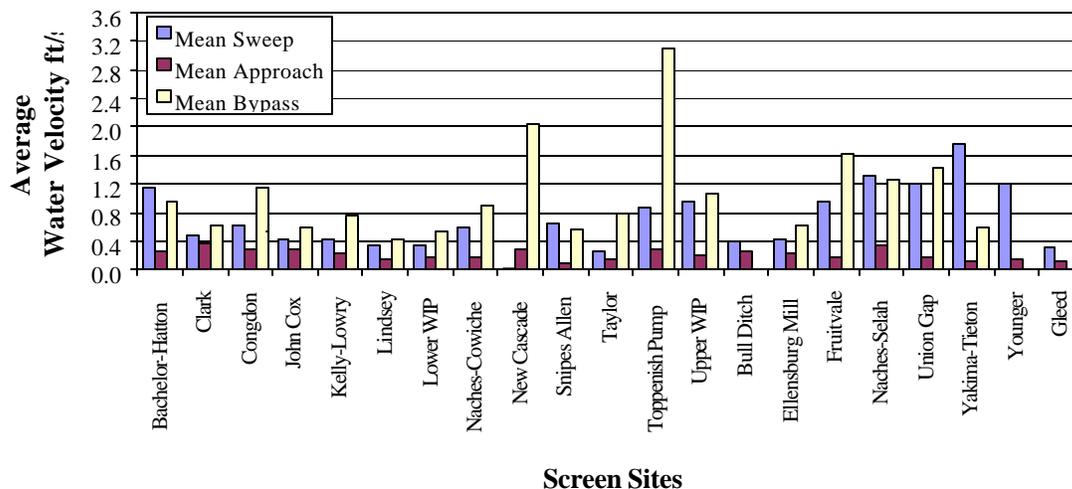
Figure 3. Mean Approach, Sweep, and Bypass Velocities (ft/s) at Phase II Fish Screen Facilities in the Yakima Basin in 2000

Averaging velocities for each screen site presented a clearer picture of the flows at these sites (Table 3; Figure 3). Considering only averages, sweep velocity was greater than approach velocity at all sites.

The ratio of sweep velocities to approach velocities at the flat plate screens was generally greater than at drum screens (Table 3). This should help minimize the time it takes for fish to reach the bypass. Bypass flows were usually faster than the average flow past the screens; only four sites had average bypass velocities less than their average sweep velocities (Table 1, Figure 3).

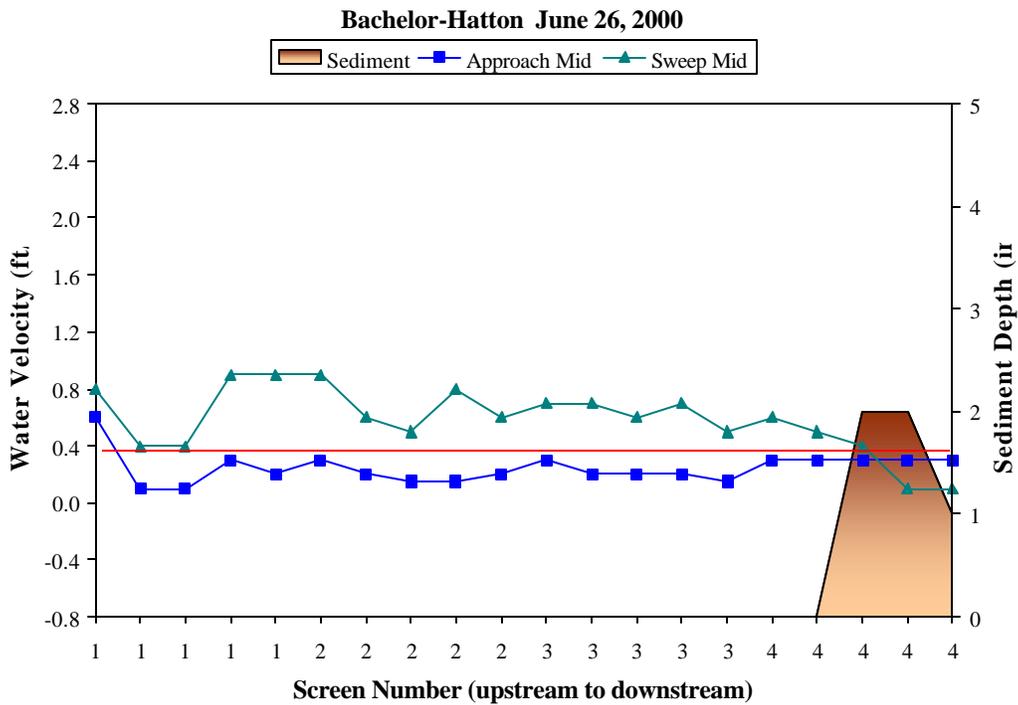
Figure 5. Water Velocities and Sediment Depths at Bachelor-Hatton, 6/26/00

The Bachelor-Hatton site was evaluated 5/25/00, 6/26/00, and 9/15/00, although no water was running through the facility in September. Approach velocities were generally within the NMFS criteria (Figures 4 and 5). Sweep velocity did not increase toward the bypass. Bypass velocities were greater than mean sweep velocities in May but not in June at this site. Water flowed smoothly over the bypass weir and through the outfall during the May and June evaluations.

The gap noted last year between the seal and the bottom of screen 2 was still present in 2000. A video survey could not be performed in June. Water was no longer running through the facility by July 25 when we went out to perform a video survey. Videotape of the site in September showed one of the bolts holding the bottom seal in place at screen 3 had broken off. This could potentially allow the seal to move away from the drum in that spot. Screen submergence was above NMFS criteria in May, with approximately 90% submergence, and within the criteria in June with 71% submergence.

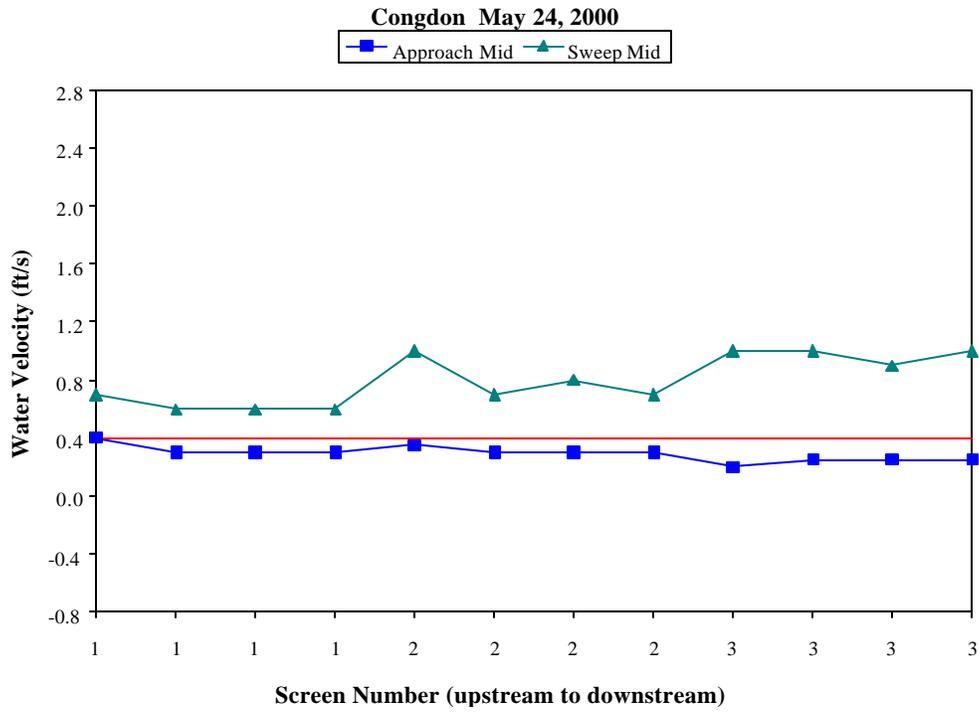
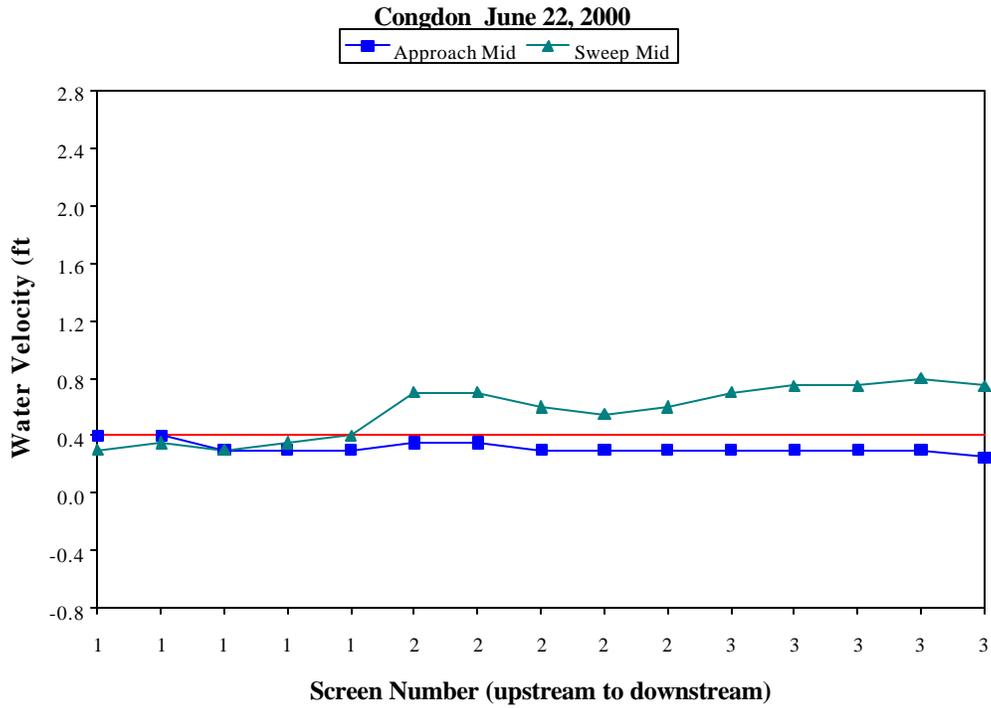
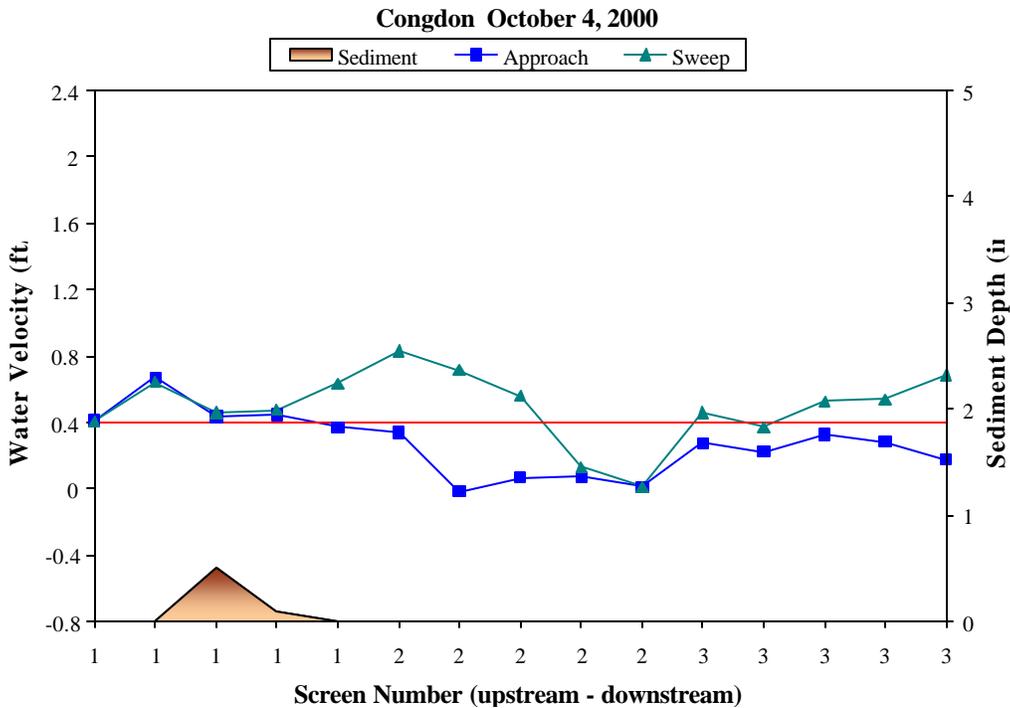
The Congdon screen site was evaluated 5/24/00, 6/22/00, and 10/4/00. Ninety-three percent of the recorded approach velocities met NMFS criteria at the Congdon site. In general, sweep velocities were greater than approach velocities and increased near the bypass (Figures 8, 9, and 10). The only places sweep velocities were less than approach velocities or where approach velocities exceeded criteria were in front of Screen 1 (farthest upstream) in June and September.

Mean sweep velocities were lower than bypass velocities and screen submergence was between 65 and 85% during each of the surveys in 2000. Water always flowed smoothly over the bypass weir and ran freely through the outfall pipe, although it did seem to surge through the outfall in June. During the June survey, we dropped a lemon into the water at the weir and timed its travel to the outfall to make sure there was no significant obstruction in the outfall pipe causing the surging. Based on this test, there did not seem to be any obstructions of the pipe. Surging may be caused by entrainment of air in the downwell. The outfall was always submerged. The seals were in good condition, and screens always turned smoothly. There were no debris or silt problems observed at Congdon in 2000.

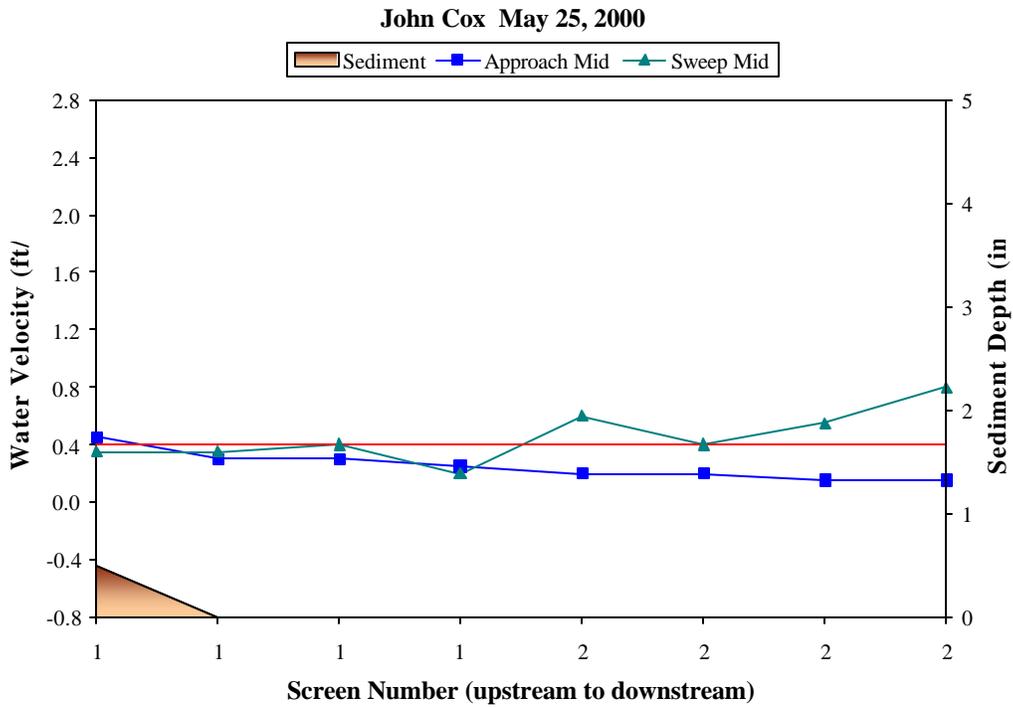
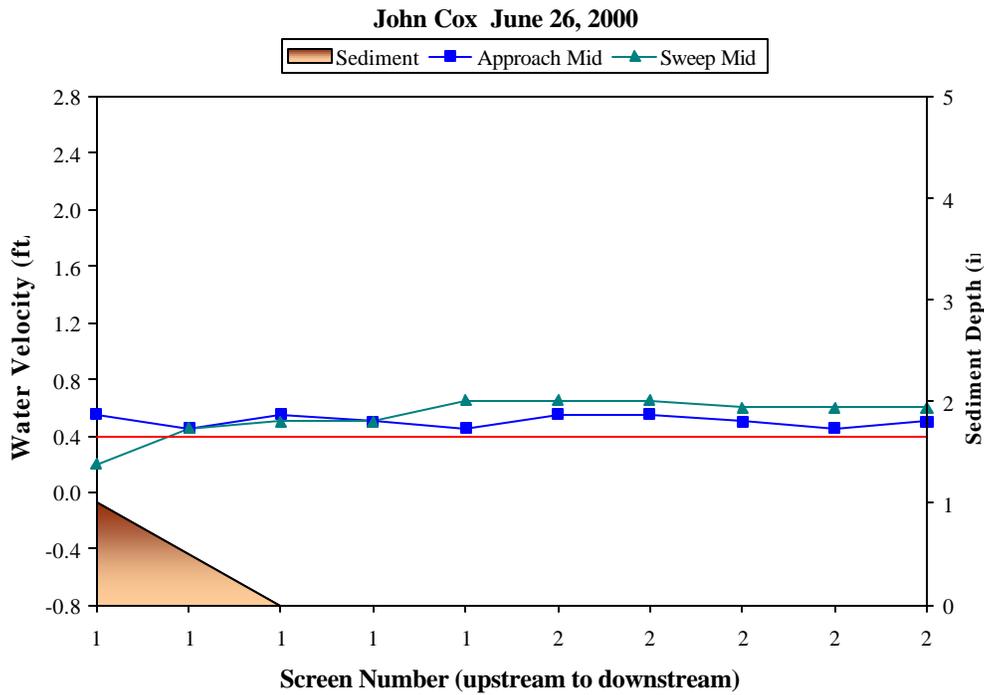
The John Cox site was evaluated for the first time in 2000. It was visited on 5/25/00, 6/26/00, and 9/15/00. Measurements using the Marsh-McBirney probe indicated approach velocities were below 0.4 ft/s in May but exceeded 0.4 ft/s in June (Figures 11 and 12). Approach exceeded sweep across most of screen 1 in June, as well as being above the NMFS criteria of 0.4 ft/s at all measuring points. Bypass velocities were greater than sweep velocities in May but not in June. Sweep also increased toward the bypass in May but not in June. This site had little flow through it in September, but equipment problems prevented accurate measurement of velocities. All screens and seals looked good.

There are no drum submergence marks at John Cox. In May, the water was backed up into the downwell, but bypass velocities were greater than sweep velocities, indicating good movement of water toward the stream. High water levels in the stream also covered the outfall pipe so much that we could not find it in May. In September, there was less than 1 ft of water in front of the outfall, and only 6 in. of water in the outfall pipe. In both May and June there was approximately 1 in. of headloss across the screens. A video survey could not be performed during the June evaluation, so an effort was made to videotape the site on July 25. By then, the screens had been turned off and remained off for the rest of the season. There was some accumulation of sediment and woody debris at the upstream end of screen 1; otherwise, the site was clean.

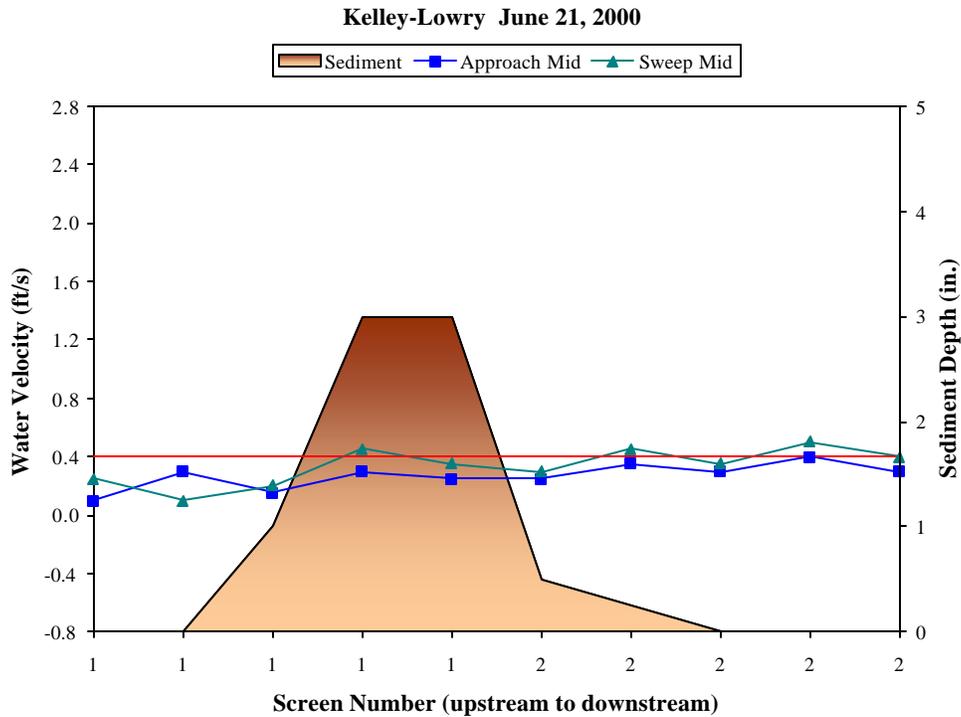
Figure 14. Water Velocities and Sediment Depths at the Kelly-Lowry Site, 6/21/00

The Kelly-Lowry screen site was evaluated 5/24/00, 6/21/00, and 9/22/00. All approach velocities recorded at this site in May and June met NMFS criteria (Figures 13 and 14). Sweep velocities exceeded approach velocities in May and equaled them in June. Sweep velocities increased toward the bypass in June only. Bypass velocities were always higher than mean sweep velocities. Equipment problems prevented measurement of velocities in September. Screen submergence levels were between 65 and 85% in May and June, but were slightly higher than 85% in September.

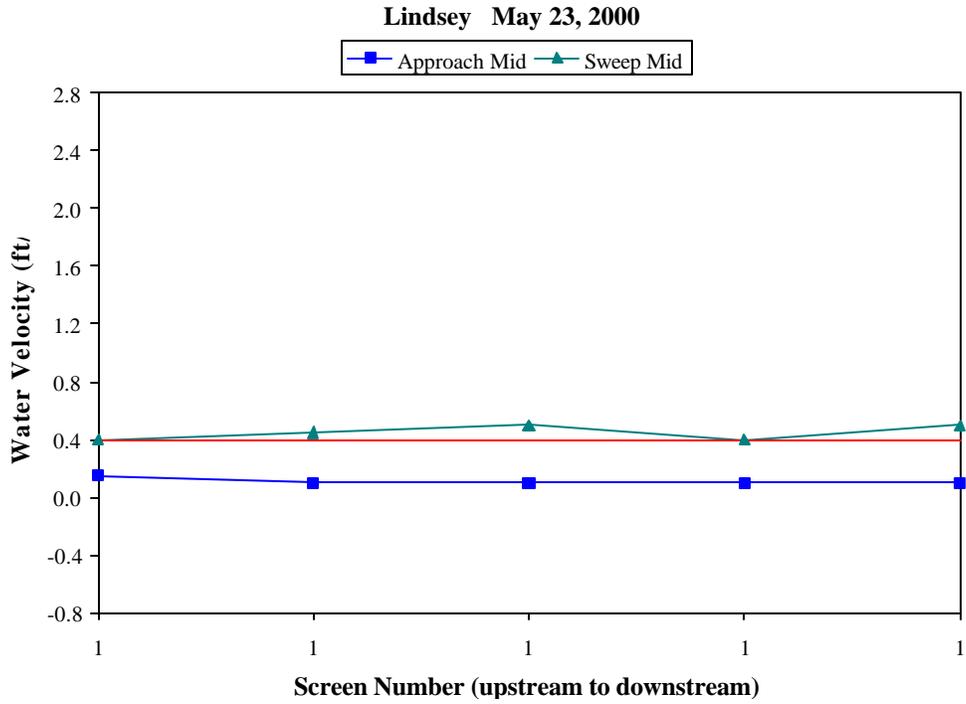
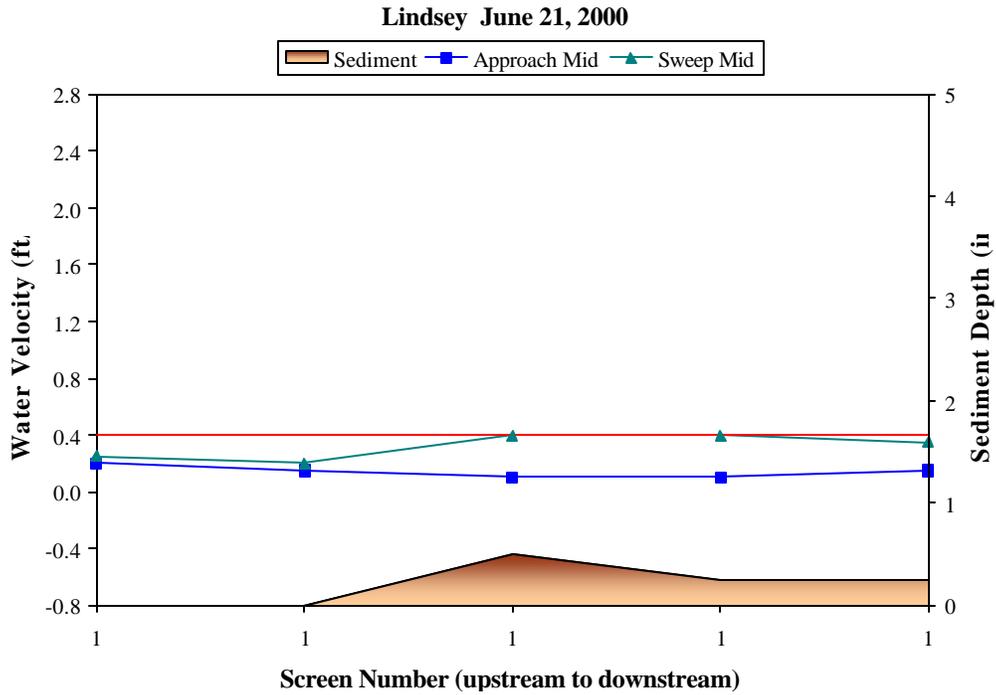
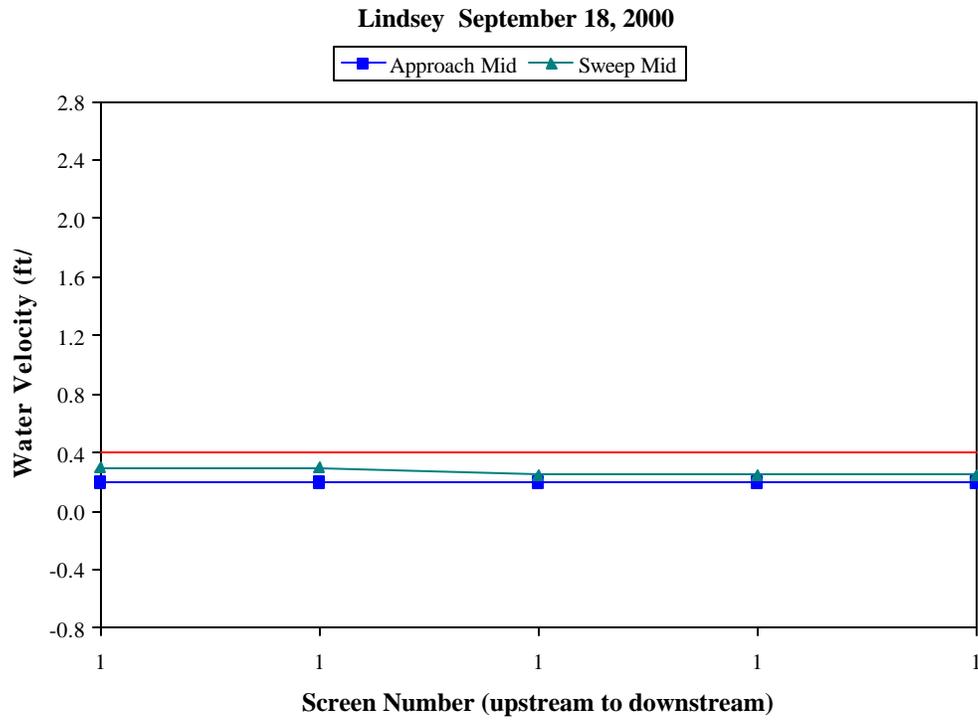
The Lindsey screen site was evaluated 5/23/00, 6/21/00, and 9/18/00. All recorded approach velocities at this site met NMFS criteria (Figures 15, 16, and 17). Mean sweep velocities were greater than mean approach velocities, but did not increase near the bypass in May and June. Mean bypass velocities exceeded sweep velocities. Screen submergence levels were within criteria.

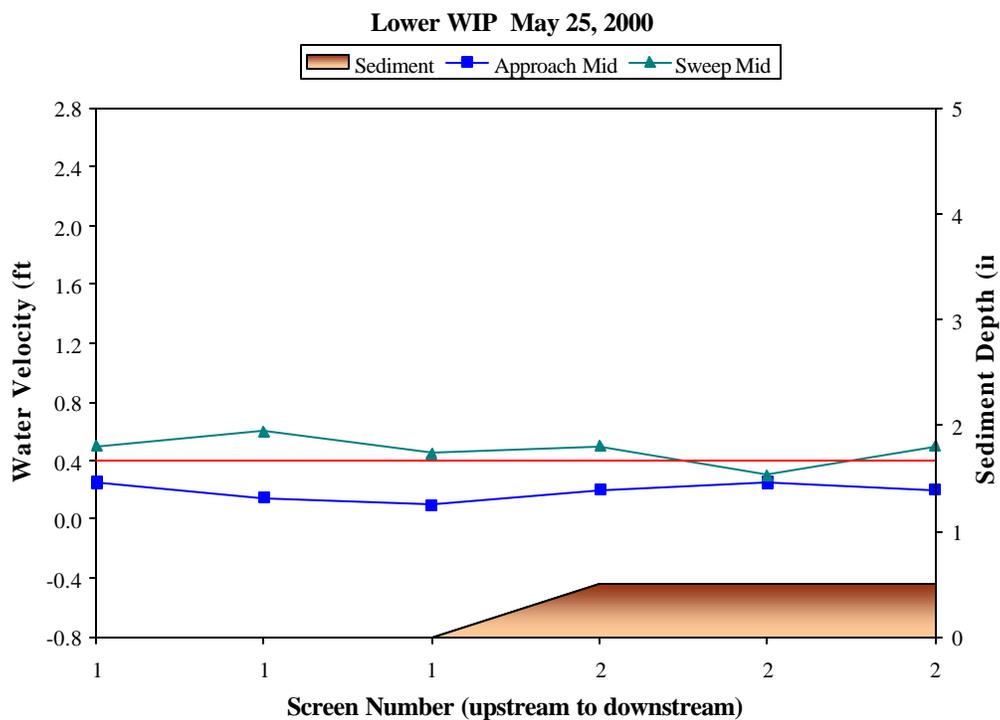
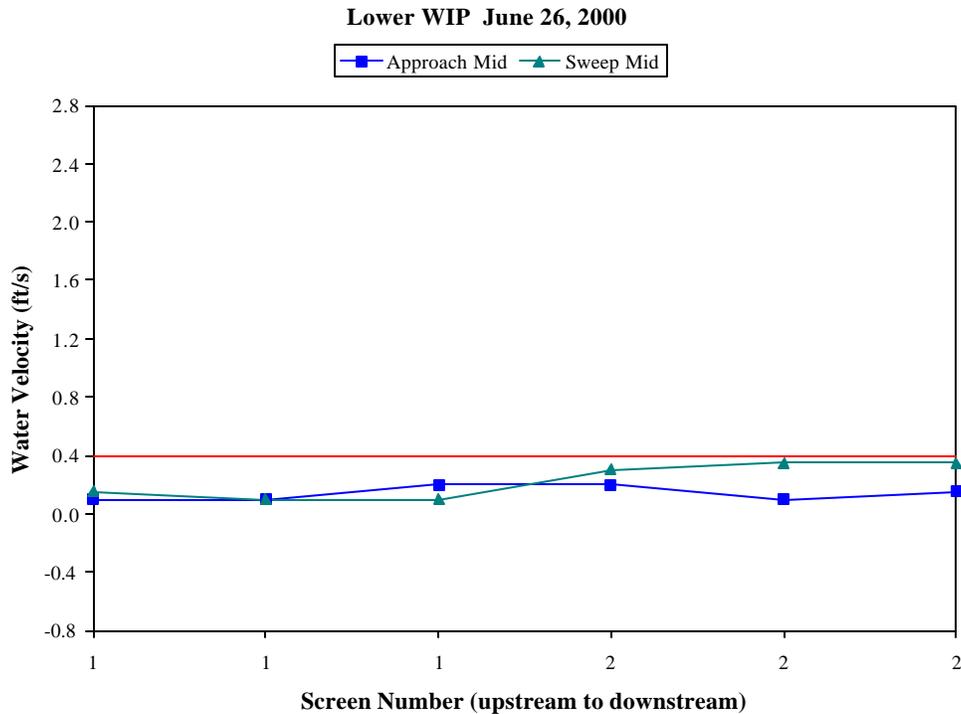
Lower WIP was visited 5/25/00, 6/26/00, and 9/15/00. The facility was shut down for the season before our September survey. All approach velocities met NMFS criteria. Mean sweep velocities were greater than mean approach velocities, but only increased toward the bypass in June (Figures 19 and 20). The bypass velocity was greater than the sweep velocity in June but not in May. Lots of small fish (not salmonids) were observed in both the forebay and aftbay in June and in the forebay in September.

Screen submergence met criteria in both May and June. The screen seals and screening appeared to be in good condition, and the drums were turning evenly. Water was running over the bypass weir, and the bypass was running smoothly into water over 1 ft deep. Some sand accumulation was noted in the aftbay in May, but this did not seem to cause any problems.

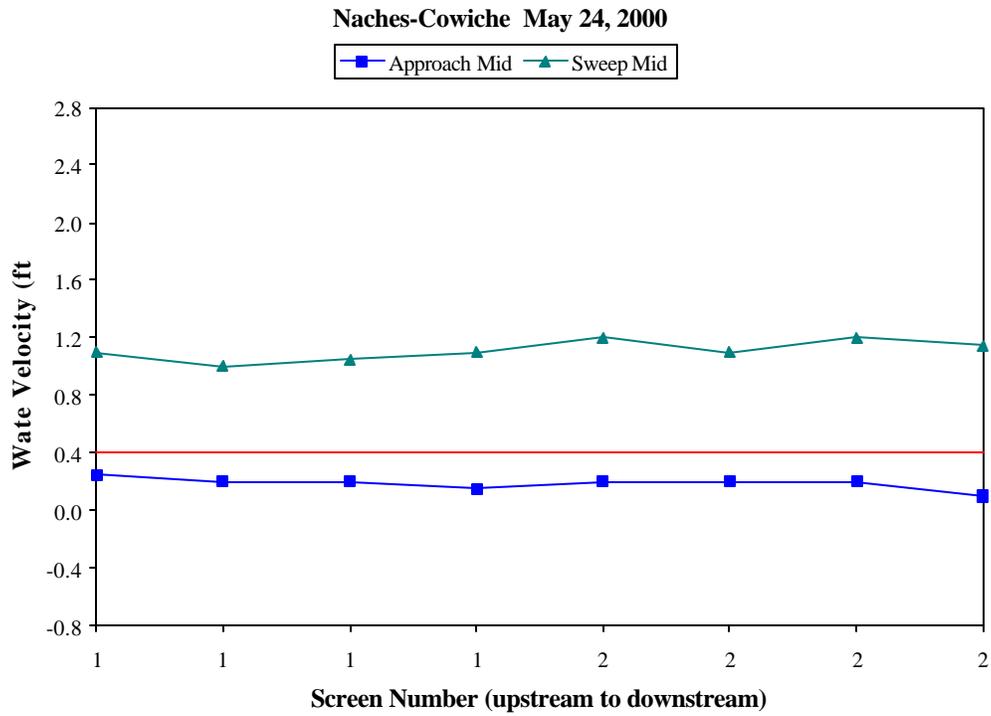
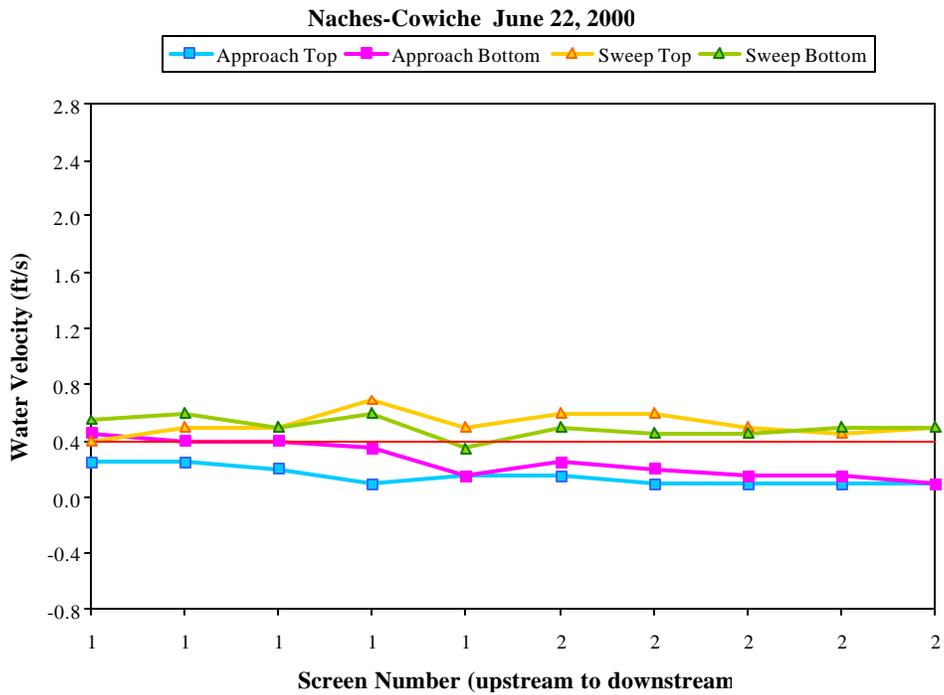
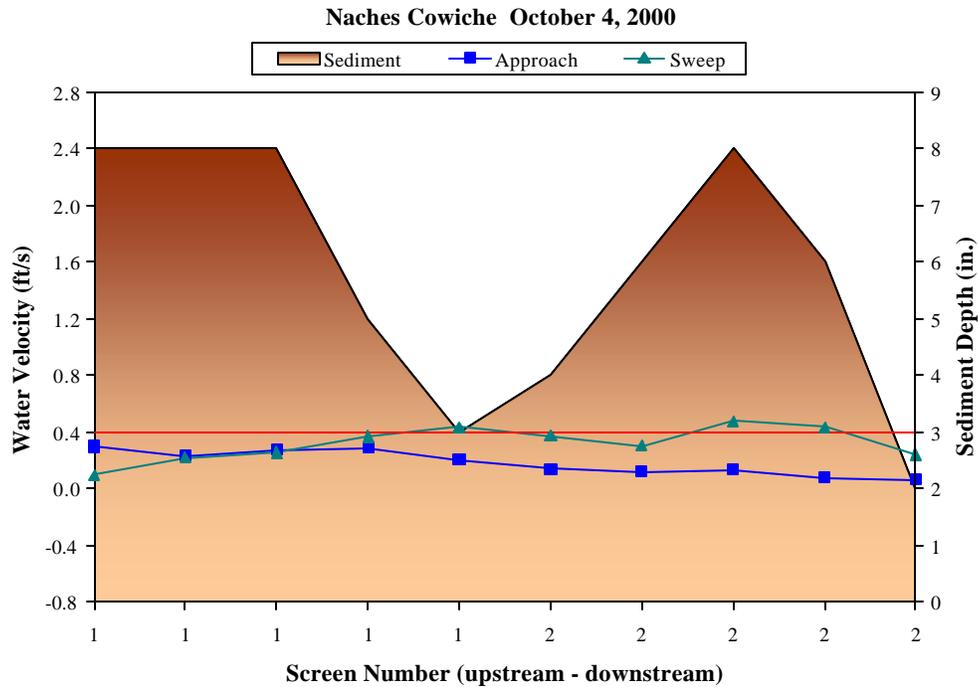
The Naches-Cowiche site was evaluated 5/24/00, 6/22/00, and 10/4/00. Only 2.6% of the recorded approach velocities exceeded 0.4 ft/s, down from 12% in 1999 (Figures 21, 22, and 23). Mean sweep velocities were greater than mean approach velocities, although they did not increase near the bypass. Bypass velocities were higher than mean sweep velocities. Screen submergence levels were within the bounds set by NMFS criteria (83, 78, and 65% in May, June, and September, respectively).

A 12-in.-tall “stop log” was used in front of screen 1 this year to try to limit the amount of sediment accumulating against the bottom seals and screens (Bill Werst, WDFW, personal communication). This prevented measurement of any sediment in front of the screens until the September visit, when the “stop logs” had been removed. As can be seen in Figure 23, there was a significant accumulation of sediment later in the season. Screens and seals were in good condition and drums turned evenly. Water always flowed smoothly over the weir. Conditions for fish at the outfall site were always good.

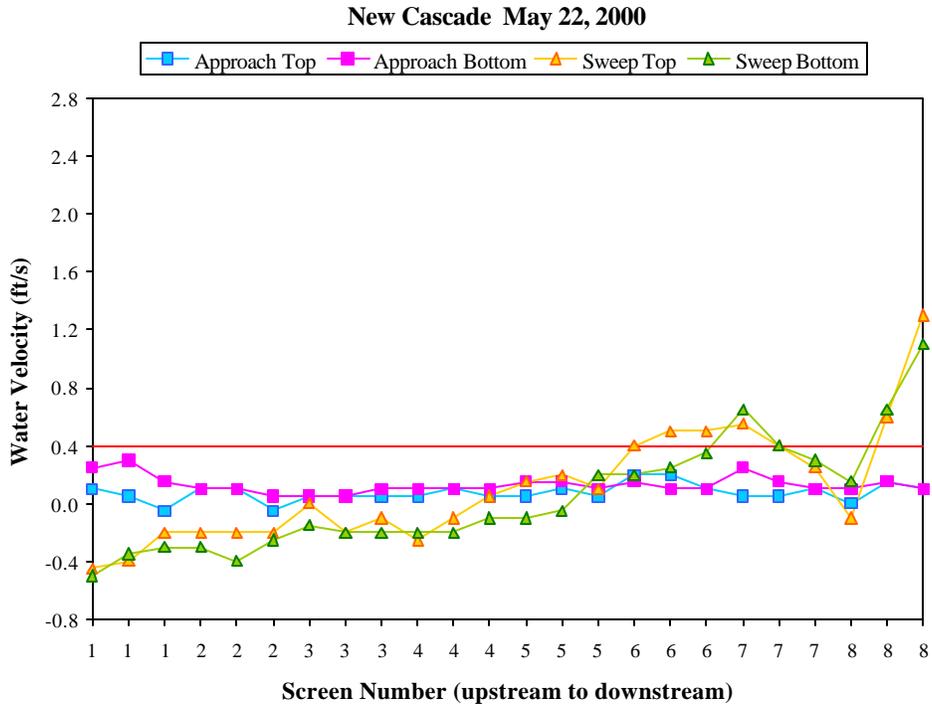
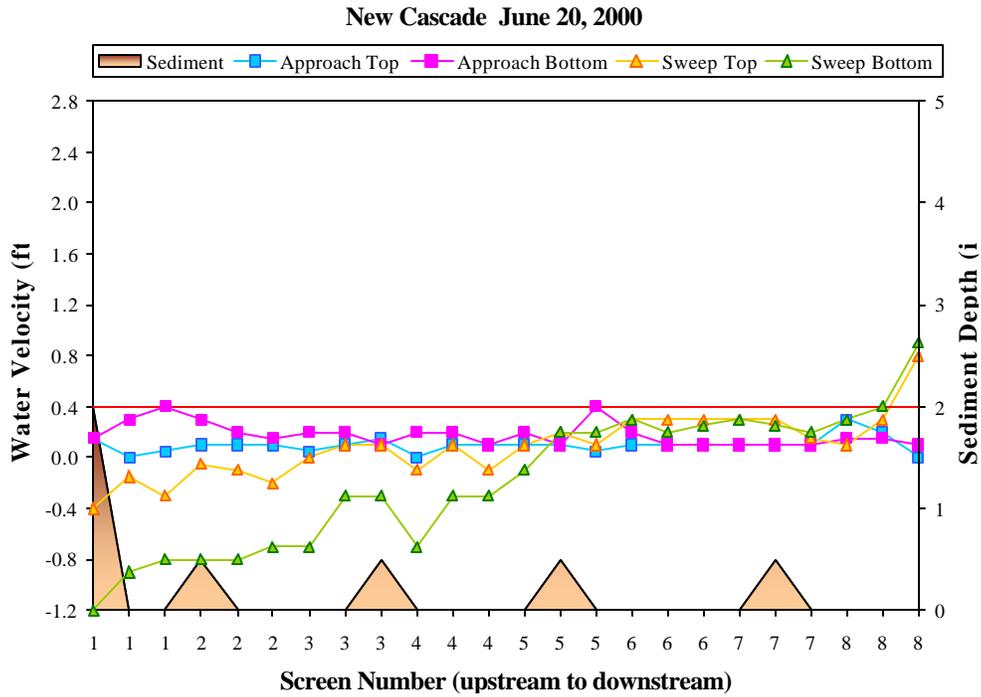
New Cascade was evaluated on 5/22/00, 6/20/00, and 9/21/00. In the past, electrical interference has limited our ability to measure water velocities at this site. We used the Marsh-McBirney probe at this site to collect data that seemed to be reasonable. The approach velocities measured at New Cascade in May and June were at or below the 0.4 ft/s NMFS criteria. In September, problems with the Marsh-McBirney probe prevented accurate measurements of flow velocities. Sweep velocities in May and June were consistently below the approach velocities at the first five drum screens and then increased for the final three screens further downstream (Figures 24 and 25). Mean sweep velocities appeared to be quite low because of the negative values for the first several screens. These negative or upstream sweep flows could have been real or could have been an artifact of whatever has caused electrical interference in the past. We will try to use the ADV system at this site next year, since it is not affected by electrical noise, to determine if this flow pattern is real. If it is real, it could cause delay in fish emigration downstream. Aluminum cans, sand, and aquatic plants accumulated throughout the summer, and in places, the aquatic plants obscured the bottom seals. Abundant small fish were observed in the forebay in June and September, but none were seen in the aftbay.

Screen submergence exceeded NMFS criteria during all three evaluations. Bypass velocities exceeded mean sweep velocities; however, many sweep velocities were negative. The screen material generally looked good. Some of the expanding insulation placed between the concrete and “cheek” of the frame was coming loose at one end and floating adjacent to the drum. Screen 8 had notches of material broken off the downstream seal (Figure 26). Water in the downwell was somewhat turbulent in May and June, causing bubbles of air to surge from the outfall pipe. Outfall conditions for fish were always within NMFS criteria.

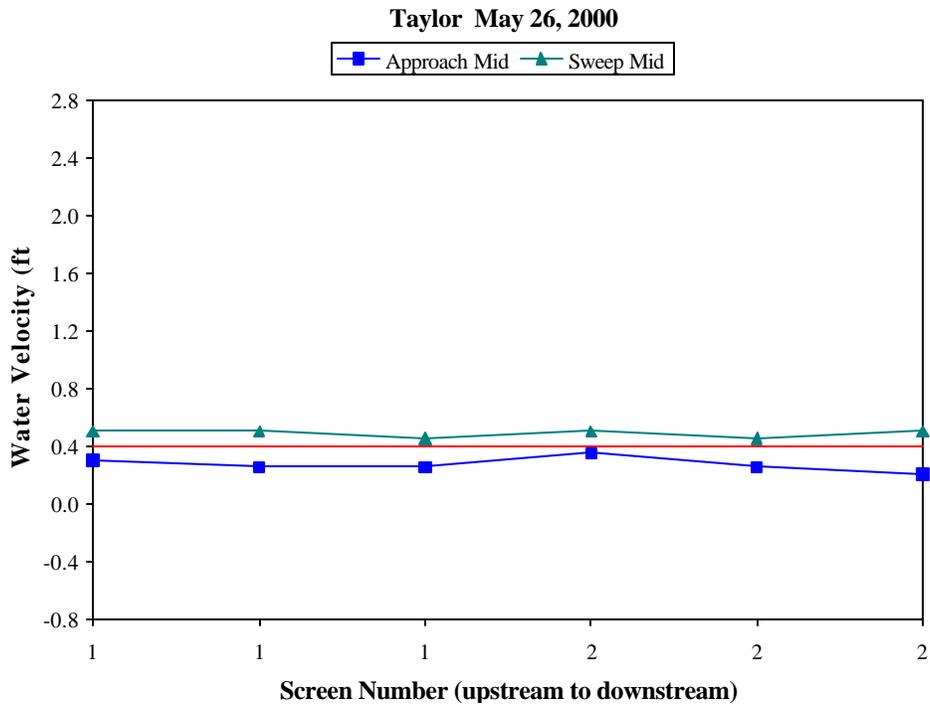
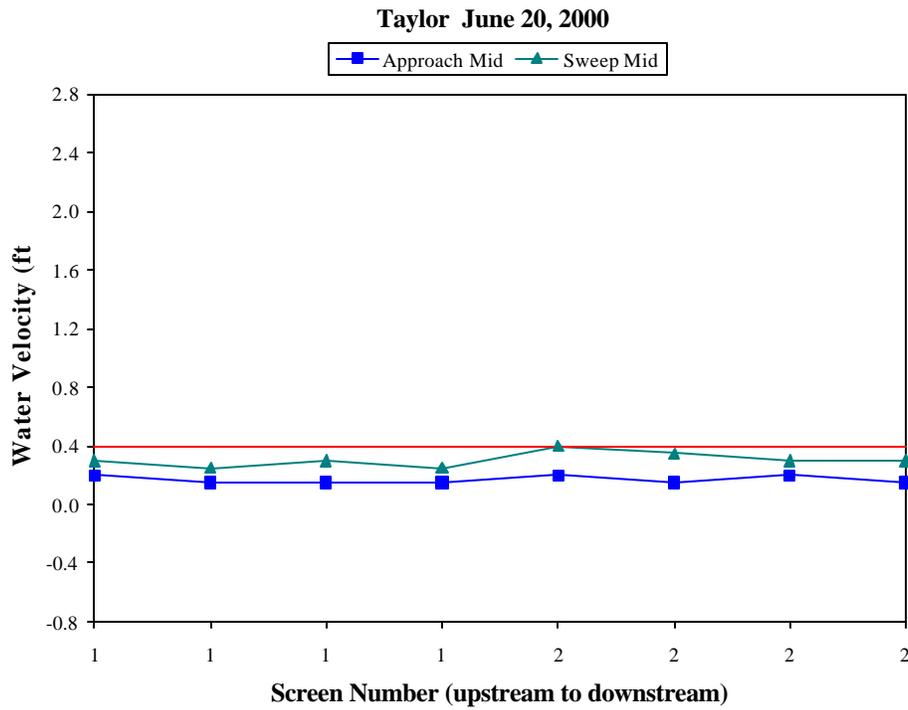
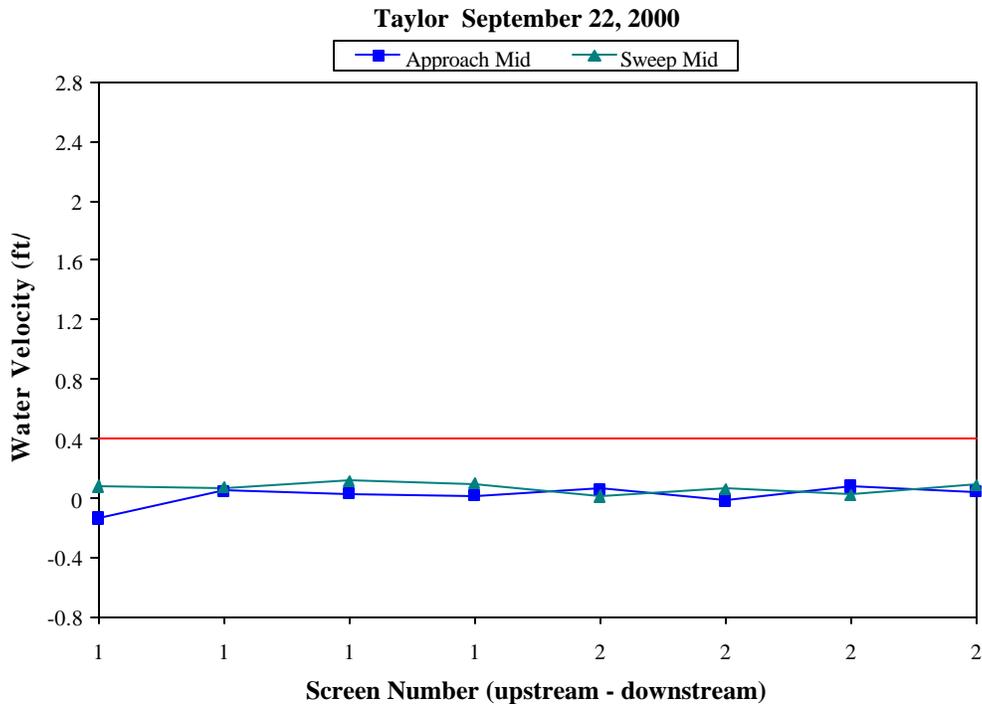
The Taylor site was evaluated 5/24/00, 6/20/00, and 9/22/00. All approach velocities recorded met NMFS criteria, and sweep velocities were greater than approach velocities. Sweep velocities did not increase toward the bypass in May or June (Figures 30, 31, and 32). In September, screen 1 had been turned off, screen 2 was still turning, and there was no water flowing over the weir (Figure 31). However, water was flowing below the stoplogs into the aftbay in September. Bypass velocities exceeded mean sweep velocities at this site in May and June; there was no flow through the bypass in September. Screen submergence was 80% in May and June and 37% in September. The site logbook indicated the screens were almost overtopped in May and June, but the headgates were used to lower the water levels.

Screen 2 no longer exhibited the rough jerking motion noted the past 2 years. The bottom seal for screen 2 does not fit snugly against the drum, causing numerous small gaps along its length. Side seals and the bottom seal along screen 1 all looked good. Debris was not a problem, and silt deposition was relatively low. Water flowed freely behind the bypass weir, and the outfall was running smoothly and discharged into an area that was over 1 ft deep. The outfall is generally overgrown with brush and grasses and is often hard to observe. Fish were seen in the forebay in September, a snake was seen in June in the forebay, and there was a fish in the aftbay in May at this site.

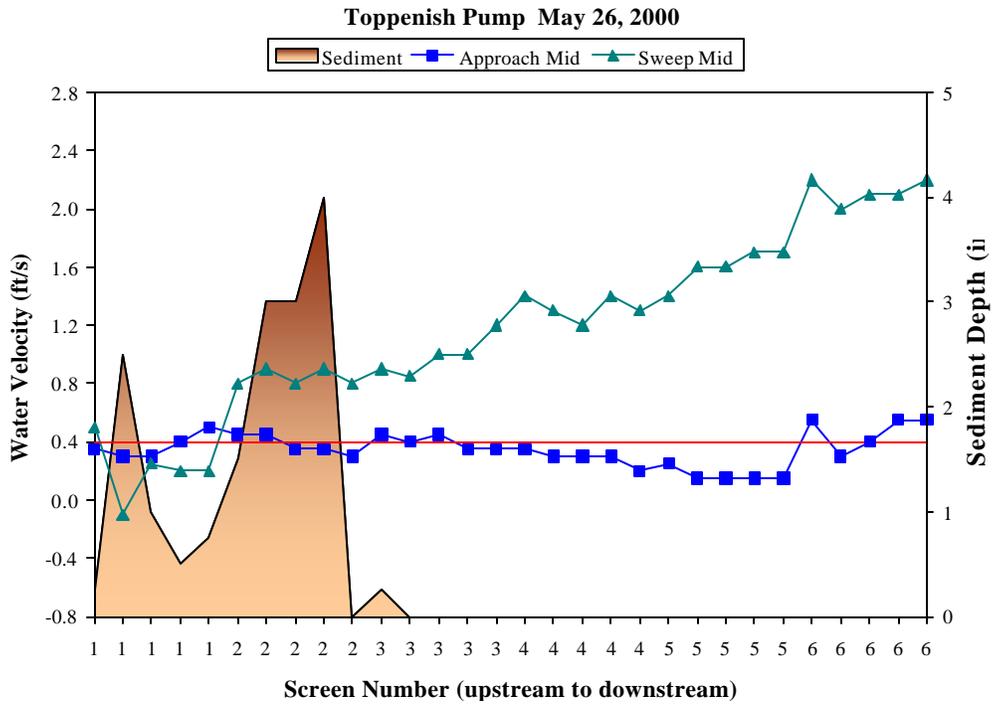
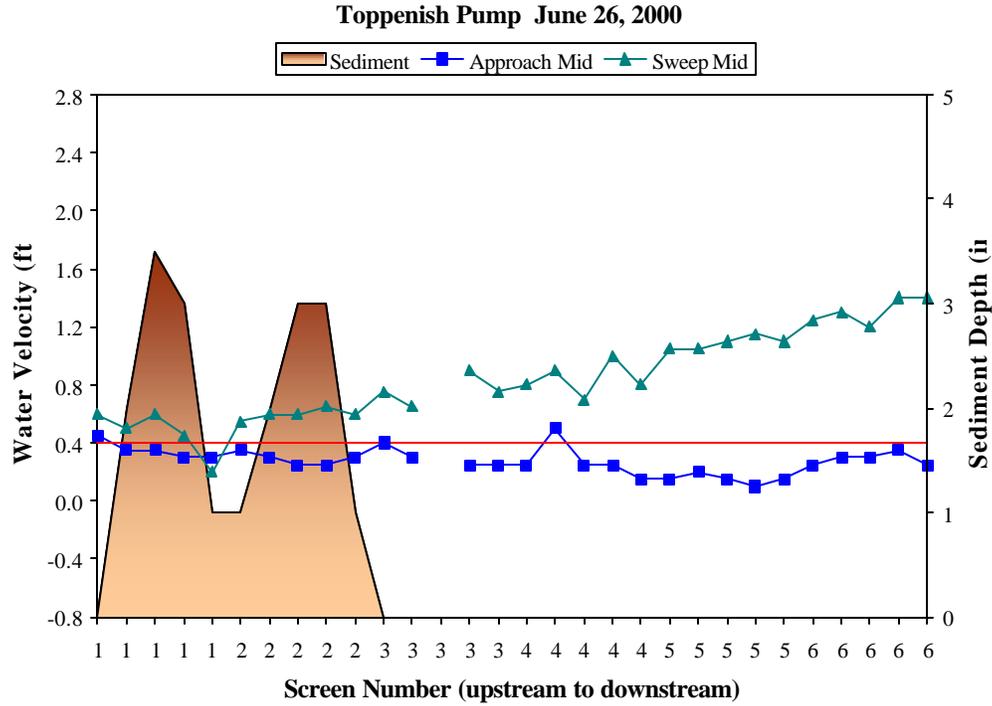
This site was evaluated 5/26/00, 6/26/00, and 9/15/00. Almost 91% of the approach velocities measured at this site in 2000 met the NMFS criteria (Figures 33, 34, and 35). Approach velocities have been steadily improving since 1998, when 60% of the approach velocities exceeded 0.4 ft/s. Sweep velocities were generally greater than approach velocities and increased toward the bypass. Bypass velocities exceeded sweep velocities by a large margin. Screen submergence was approximately 52, 70 and 68% in May, June, and September, respectively.

Screens were partially covered in brown algae and diatoms, but seemed to be functioning normally. All screens turned smoothly, and seals were generally in good condition. Water was too turbid during all three evaluations to observe the bottom seal very well. There is no standard weir here; a stoplog is used in the bypass entrance to control flow. Water flowed freely through the bypass entrance, but sometimes formed a “whirlpool” in front of the entrance to the outfall pipe. Conditions were acceptable for fish bypass. Some woody debris accumulated near the bottom seals, but did not pose a problem. Sediment tended to accumulate near the upstream screens, and occasionally got close to the bottom seal. Small fish were observed in the aftbay in both June and September.

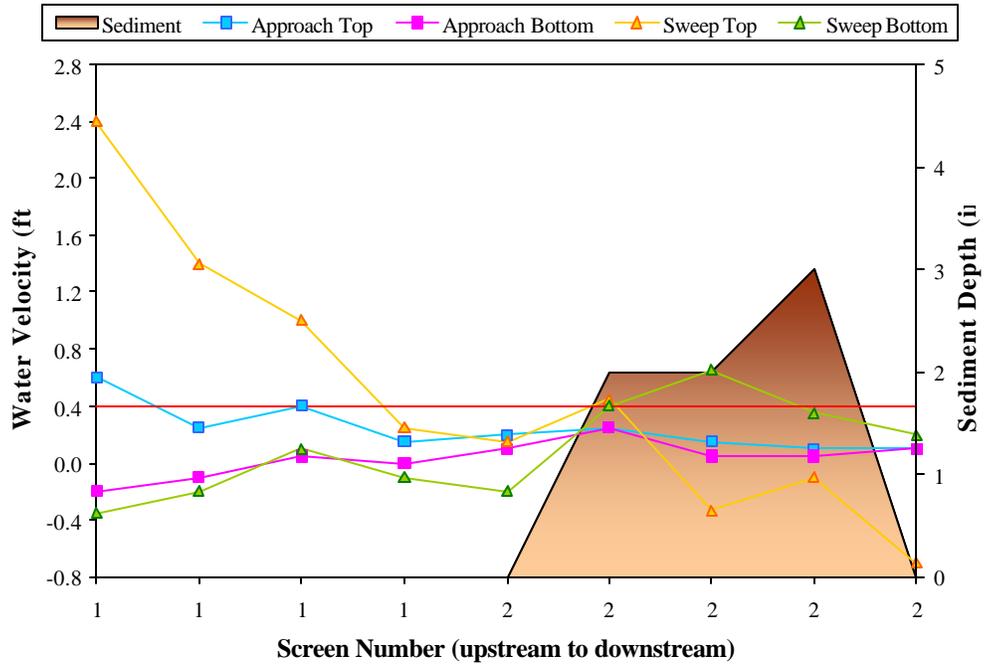
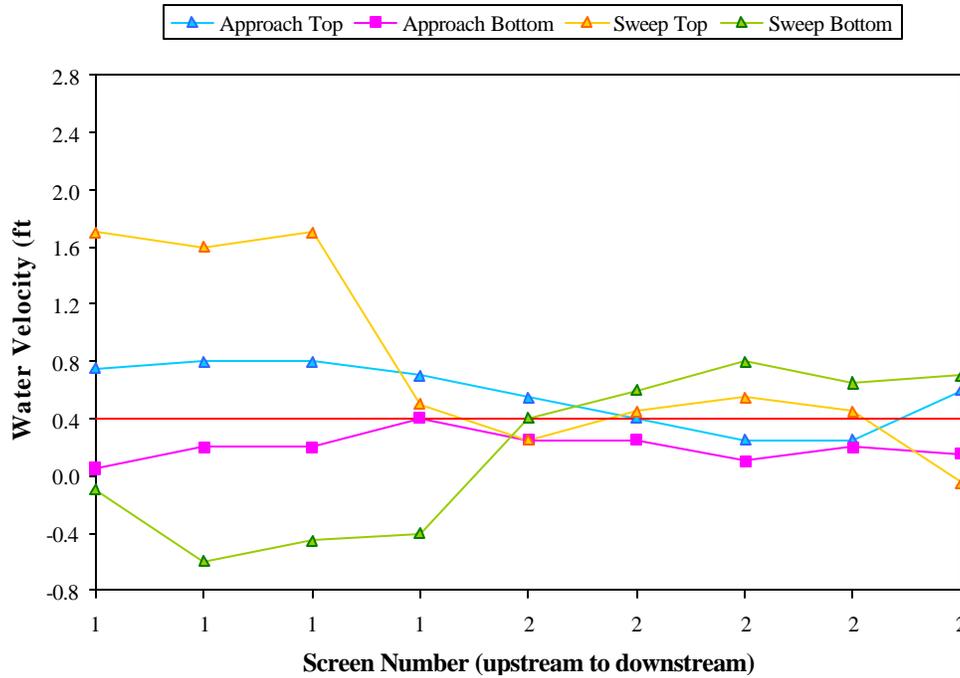
The Bull Ditch site was evaluated 5/23/00, 6/20/00, and 9/21/00. At least 22% of the recorded approach velocities exceeded 0.4 ft/s in 2000. Mean sweep velocities were higher than mean approach velocities (Figures 39 and 40). Sweep at the downstream end of panel 2 actually eddied around to move upstream in the upper portion of the panel. Overall, bottom sweep values were often less than corresponding approach velocities. Equipment problems prevented velocity measurements in September, but a video survey and visual inspection were performed. Water levels were fairly high with 88% of the screen submerged in May and June.

The screens were generally in good condition. Some caulking was missing in places along both the bottom and side seals. Woody debris and sediment tend to accumulate on the bottom in front of the downstream screen panel. The cleaning brushes were unable to permanently move the leaves and twigs off of the screen; eddies around the brushes seemed to push the loose material back onto the screen. This resulted in debris build-up, but this did not seem to cause headloss across the screen. This site was much cleaner at the surface in 2000 – sandbags that were on the walkways in 1999 had been removed by the first visit in May.

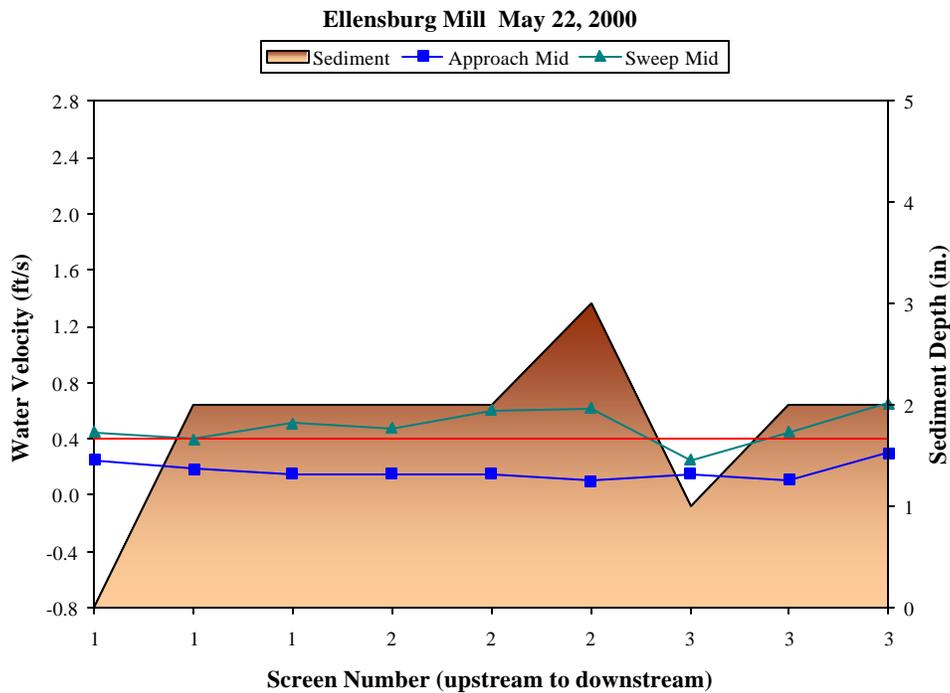
Figure 41. Water Velocities and Sediment Depths at the Ellensburg Mill Site, 5/22/00

The Ellensburg Mill site was evaluated 5/22/00, 6/19/00, and 9/21/00. Screen submergence levels during all three evaluations were below NMFS criteria, with submergences of 49, 51, and 59% in May, June, and September, respectively. This site often has low water levels. Equipment problems prevented measurements of velocity in September, but a video survey and visual inspection were performed. In May and June, mean sweep velocities were higher than mean approach velocities (Figures 41 and 42). Twenty-six percent of the measured approach velocities were greater than 0.4 ft/s. Sweep did not generally increase near the bypass. In May and June, bypass velocities were greater than the mean sweep velocities.

The screens were in fairly good condition, although build-up of algae along screen 1 near the bottom may have been plugging some of the screen openings. This same build-up, along the bottom seal in particular, made it difficult to inspect the bottom seal. Some caulking may have been missing along the bottom in places. The weir was set in flush mode each time the site was visited, with fairly turbulent flow in the downwell. Conditions at the outfall were good for fish passage in 2000. Several fish were noted in the forebay in June.

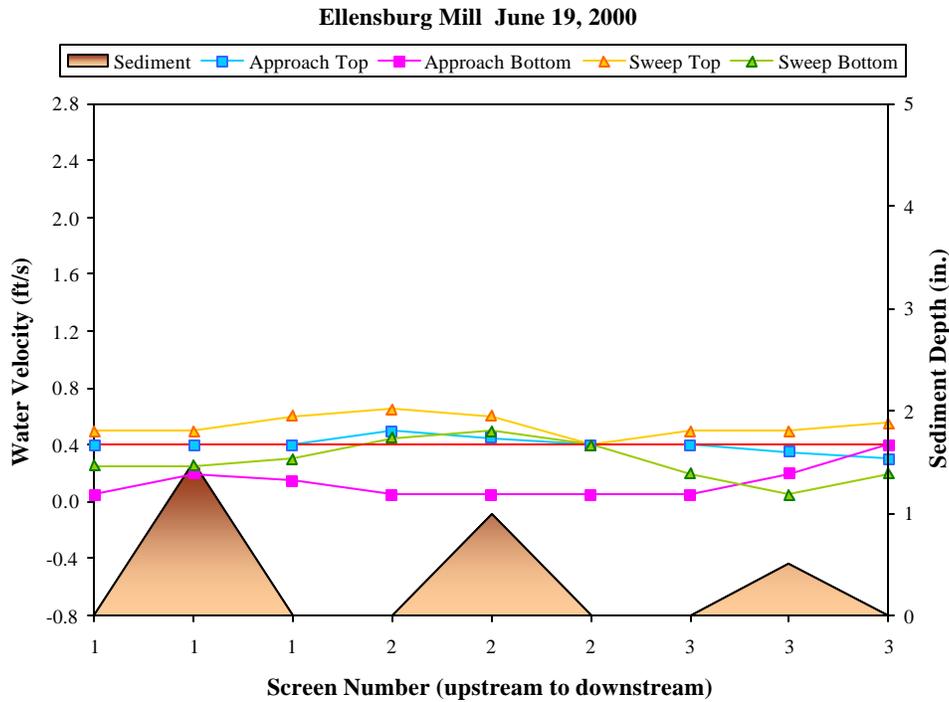
Figure 42. Water Velocities and Sediment Depths at the Ellensburg Mill Site, 6/19/00
