Washington Phase II Fish Diversion Screen Evaluations in the Yakima River Basin

Annual Report 2000

March 2001

DOE/BP-00000652-3

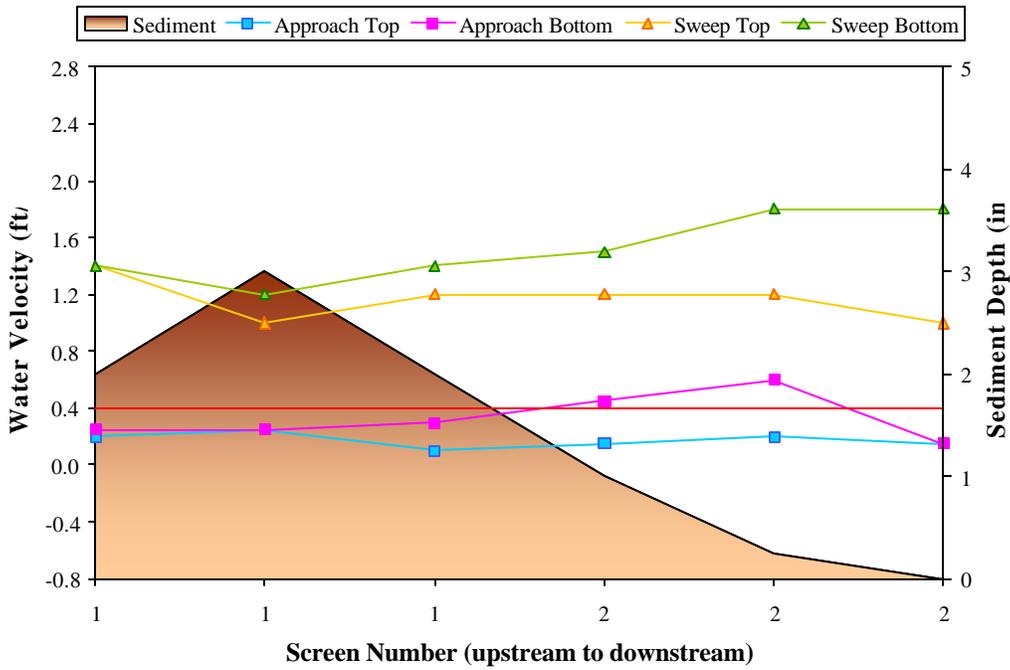
Fruitvale May 24, 2000

The Fruitvale site was evaluated 5/24/00, 6/22/00, and 9/22/00. Electrical interference kept us from collecting any reliable water velocities in the past. We decided to try to measuring velocities in May and June using the Marsh-McBirney probe and then used the Sontek ADV system in September. The results are presented in Figures 43, 44, and 45. Almost 83% of the measured approach velocities were below 0.4 ft/s. Mean sweep velocities were greater than mean approach velocities during all surveys. Sweep velocities did not increase consistently toward the bypass. Bypass velocities were greater than mean sweep velocities.

Figure 43. Water Velocities and Sediment Depth at the Fruitvale Site, 5/24/00

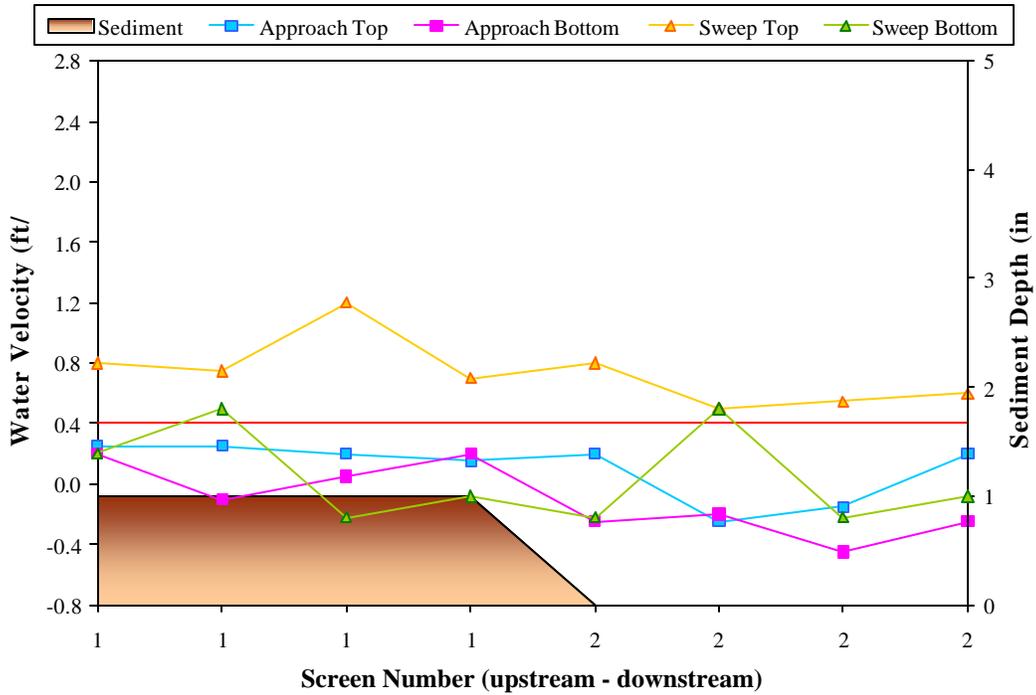
Fruitvale June 22, 2000

Figure 44. Water Velocities and Sediment Depth at the Fruitvale Site, 6/22/00

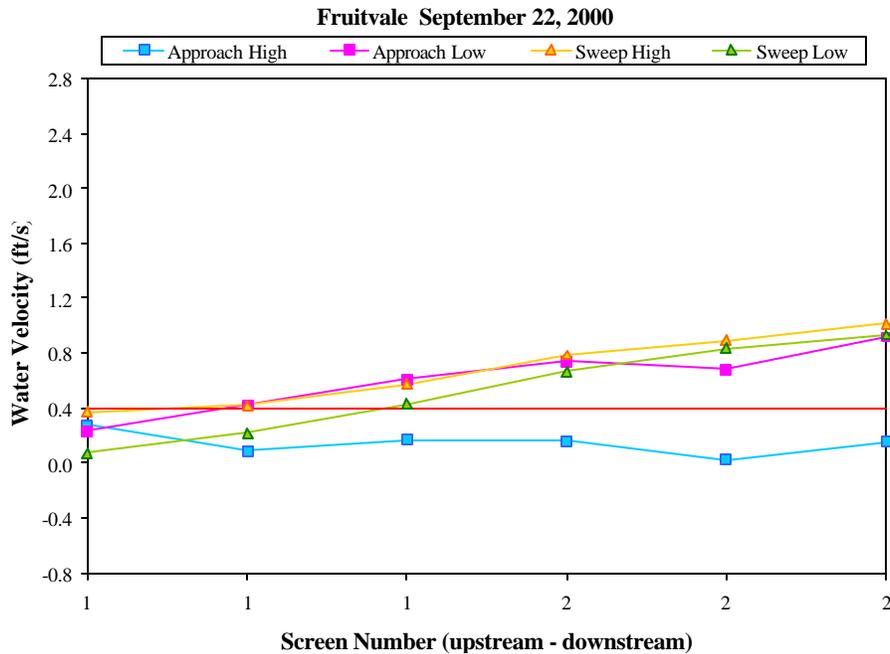
Figure 45. Water Velocities at the Fruitvale Site, 9/22/00. Sediment depth was not measured.

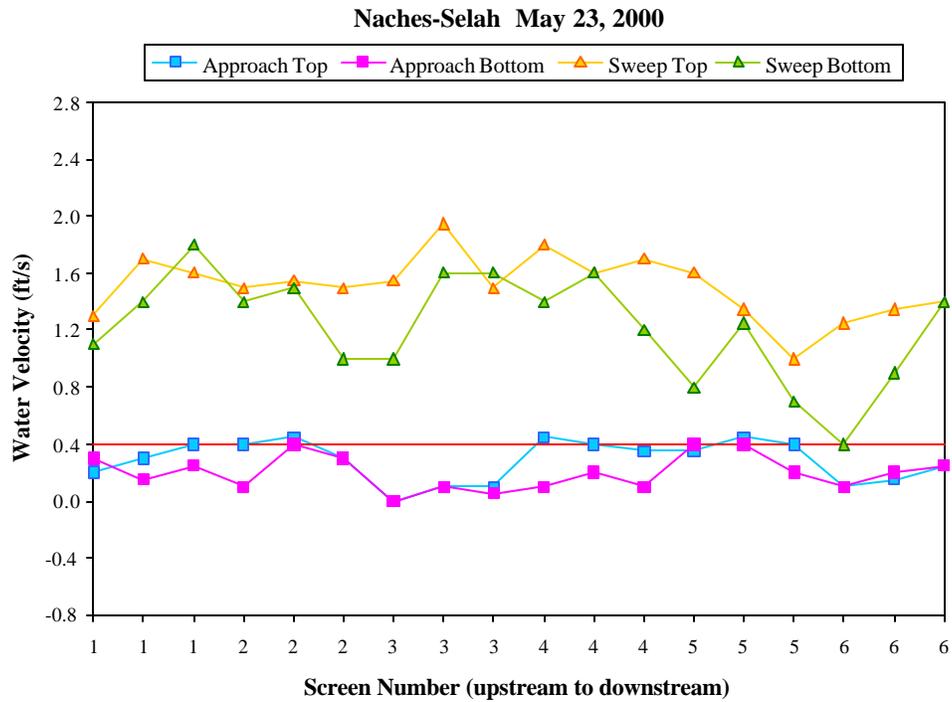
This site was evaluated 5/23/00, 6/21/00, and 10/4/00. Almost 29% of the approach velocities at Naches-Selah were greater than 0.4 ft/s (Figures 46, 47, and 48). This was similar to 1999 when 28% of the approach values were greater than 0.4 ft/s. The highest approach velocities were in October, when over 69% of the approach velocities exceeded 0.4 ft/s. Mean sweep velocities were generally much greater than their corresponding mean approach velocities. Bypass velocities were higher than the mean sweep velocities in May and June, but not in October. Screen submergence values for this flat plate screen were 90 and 85% in May and June, respectively. They were not measured in September. The submergence marks became much harder to read as summer progressed.

Figure 46. Water Velocities at the Naches-Selah Site, 5/23/00

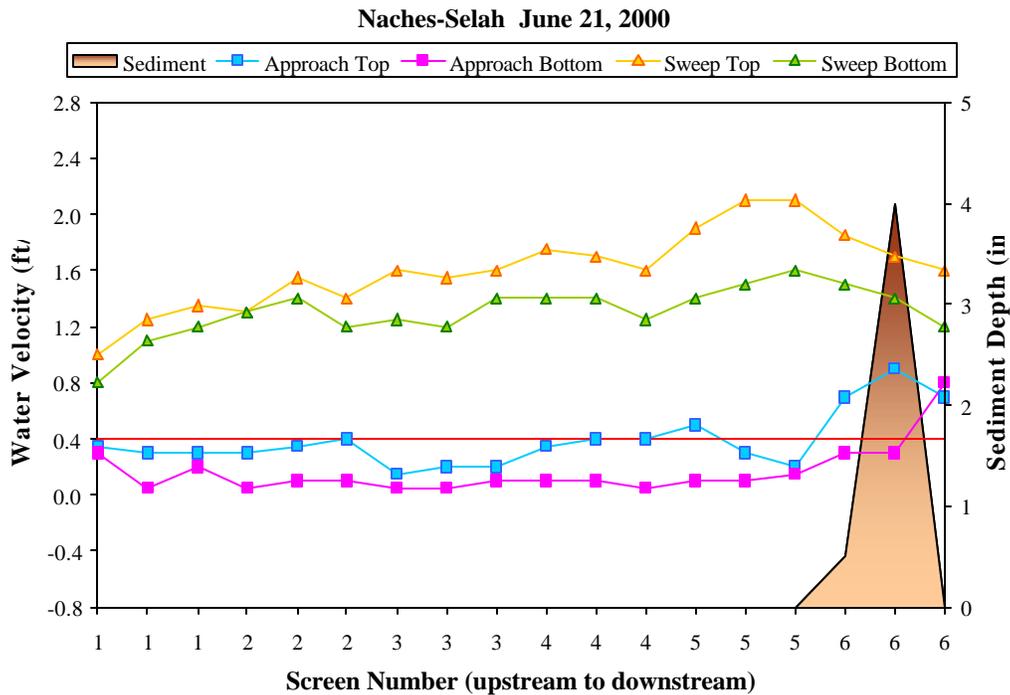
Figure 47. Water Velocities and Sediment Depths at the Naches-Selah Site, 6/21/00

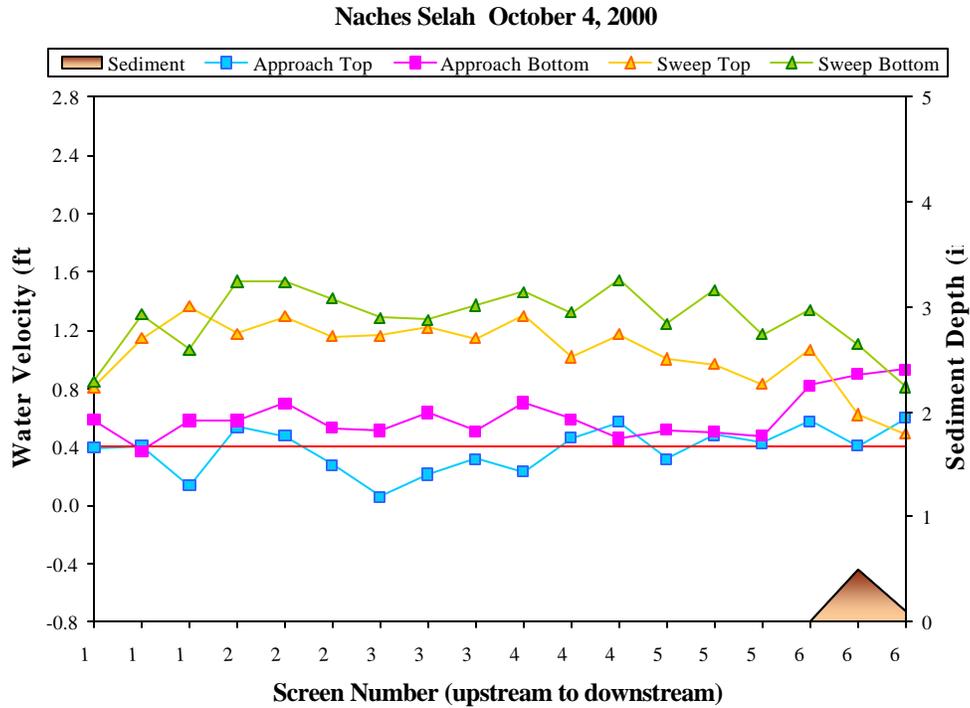
Figure 48. Water Velocities and Sediment Depth at the Naches-Selah Site, 10/4/00

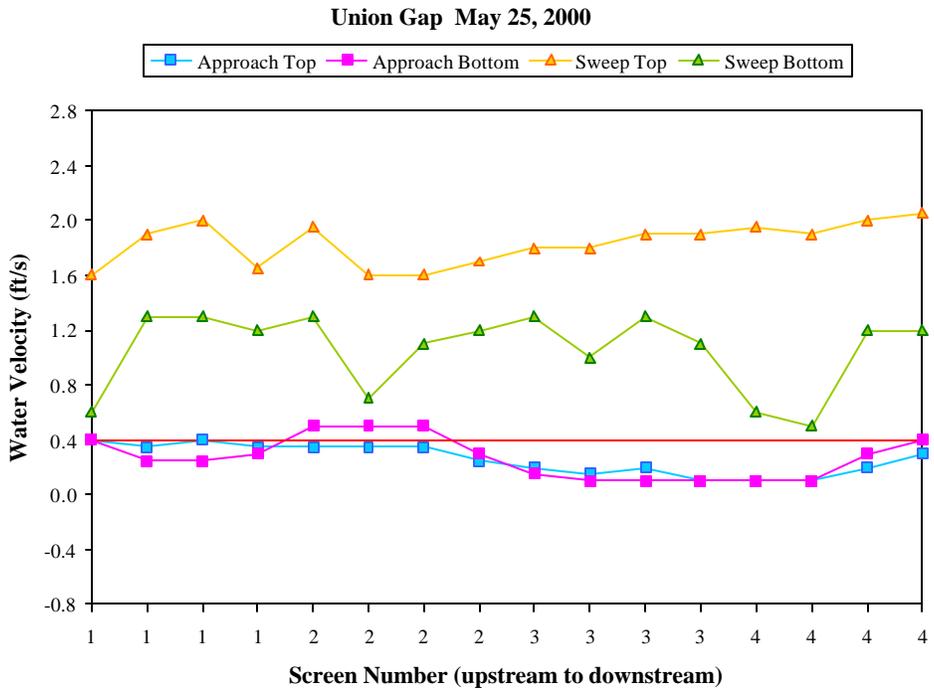
The Union Gap site was evaluated 5/25/00, 6/22/00, and 10/4/00. Approach velocities in 2000 were lower than in 1999, with only 12.5% of the approach velocities exceeding 0.4 ft/s (Figures 49, 50, and 51). Mean sweep velocities were always substantially higher than mean approach velocities. In May, sweep velocities increased slightly near the bypass; in June they remained relatively constant; and in October they decreased slightly near the bypass. Bypass velocities were greater than mean sweep values during each survey. Screen submergences at this flat plate site were 94 and 92% in May and June, respectively.

Figure 49. Water Velocities at the Union Gap Site, 5/25/00

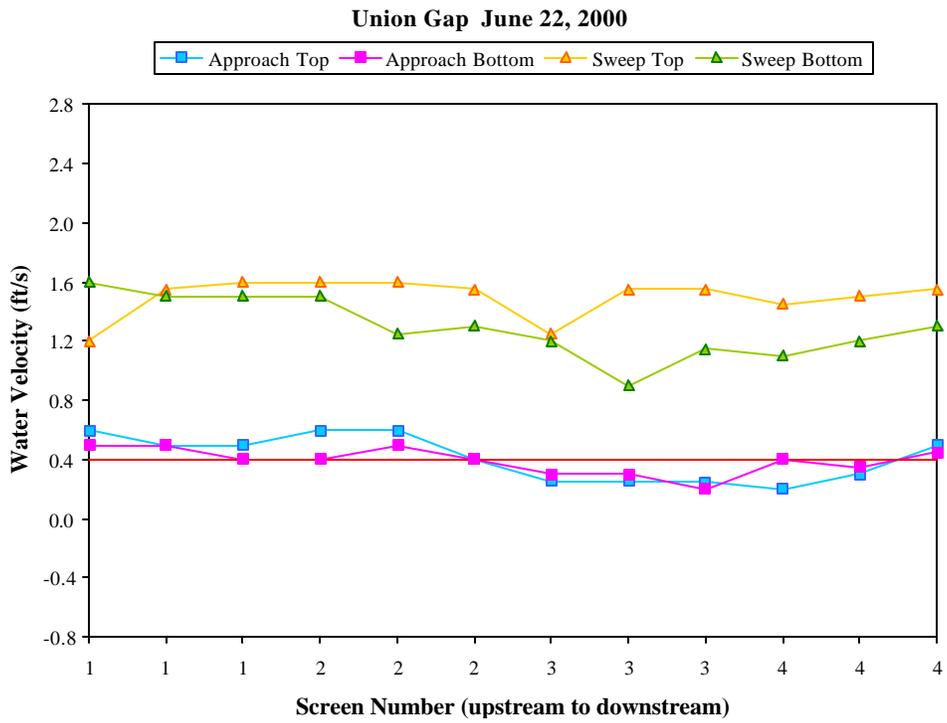
Figure 50. Water Velocities at the Union Gap Site, 6/22/00

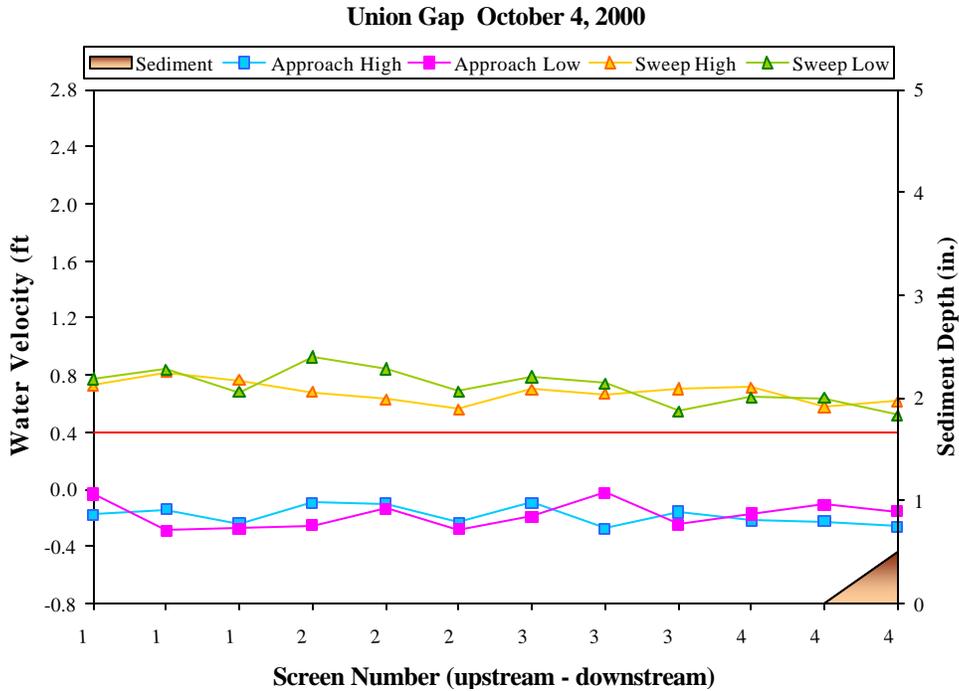
Figure 51. Water Velocities at the Union Gap Site, 10/4/00

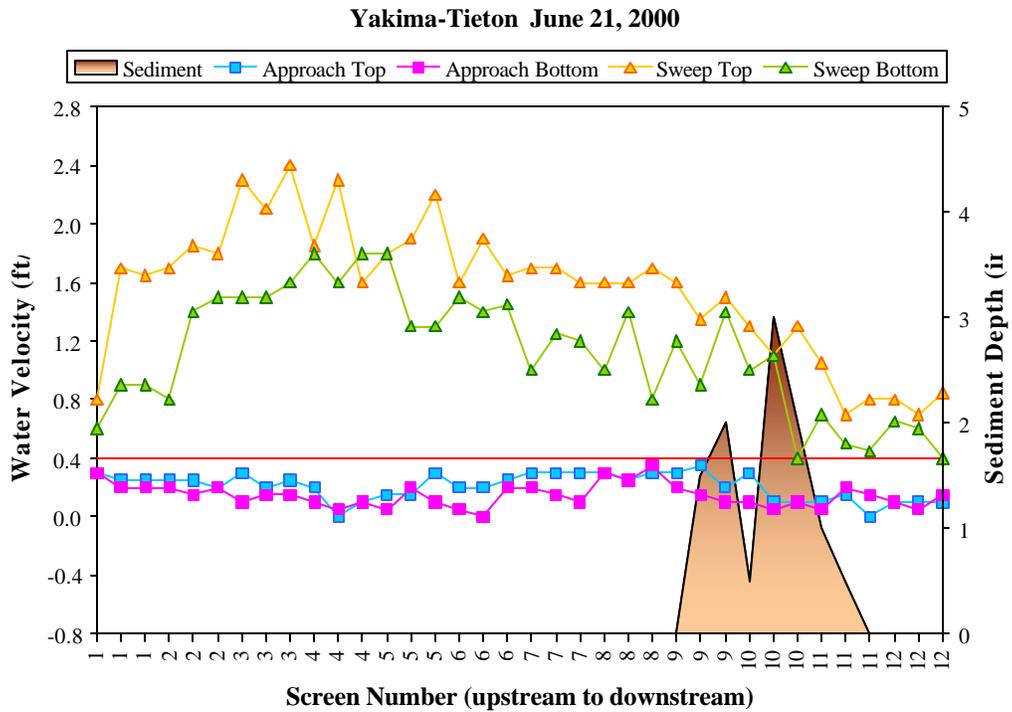
The Yakima-Tieton site was evaluated 5/23/00, 6/21/00, and 9/18/00. Velocity measurements were not made in May, and equipment problems prevented accurate measurement of sweep velocities in September. Over 98% of the recorded approach velocities in June were less than 0.4 ft/s (Figures 52 and 53). Water flows very quickly at this site, and sweep velocities were much higher than their corresponding approach velocities. Sweep velocities were higher than the bypass velocity. Sweep velocities also decrease toward the bypass, but were generally high enough to mitigate this condition. Screen submergence at Yakima-Tieton was 87% in June.

Figure 52. Water Velocities and Sediment Depths at the Yakima-Tieton Site, 6/21/00

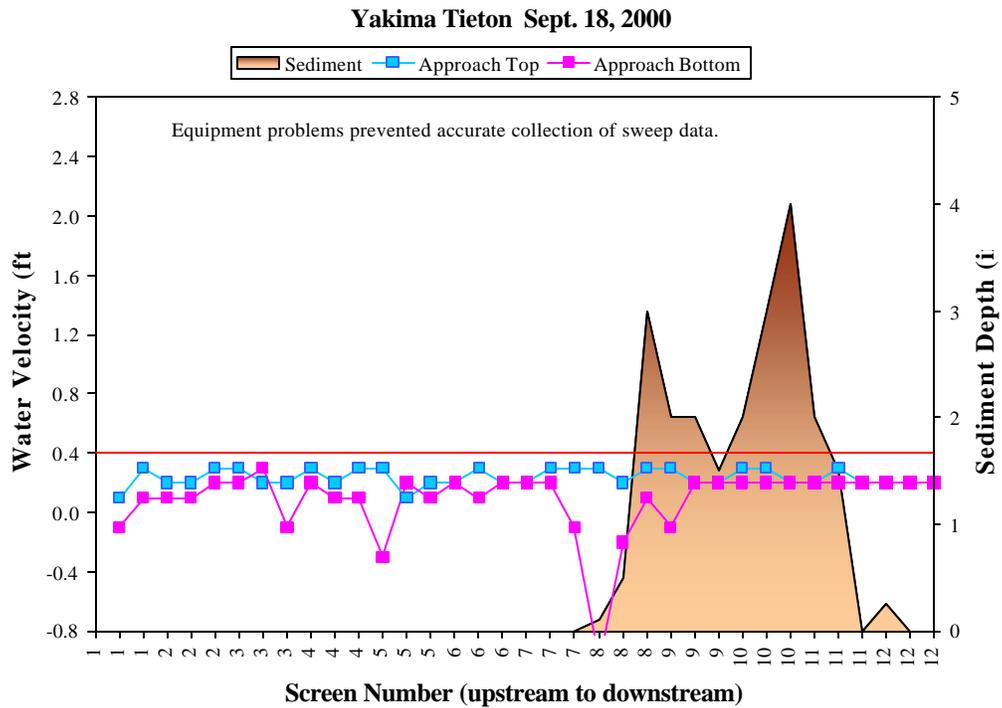
Figure 53. Water Velocities and Sediment Depths at the Yakima-Tieton Site, 9/18/00

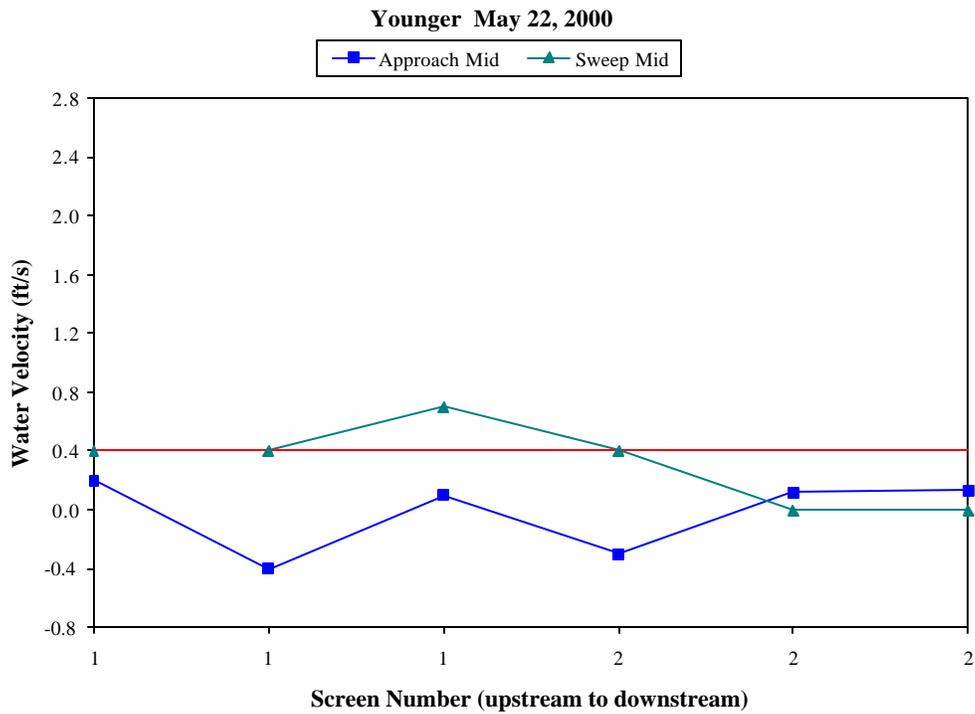
The Younger site was evaluated on 5/22/00, 6/20/00, and 9/21/00. Most approach velocities were below NMFS criteria of 0.4 ft/s and the one exception may have been caused by eddies from the brushes cleaning the screens (Figures 54 and 55). The cleaning brushes run continuously and affect water velocities. Brushes are run by a hydraulic paddle-wheel system. The facility had been shut down for the season prior to our visit in September, and no water was moving into the canal. Mean sweep velocities exceeded mean approach velocities during both surveys. Submergence was approximately 50% in May and 70% in June. Screen and seal conditions were good. This site has no bypass. Debris was not a problem at Younger during the 2000 evaluations.

Figure 54. Water Velocities at the Younger Site, 5/22/00

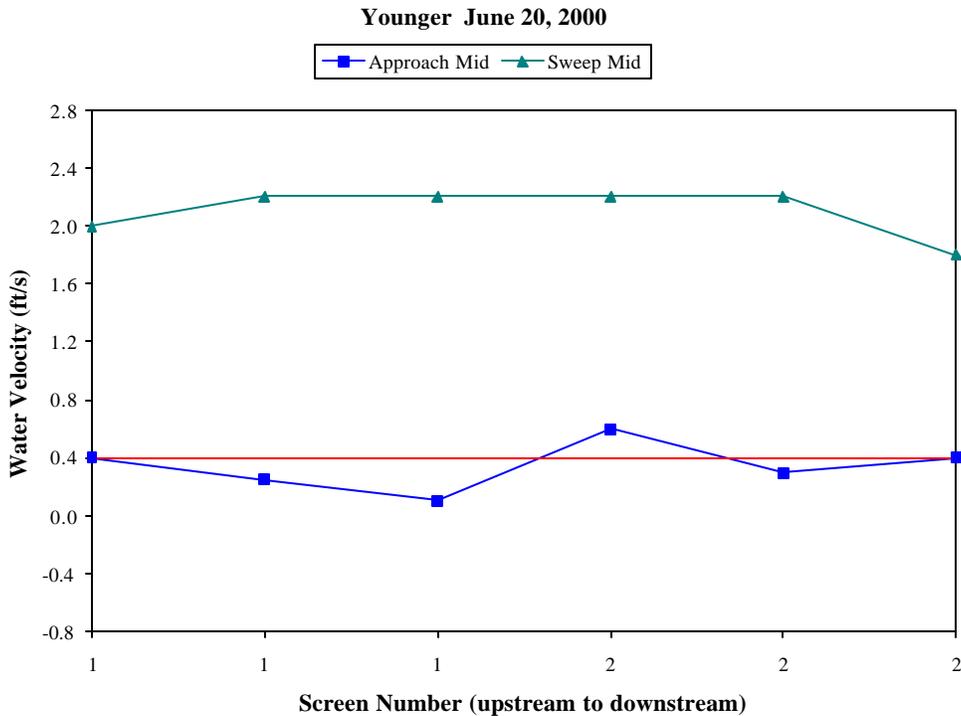
Figure 55. Water Velocities at the Younger Site, 6/20/00

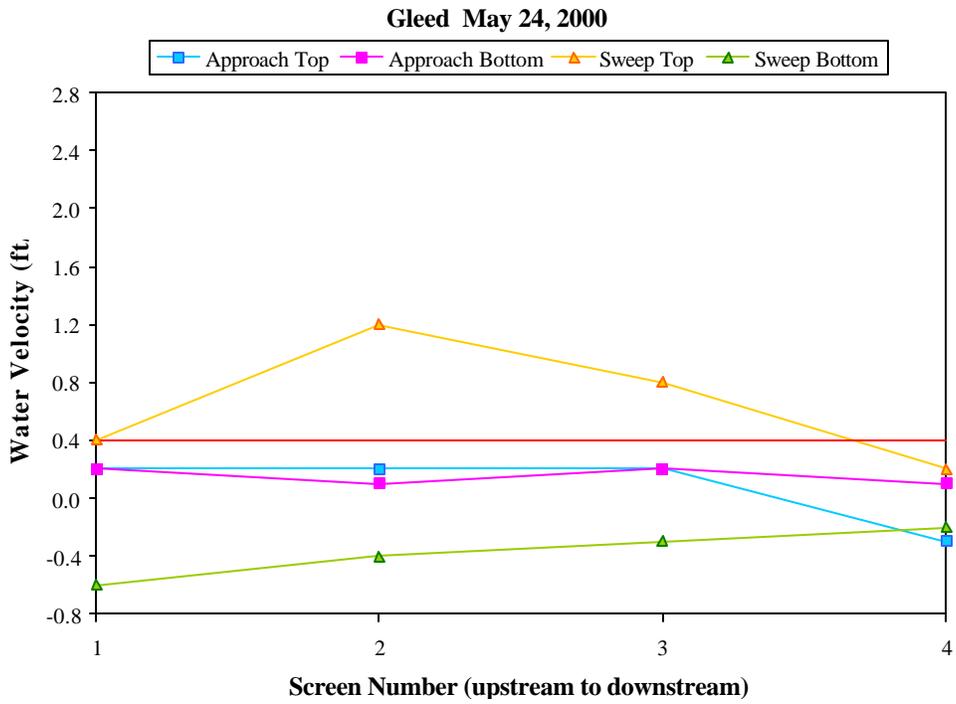
The Glead site was evaluated 5/24/00, 6/22/00, and 10/4/00. In the past, electrical interference with the Marsh-McBirney probe prevented us from collecting much water velocity data. We tried once again this year using the same probe in May and June and the ADV system in October. The velocity data we were able to collect in May and October look reasonable, although the data collected in June is highly variable (Figures 56, 57, and 58). The variability in June could be due to electrical interference or water swirling around the steel plates put on the stream side of the facility to prevent branches and other large debris from damaging the screens. A third possibility is that changes on 6/19/00 to the height of steel plates protecting the screens could have caused the variability.

Figure 56. Water Velocities and Sediment Depths at the Gleed Site, 5/24/00

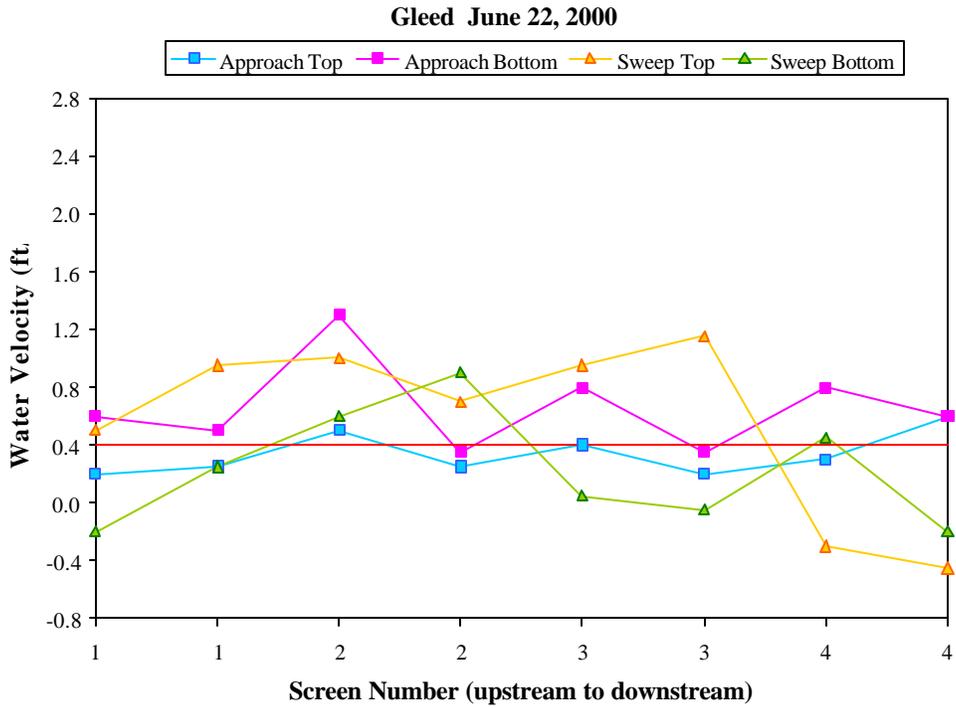
Figure 57. Water Velocities at the Gleed Site, 6/22/00

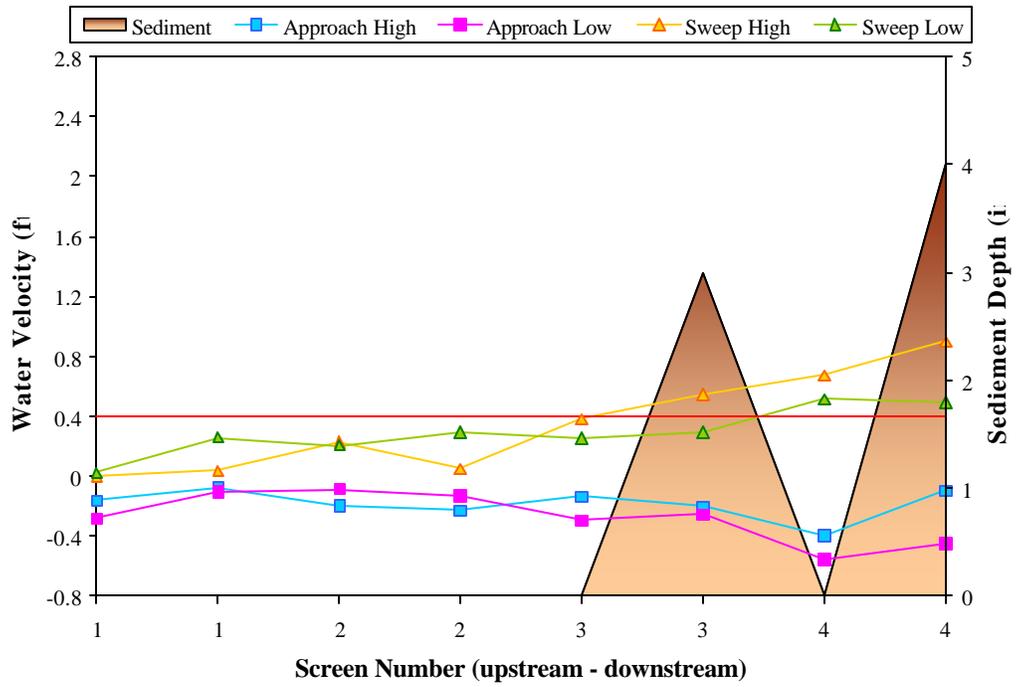
Gleed October 4, 2000

Figure 58. Water Velocities and Sediment Depths at the Gleed Site, 10/4/00
