# Failure Analysis of 6.8 Evaporator Thermowell (U)

Savannah River Technology Center  
Strategic Materials Technology Department  
Materials Technology Section

June, 2004

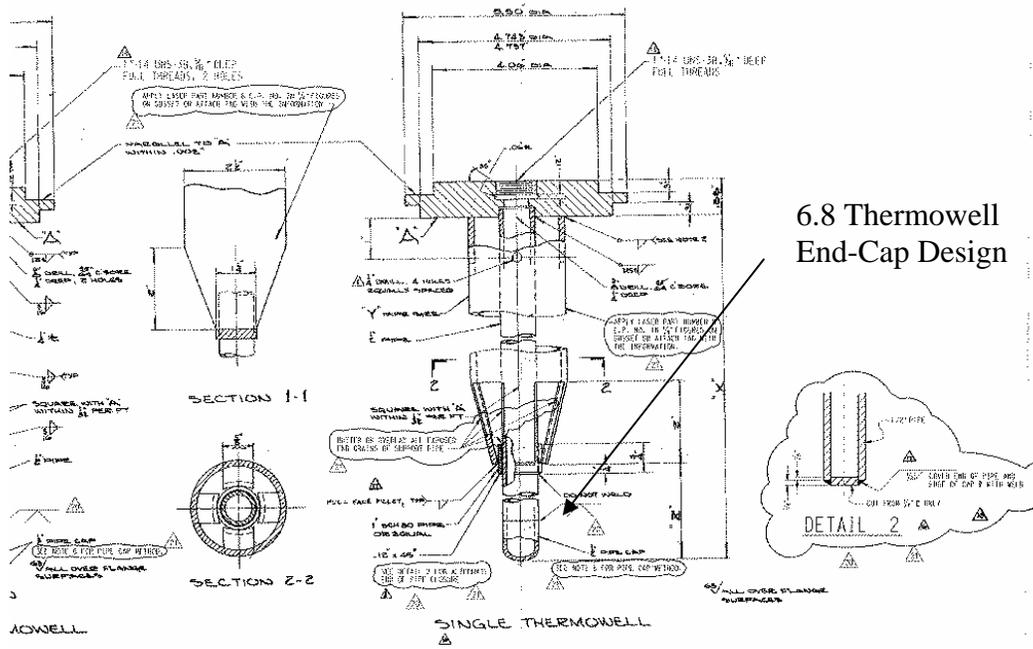
Figure 1. Drawing of Jumper Thermowell For LAW Evaporators (D138562).

The thermowell from the current failure was presumed to have also been penetrated. Initial testing and observations, however, did not support this conclusion. The drawing of a thermowell is shown in Figure 1. No leak was found when the inner tube was pressure tested to 50 psi. After this test, the RTD could not be removed from the thermowell, which was atypical. During the replacement of the RTD and thermowell, significant moisture was noted on the RTD wiring between the Upper and Lower Hanford connectors. The connector pins in the upper Hanford connector were covered with a black film/coating indicating oxidation of the pins.
