COMBUSTION TURBINE (CT) HOT SECTION COATING LIFE MANAGEMENT

Semi Annual Technical Progress Report

***Agreement Number:* DE-FC26-01NT41231**

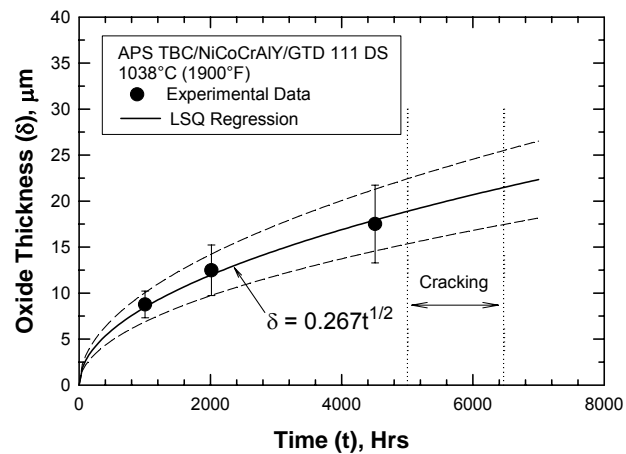
Figure 5-6. Determination of the critical oxide thickness at TBC cracking for APS TBC/NiCoCrAlY/GTD 111 DS. TBC cracking was observed after 5000 hrs at 1038°C (1900°F).

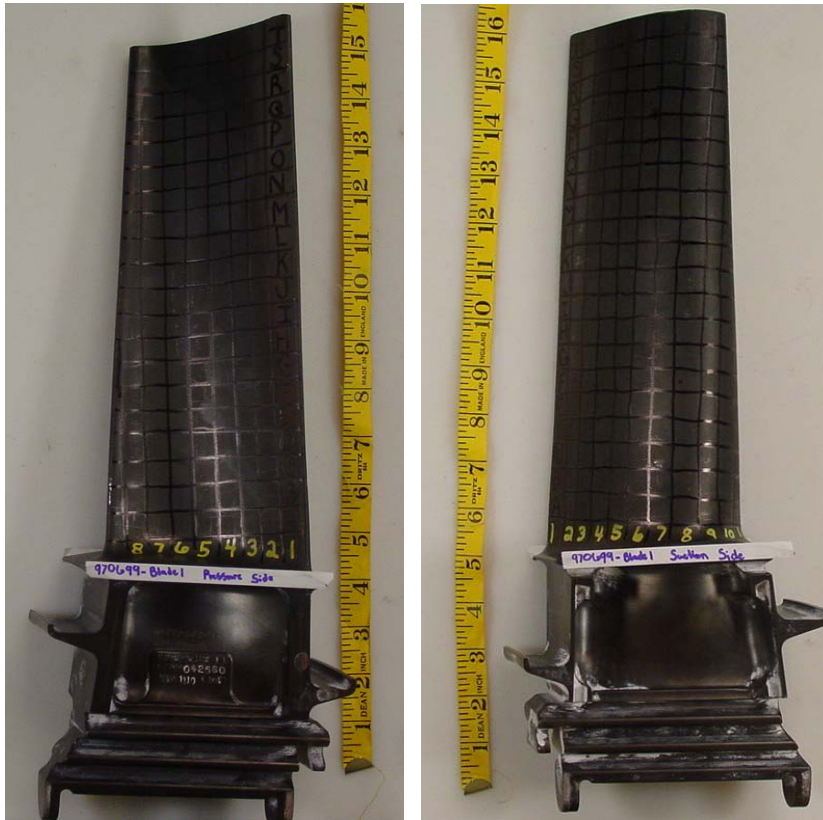
This 2nd stage bucket has undergone 24,000 hours of base-loaded operation with only 40 startups. This blade was taken out of service from the 7FA+ engine (7231FA) and is made of GTD-111 base material with GT 33+ duplex coatings. This blade came out of a base-loaded unit. Figure 6-1 shows an overall layout of the inspected 2nd stage bucket that has been gridded out for eddy current measurements.

Figure 6-1. Details of the grid marks from the pressure and suction sides of the 2nd stage bucket coated with GT 33+ coating

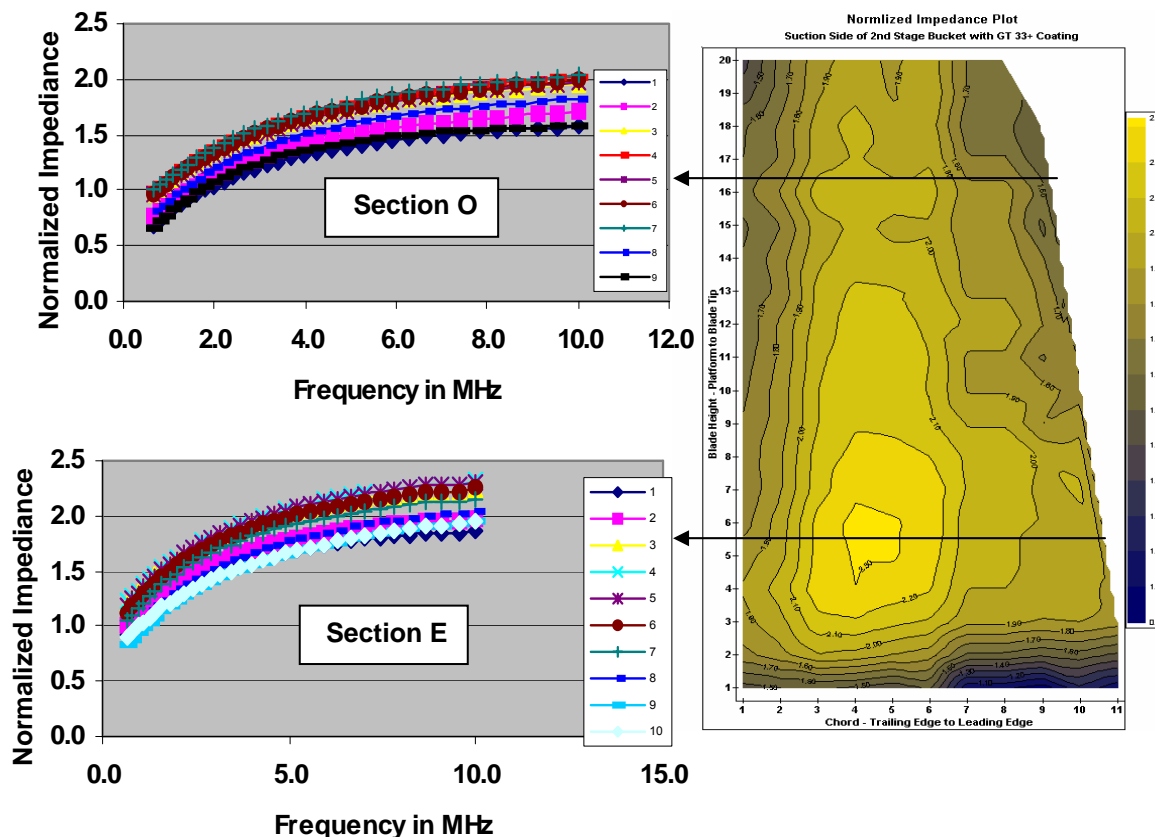
Figure 6-3 shows normalized impedance plots from Sections E and O along with the composite contour plot of normalized impedance plot from the entire suction side. No obvious cracking (negative slope) or typical beta-depletion (flat line with no slope) curves were noted. In general, higher normalized coil impedance values were noted at Section E than Section O. This generally indicated that more normal coating conditions are found at Section E than Section O.

Figure 6-3. Normalized Coil Impedance Plots from Sections E and O and a Composite Contour Plot of Normalized Impedance Plot from the Entire Suction Side

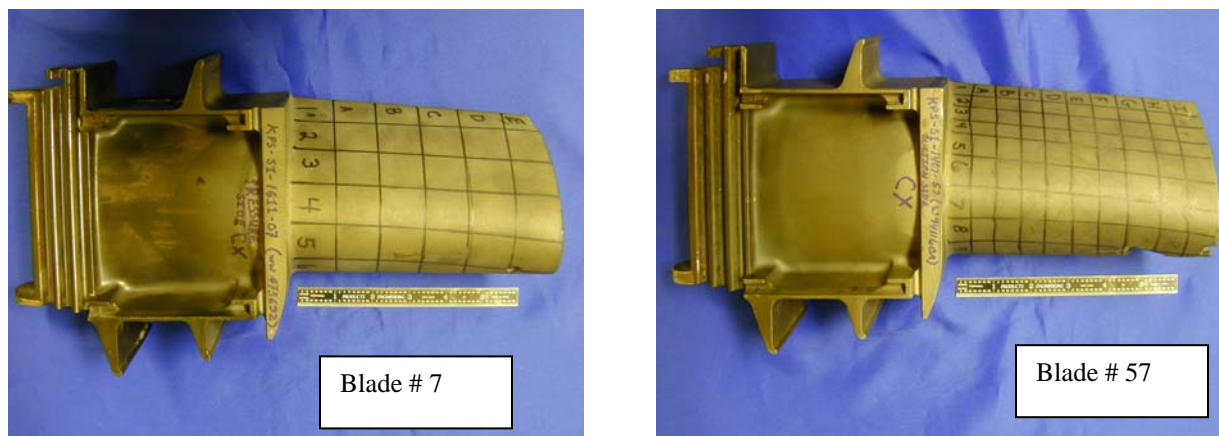
Following NDE evaluation, two service-run GE Frame 7FA blades (# 7 and 57) were received at SwRI. It was reported that Blade 7 had seen 8286 hours of operation with 670 start-stop cycles. Blade 57 had seen 2000 hours of operation with 219 start-stop cycles after the blade was refurbished. The blade was refurbished after it had seen 14,795 hours and had experienced 518 start-stop cycles.

Figure 7-1: Photograph of Blade 7 showing grids on the airfoil sections of Blades 7 and 57 where NDE measurements were taken. Note smaller squares on Blade 57.

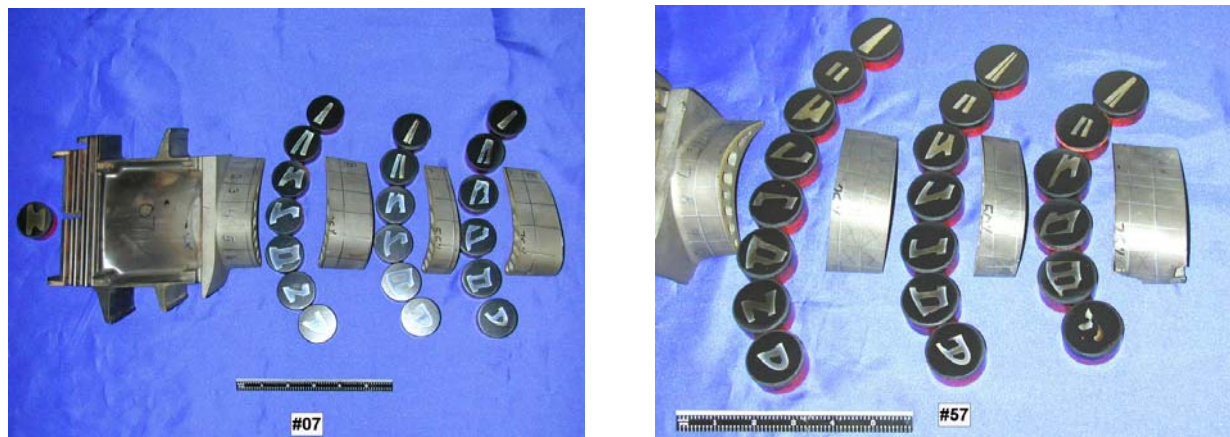
Figure 7-2: Photographs showing metallurgical sample locations in Blade 7 and 57

These examinations of the mounts showed that these blades had over aluminized NiCoCrAlY coating (GT 33 Plus). Thermal-mechanical fatigue (TMF) cracks were seen on the convex side of the airfoil near the leading edge of Blade 7. Majority of the cracks in this blade were shallow and only a crack in the blade at 25% height had extended into the substrate. Blade 57 was more severely cracked than Blade 7. On Blade 57, TMF cracks were observed on both the convex (suction) and concave (pressure) sides of Blade 57. Several cracks in Blade 57 at different blade heights were extended into the substrate. Morphology of TMF cracks is shown in Figure 7-3.
